Status Investigation and Damage Analysis of the Dougong under the External Eaves of the Main Hall of Chuzu Temple in the Shaolin Temple Complex

Ziyin Yao,^{a,#} Yilin Que,^{b,#} Xiaolin Yang,^{c,#} Qicheng Teng,^d Zherui Li,^a Xiaolan Zhang,^a Weizhen Cai,^a Hongyi Lv,^c Tongyu Hou,^a Yifan Liu,^a and Zeli Que^{a,*}

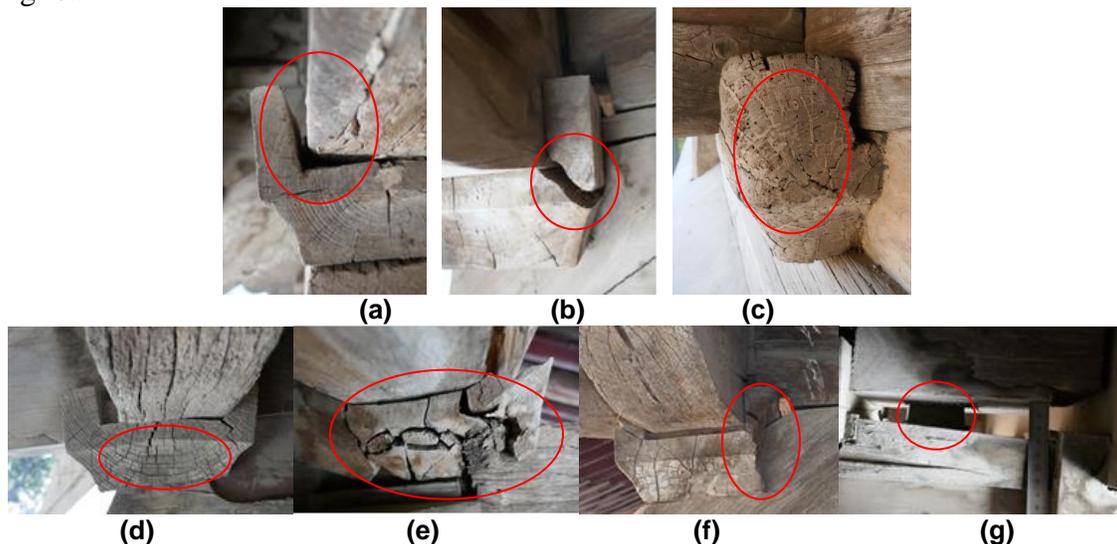
The main types of damage (Fig. 5) included detachment, plucking (tenon pulled out), holes, cracking, crushing, separation, and missing parts. The summary statistics of the damage types are shown in Table 1. Percentages of the various damage types are shown in Fig. 6a.

Fig. 5. Main types of damage: detachment (a), separation (b), holes (c), cracking (d), crushing (e), missing parts (f), and plucking (g)

Among all of the damaged members, the number of members with cracking damage was 241, which was the largest amount and accounted for a high proportion of the damage (32.8%). The number of cracked members of the east dougong was 56. Because the dominant wind direction in Dengfeng area is the northeasterly wind, the cracks resulting from degradation defect of wood material in the east was more significant. The Secondly, there were some members with detachment damage, which accounted for 8% of all of the damaged members. The number of members with hole defects accounted for 5.2%. The north side of the building was less exposed to sunlight and the roof is leaking, so the dark and humid environment was suitable for fungi and termites. Therefore, the hole damage in the north side was more significant than other three sides, and there were 20 members of the north dougong with holes caused by bioerosion. The plucked members accounted for 2%, and the proportion of the members with crushing damage was 1.8%. Additionally,

The east dougong members were mostly damaged by wormholes and cracking. The materials of said members were affected by material degradation. The members of the north dougong were damaged during rainy and snowy days because of water leakage from the roof during rainy and snowy days. As a result, problems involving decay and wormholes were notable, and cracking damage on the end surface of the members was common. The members of both the east and north dougong had relatively obvious cracks, which cracked along the direction of the wood rays, and both were affected by bioerosion. On the south and west sides, the members frequently had cracks that resulted from material degradation. Additionally, the detachment, plucking, and missing part damage types occurred in the dougong members on the south and west sides. As for the corner dougong, most of the members were installed during restoration according to the restoration records. Therefore, material degradation and cracking were not severe compared with other dougong. However, some members were crushed because of heavy load-bearing.

To prevent the dougong under the external eaves of the main hall from being further damaged by dampness or biodeterioration, it is necessary to improve their moisture-proof conditions and keep them as dry as possible. Rain and snow should be cleared off the roof during and after rainy and snowy days. Preservative treatment should be done for the

members susceptible to dampness and biodeterioration. The wood preservatives should meet the relevant requirements stated in GB 50165-92 (1993).

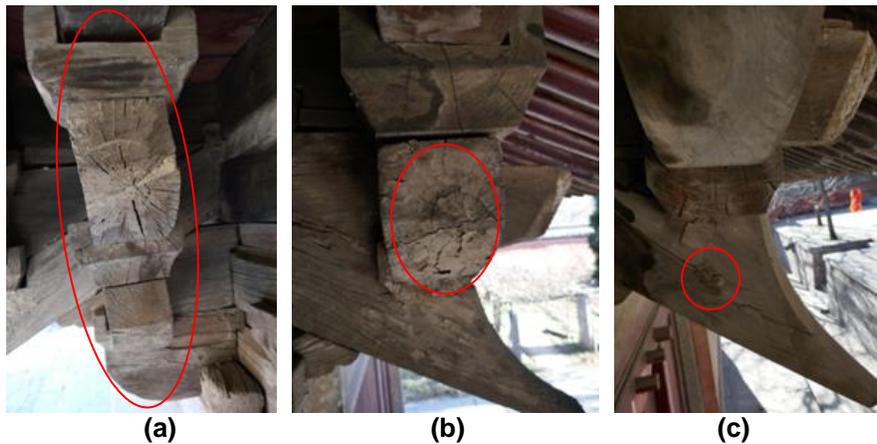
In addition to the seven main types of damage, there were some other defects (Fig. 7), such as incline, exfoliation, and knots. For instance, incline was observed in C4-D4 East-north Bu, C4 East-north Tou, and A2-A3 South-door East, and appeared in the vertical central axes of the members (Guazi gong (瓜子拱) and the dou above it, and Waitiao Mangong (外跳慢拱) and the dou above it) that were not in the same line. The ang (昂) member of the C4 East-north Tou inclined downwards. The surface materials of the west end surface of the ling gong (令拱) member of A2-A3 South-door East were exfoliated. There was a knot with cracks in the ang member of D3 North-east Tou.

Fig. 7. Examples of other types of damage: incline (a), exfoliation (b), and knot (c)

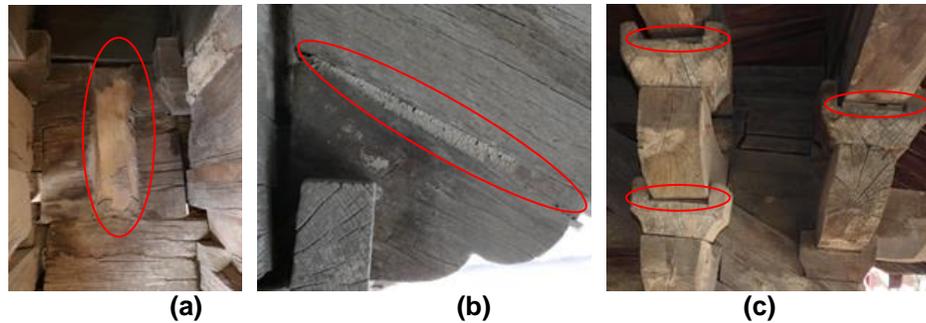
Some members had been repaired and reinforced in the past. The shuatou (耍头) members of B4 East-south Tou, A2 South-west Tou, and D2 North-west Tou had been reinforced with fabric (Fig. 8a). Wedges (Fig. 8b) were present above the huatouzi (华头子) members of B4-C4 East-middle Bu, A3 South-east Tou, and D3 North-east Tou. Padding blocks (Fig. 8c) were found in some dou members. Figures 8 shows examples of repairs.

Fig. 8. Examples of repairs: fabric reinforcement (a), wedges (b), and padding blocks (c)

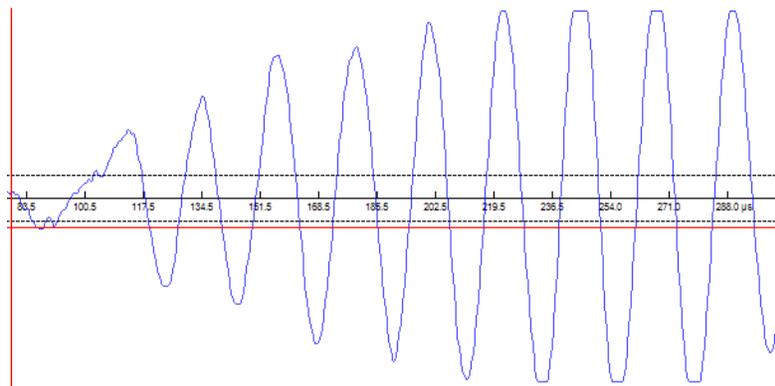
The ultrasonic propagation velocity in the dougong members was around 1600m/s. But the inside defects should be further studied because the ultrasonic velocity was affected by many factors on site. Figure 9 shows output of tests with an oscillogram.

Fig. 9. Ultrasonic oscillogram
