Detection and Analysis of an Eave Purlin of the Timber Building Eroded by Carpenter Bees Based on Computed Tomography

Xiaoxia Yang,^a Yisheng Gao,^{b,*} Ziyu Zhao,^a Zhedong Ge,^a Xiaoping Liu,^a and Yucheng Zhou^a

DOI: 10.15376/biores.17.2.2443-2456

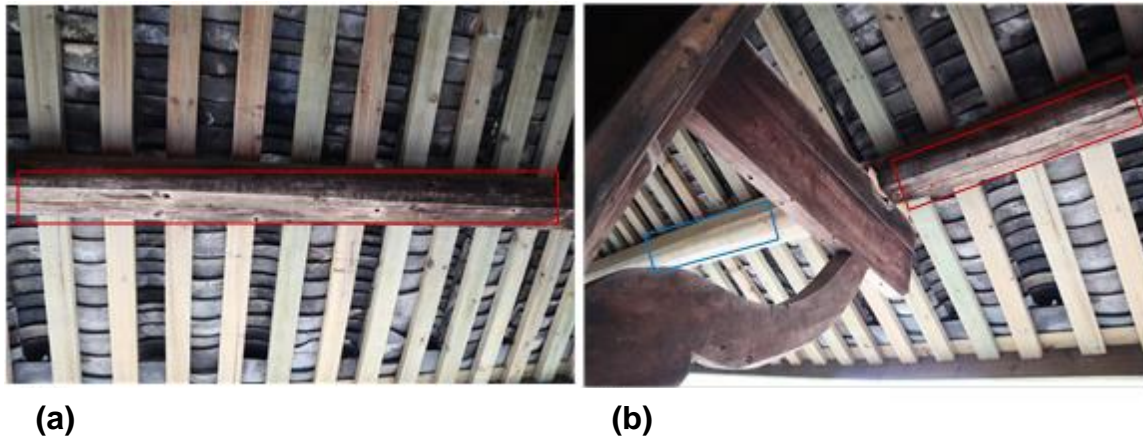
Fengqi Wu's mansion in Zherong County, Ningde City, Fujian Province (27.19 °N, 120.06 °E) is a timber building (You 2016). Eave purlins are important building components that bear the weight of the roof. It is necessary to study the influence of carpenter bees on it. Figures 1 (a) and (b) show a photo of the eave purlin, where the part selected with the red box is the eave purlin. Obvious holes left by carpenter bees can be seen from the surface of the eave purlin. It can be seen from part (b) of the figure that the eaves purlin seriously damaged by carpenter bees has been replaced, and the part selected with the blue box is the replaced eave purlin. In the timber buildings, one of the eave purlins was built with *Cunninghamia*, 3000 mm in length and 250 mm in diameter. Because the eave purlin was too long for shipment, it was cut into three logs (Log A: 977.7 mm long, Log B: 998.5 mm long, and Log C: 990.1 mm long). There were some holes on the surface of the eave purlin, which were caused by carpenter bees. To estimate the degree of wood damage after being eroded by carpenter bees, logs were scanned on a CT (SIEMENS SOMATOM Definition AS, Berlin, Germany). The CT collected the attenuation data of X-ray energy after passing through the log, and the images of defects and holes in the log were reconstructed. The voltage and current of the X-ray source were set to 120 kV and

Fig. 1. Photos of eave purlin in ancient wooden structures; (a) The Eave purlin before replacement; (b) A purlin component has been replaced

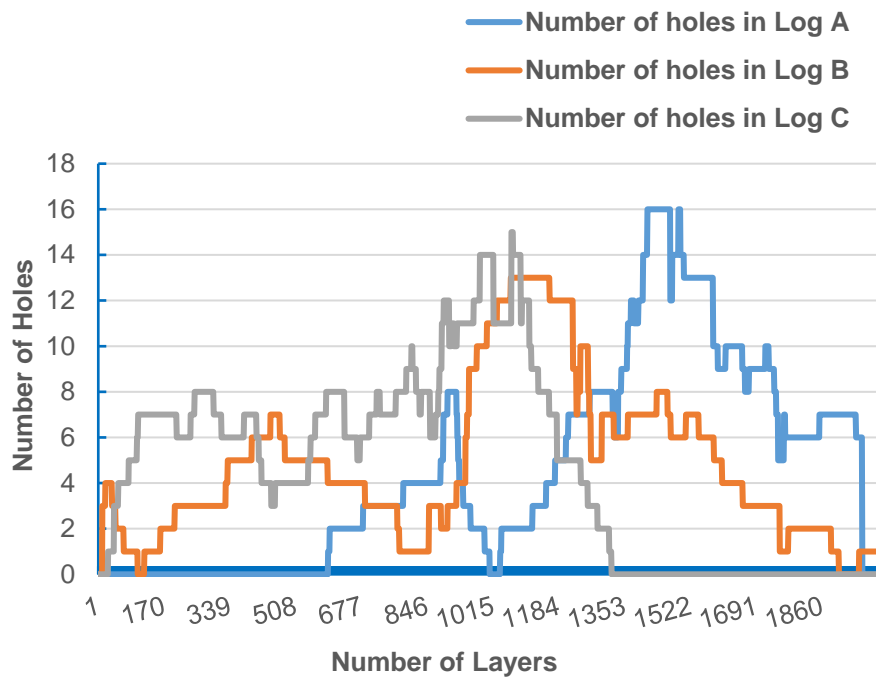
To obtain the distribution information of carpenter bee nests, multiple sections of logs were reconstructed, and each section was perpendicular to the growth direction of logs. As shown in Fig. 3., X coordinate represents the section number of each log, and Y coordinate represents the number of cross-sectional holes in the carpenter bee nests. Log A was damaged by carpenter bees from the 591st layer, and the damage gradually increased from the first hole, which was 295.5 mm away from the end of Log A. The 1411st to 1469th layers of logs were the most seriously eroded by carpenter bees, corresponding to 705.50 mm to 734.5 mm of Log A. There were at most 16 holes in a layer. Log B was the middle part of the eave purlin. There were only three holes in the first layer. The most seriously eroded by carpenter bees were the 1060th to 115th layers, which are located at 530 mm to 579.5 mm of Log B. There are at most 13 holes in a layer. The most serious damage of Log C by carpenter bees is from the 1062nd to 1085th layers, which were located at 531 mm to 542.5 mm. There were at most 15 holes in a layer. After the 1319th layer of Log C, the structure between 659.5 mm to 990.1 mm was not damaged by carpenter bees, because this part was the end of the eave purlin. Consistent with the previous inference, the end of the eave purlin is not easy to be eroded by carpenter bees, and the middle structure was most seriously damaged.

According to the distribution of carpenter bee nests in the eave purlin, both ends of the eave purlin were not eroded by carpenter bees. The direction of wood erosion by carpenter bees is random, so an eave is usually eroded by carpenter bees, resulting in multiple unconnected nests. Carpenter bees like to live in a high temperature environment, and the components near the flowers are vulnerable to carpenter bees (Pando *et al.* 2011; Azmi *et al.* 2012), so preventive protection measures must be taken in advance in this area.

Fig. 3. Statistics on the number of holes in transverse images of three logs

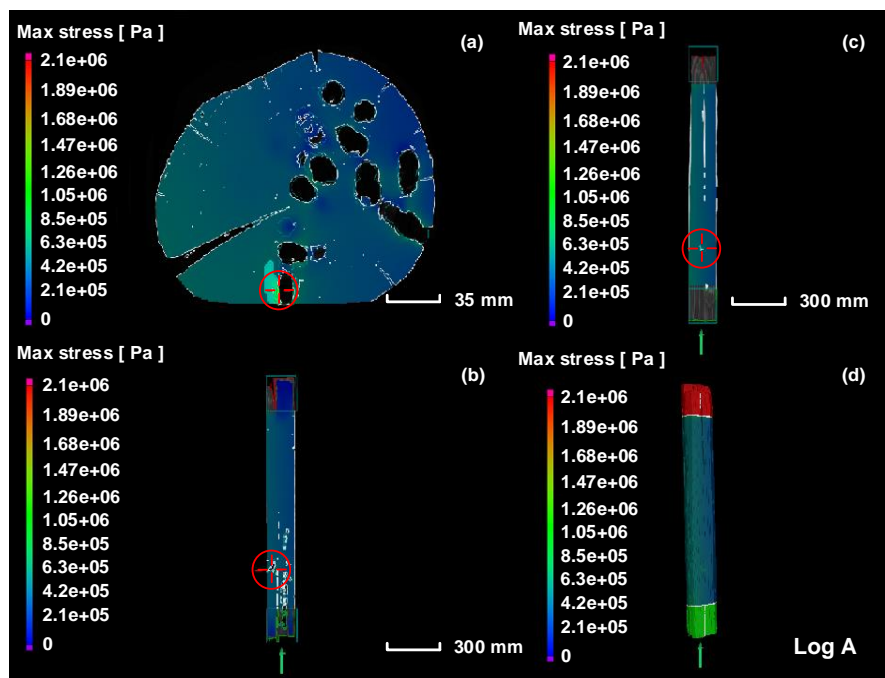
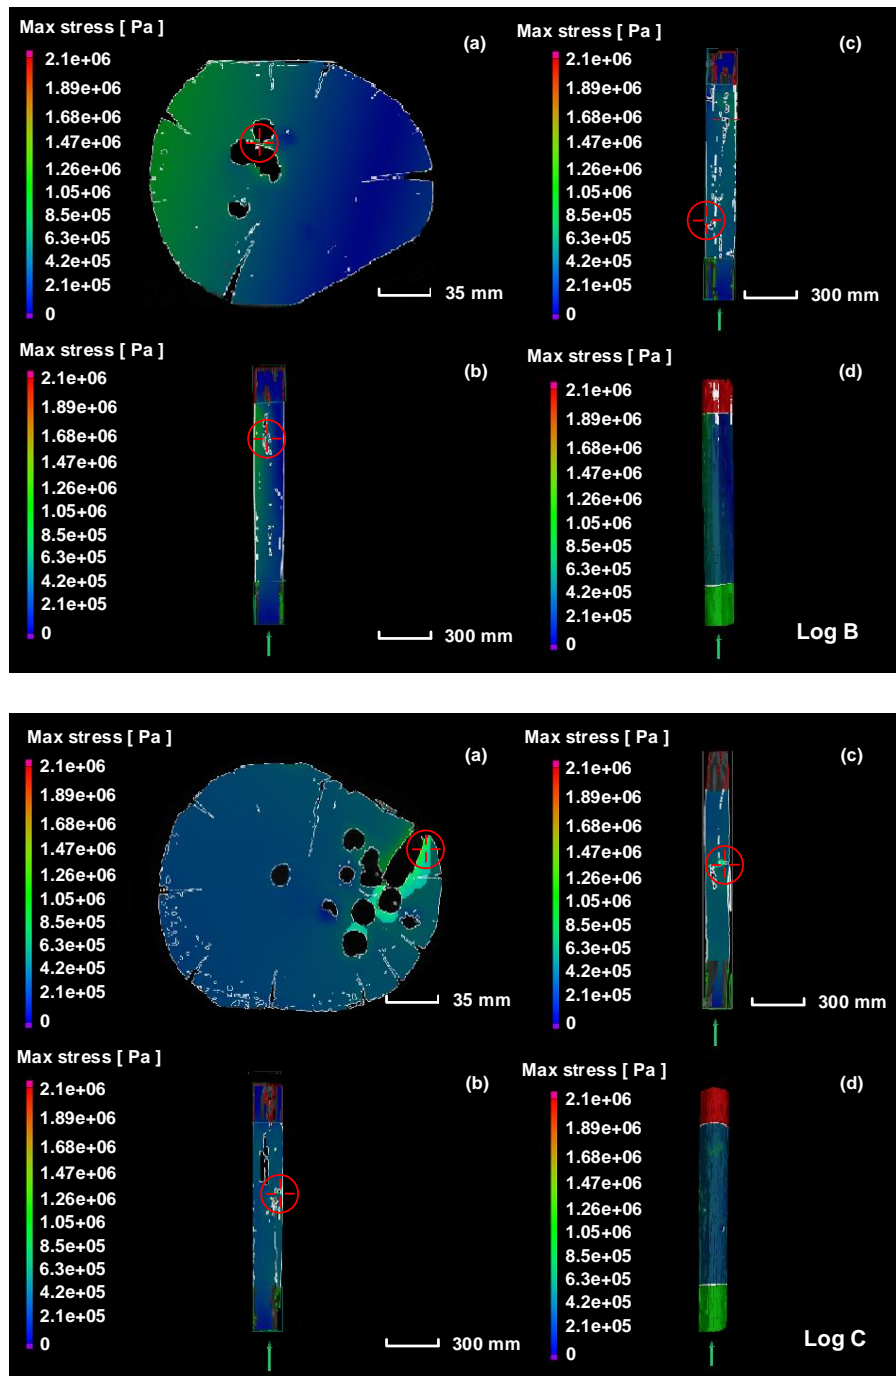
From Fig. 4, Log A, Log B, and Log C, it is possible to see the location and range of the maximum hot spot distribution of the maximum stress after directional force is applied. In the top view (a) of Log A and Log C, the position of the hot spot with the maximum stress occurred at the edge hole, and in the top view (a) of Log B, the position of the hot spot with the maximum stress was located at the larger part of the internal hole. It can be seen from the front view (b) and right view (c) of Log A, Log B and Log C that the hot spots with the maximum stress were mostly in the places with dense concentrations of holes. It is concluded that holes will reduce the mechanical properties of wood, and the directional force has a great influence on holes.

Fig. 4. Figure 4 shows the simulation results of three logs (Log A, Log B, Log C) under the directional force; (a) Represents a top view; (b) represents a front view; (c) Represents the right view; (d) Represents a stereogram

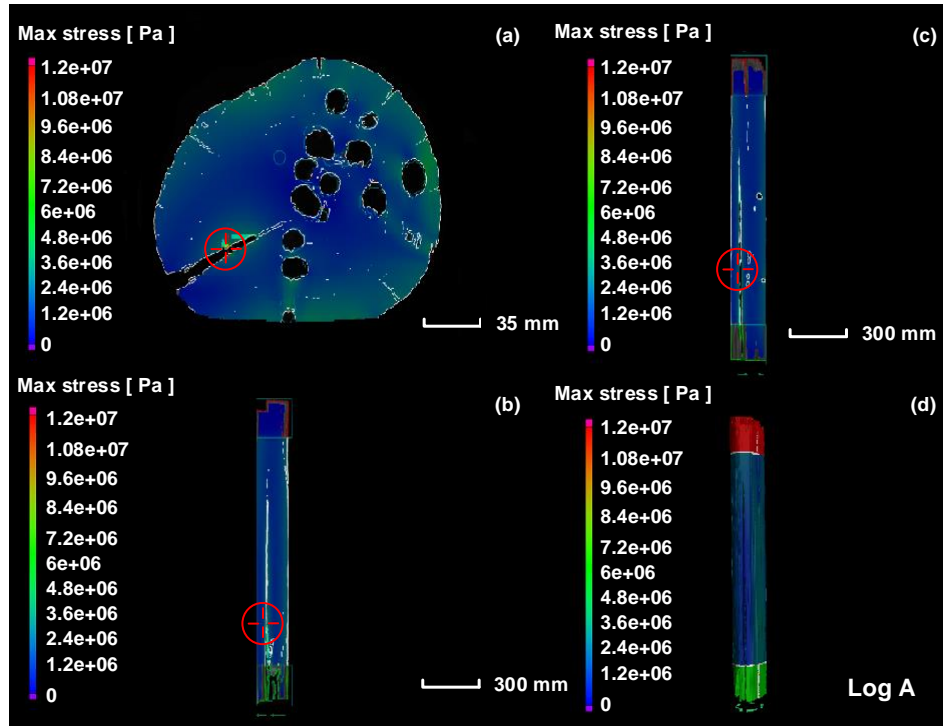
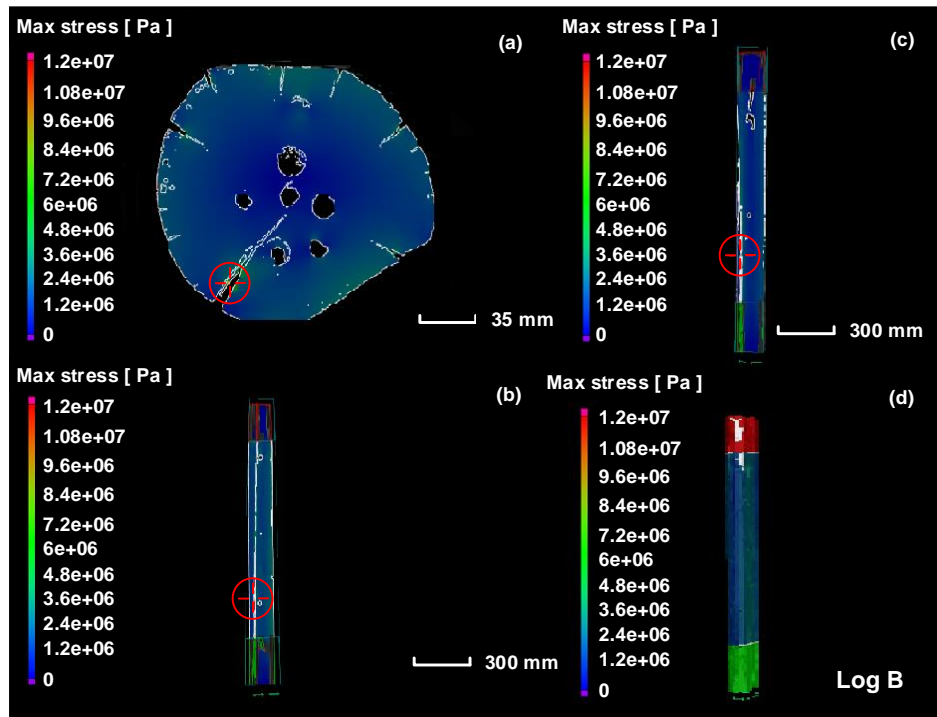
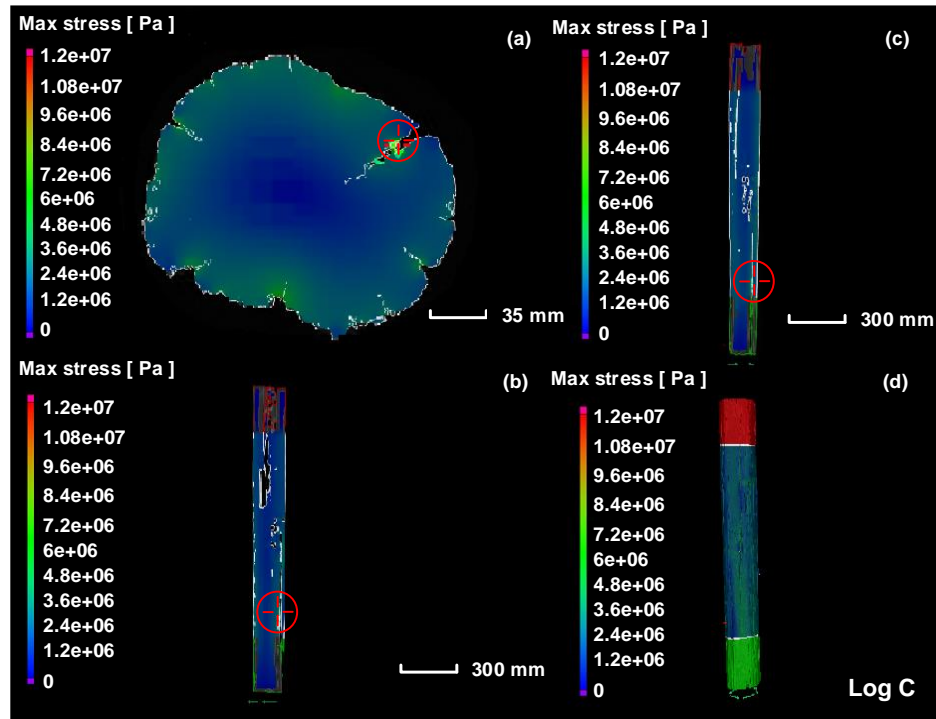
From Fig. 5, Log A, Log B, and Log C, one can see the location and range of the maximum hot spot distribution of the maximum stress after the torque force is applied. In the top view (a) of Log A, Log B and Log C, the hot spot with the maximum stress was located at the large crack.

According to the front view (b) and right view (c) of Log A, Log B and Log C, the hot spot of the maximum stress also occurred at the edge crack or large crack. It is concluded that cracks reduce the mechanical properties of wood, and the torsion has a great influence on cracks.

Fig. 5. Figure 5 shows the simulation results of three logs (Log A, Log B, Log C) under the torque force; (a) Represents a top view; (b) represents a front view; (c) Represents the right view;(d) Represents a stereogram
