Species and Deterioration of Woods Used in a Traditional Turkish House

Kamile Tırak Hızal *

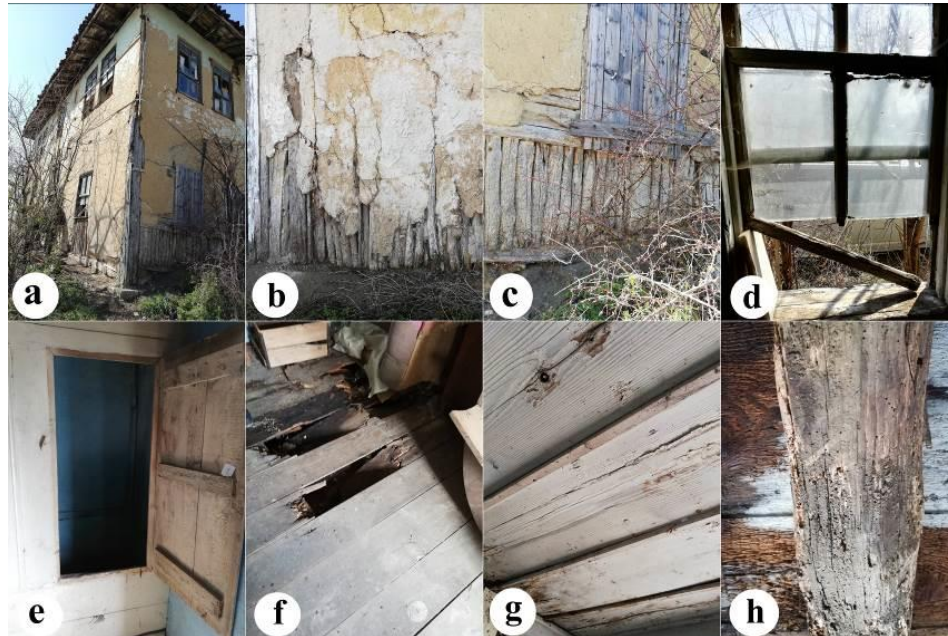
Fig. 2. Samples taken from the house in plot 1766: a: General aspects of house, b, c: Cripple studs, d: Window frame, e: Cabinet, f: Floorboard, g: Ceiling board, and h: Joist

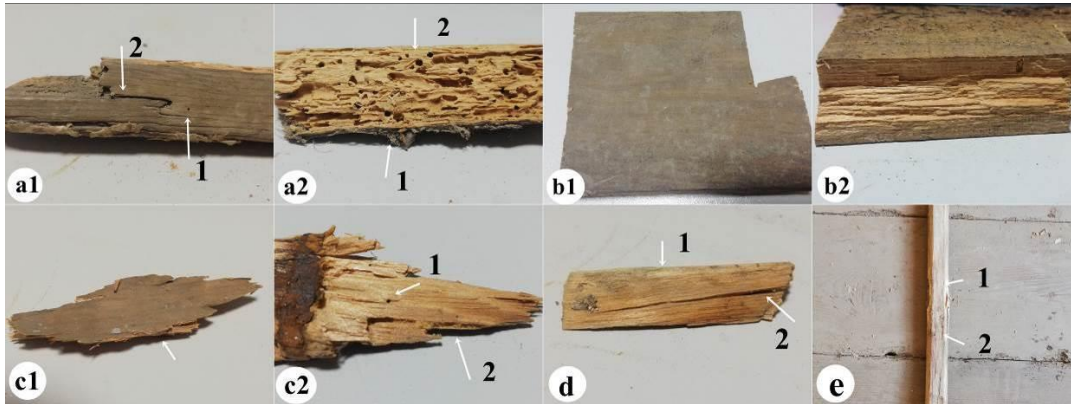
Fig. 3. Macroscopic views of floorboards, cabinet, window frame, and ceiling board. Floorboards: a1 – The wood surface in green, circular bore holes (arrow 1), cracks in wood surfaces (arrow 2); a2 – Eroded wood structure (arrow 1), larva galleries and several bore holes inside the sample (arrow 2), b1 – Upper surface of the floorboard, b2 – Small insect holes (≤ 0.1 mm) and brittle wood structure. Cabinet: c1 – Circular bore holes (≤ 0.1 mm) on the outer surface (indicate arrow), c2 – Circular bore holes (≤ 0.5 mm) (arrow 1), larva galleries on the inner surface (arrow 2). Window frame: d – White rot, 2– Fine cracks, and splits. Ceiling board: e – Small circular bore holes (arrow 1), 2 – Checks and raised grain on the surface (arrow 2)

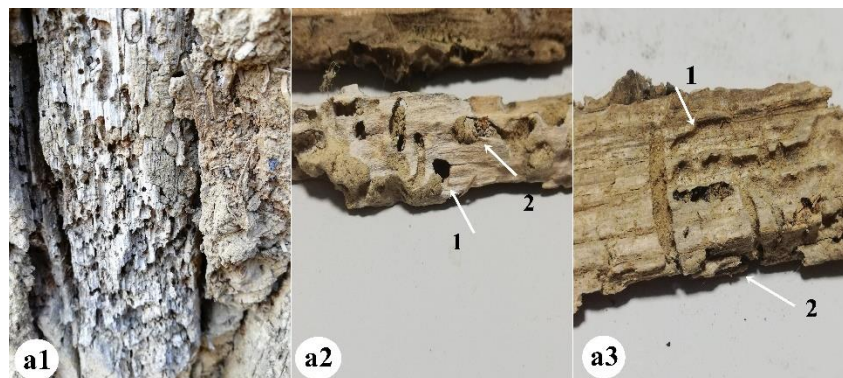
Fig. 4. Cripple studs: a1 – Visible bore holes; a2 – Light brown, intensive insects attacks, bore holes (arrow 1) and fecal pellets (arrow 2) visible on longitudinal sections; a3 – Larval galleries (arrow 1), cubic cracks (arrow 2)

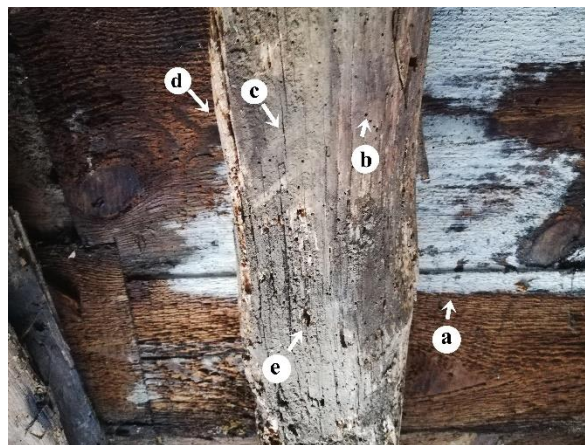
Fig. 5. Joist; a – Fungal attack, b – Bore holes of insects, c – Cracks in wood surfaces, d – Softened and bleached color, e – Large voids

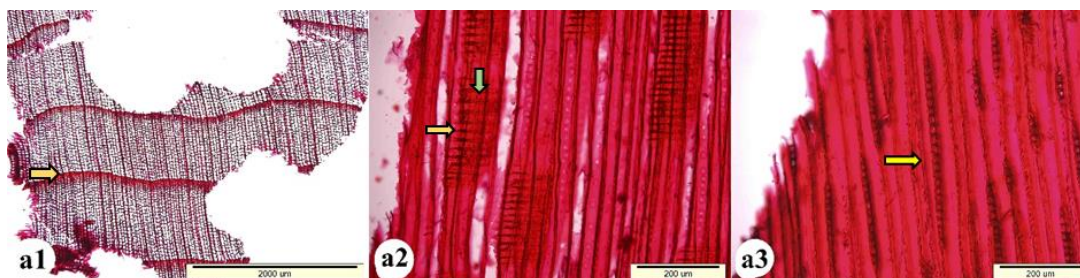
Fig. 7. Microscopic photographs of *Abies spp.* wood. a1, a2, a3 – Floorboard
