Factory-mounted and Retrofit Passive Resistance Sensors Adapted to Monitor Moisture Content in Timber Bridges

The biggest threats to the longevity of a timber bridge are rot and decay. Wood protection by design, inspections, and monitoring of the bridge for elevated moisture content will ensure that the full service life of the structure can be achieved. Today's sensors for moisture content measurements are limited in their functionality and range. This paper presents a sensor that can be both factory installed and retrofitted, which can measure the moisture content through the cross-section of the member in a timber bridge. The sensor has been mounted on Sundbron bridge during manufacturing and retrofitted on Gislaved bridge. The ensuing measurements helped to adjust a design flaw on Gislaved bridge. Monitoring of Sundbron showed that the bridge deck dried up after the bridge had been exposed to sleet and snow during the on-site assembly of the stress laminated bridge deck.

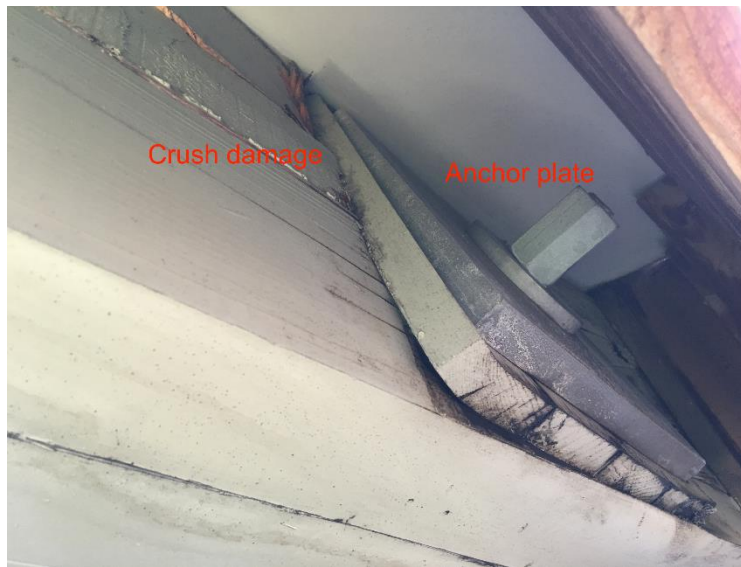
Fig. 1. Anchor plate crushing a rotten glulam beam

Bridges built in Sweden today have a required service life of either 40 years, 80 years, or 120 years (Anon 2004). The service life depends on the intended traffic and length of the bridge. Most timber bridges have a required service life of 80 years. The biggest threat to the service life is elevated moisture content (MC) levels in the wood. When the MC reaches over 20%, mold can attack the timber. For decay fungi to develop, the relative humidity (RH) must be over 95% and the MC over 25%, at temperatures between 0 and 45 °C (Viitanen 1994). The MC also affects the mechanical properties of wood up to the fiber saturation point, *circa* 28% MC for Norway spruce. An increase in MC decreases the mechanical properties (Ross 2010). Fjellström and Just (2017) presented the results from inspections of 17 Estonian bridges; one of the bridges was poorly designed and poorly maintained and showed decay so severe after six years of use, that it was demolished. High MC on the bottom of the timber bridge deck can lead to cupping of the deck. Swedish timber bridges are built with untreated spruce, because chemical treatments come with various environmental concerns. To ensure the full service-life of the bridge is reached, wood protection by design is used, and in-depth inspections are performed every six years. MC sensors can be a valuable complement to the two aforementioned processes. By measuring the MC at key points; the ends of the bridge decks, close to connections and attachments, *etc.*, the performance of the protection can be verified and give important data to bridge inspectors. Figures 1 through 3 show examples of rot and cupping from in-depth inspections of bridges.

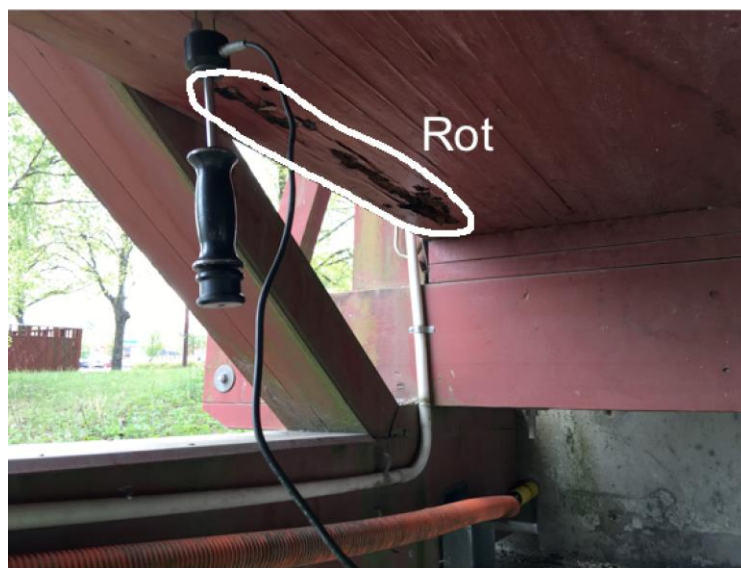
Fig. 2. The bottom of a pedestrian bridge with severe decay shown in the outer beam

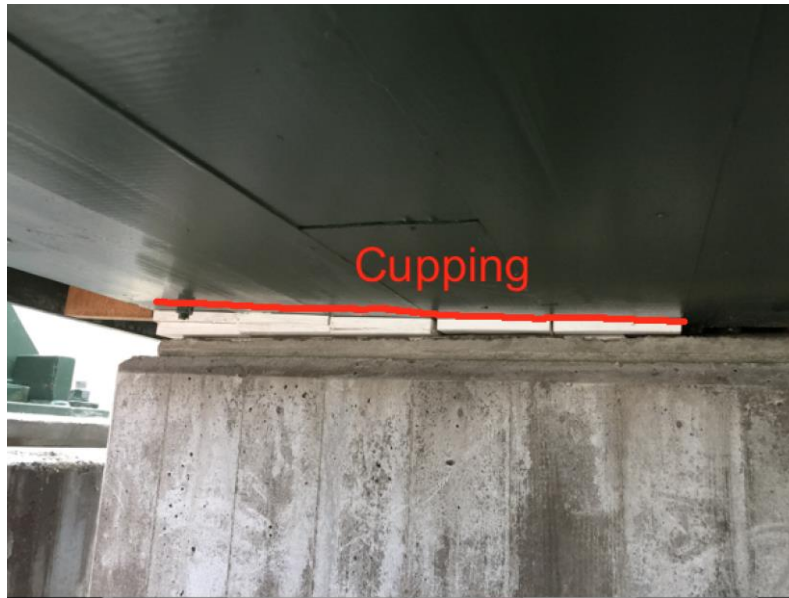
Fig. 3. Cupping of a stress laminated bridge deck, the white wedge have been inserted afterwards to give full contact between abutment and deck.

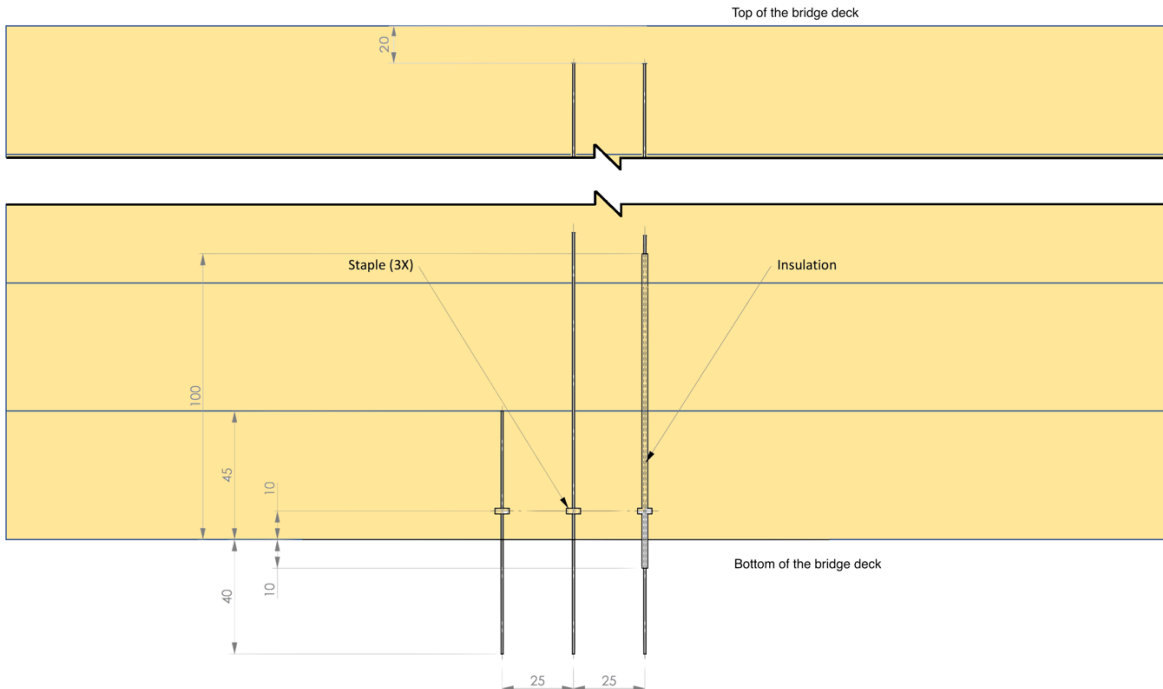
In Fig. 4, the schematics of the sensor are shown. Before the electrodes are clamped between two glulam beams, they are stapled on to the surface of one of the glulam beams to stay in place. The three electrodes give two measurement points, one close to the bottom of the bridge deck and one that measures from the middle to right below the top of the bridge deck. Measurement point 1 (MP1) uses the 45 mm long left electrode, and the middle electrode which is 20 mm shorter than the height of the bridge deck, to measure the lowest resistance from the bottom of the bridge deck to a depth of 45 mm.

Fig. 4. Schematics of the sensor: three electrodes making two measurement points, one close to the bottom of the deck, and one for the middle and top of the deck. All measurements are in millimeters.

Measurement point 2 (MP2) consisted of the right and middle electrode, where the right electrode is isolated with shrink tubing for the first 100 mm. The MP1 will measure the lowest resistance from the end of the isolation to the end of the electrode, 20 mm below the top of the bridge deck. The lowest resistance measured answers to the highest MC. The factory mounted sensors used stainless steel wire with a diameter of 0.75 mm for the electrodes. For the retrofitting, stainless steel electrodes with a diameter of 2.4 mm were pushed into the drilled holes. Each bridge also had two thermocouples installed, one on the south facing side and one on the north facing side. The thermocouples are located 25 mm to the left from the short electrode and 100 mm from the bottom. The ends of the electrodes were collected by push-in wire connectors and connect to a terminal block. The wires are zinc coated to ensure the sensor will last as long as the service life of the bridge. An IP 65 classed junction box protects the sensor from the elements (see Fig. 5). Resistance measurements were then made with a standard Delmhorst moisture meter (Delmhorst Instrument Company, Towaco, NJ, USA), with a connector fitting the terminal block. The resistance data acquired was then converted to a MC% using two formulas (Björngrim *et al.* 2017) for the two electrode lengths.

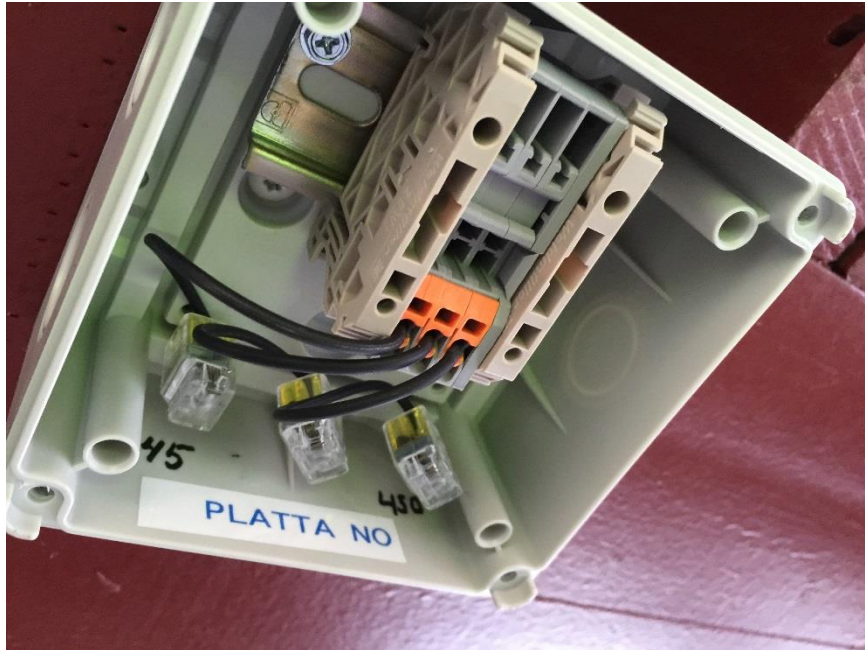
Fig. 5. The sensor mounted on the bottom of a bridge deck

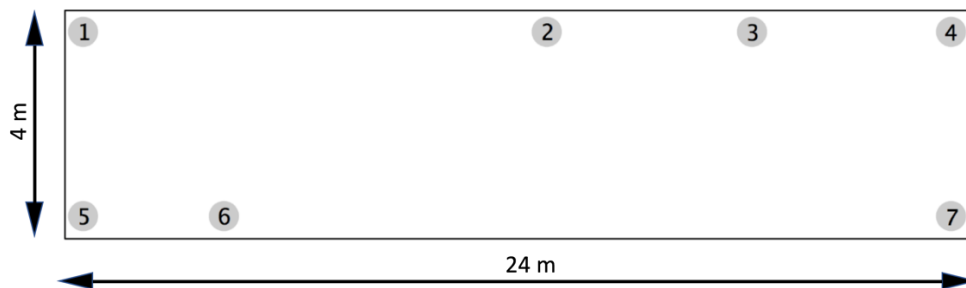
Figure 6 shows the sensor placement. Sensors 2 and 3 were wired to the junction box for sensor 4, allowing sensors under the span to be measured. Analogously, sensor 6 was wired to the junction box for sensor 6. The thermocouples are located at 1 and 7.

Fig. 6. Schematic top view of the bridge deck of Sundbron Bridge, the locations of the seven sensors are shown.

At the end of the construction phase, Sundbron was equipped with passive sensors at the bridge factory. The sensors were clamped between the first and second glulam beam and transported as a unit to the bridge site. Sundbron has seven MC sensors and two thermocouple measuring the temperature of the bridge deck.

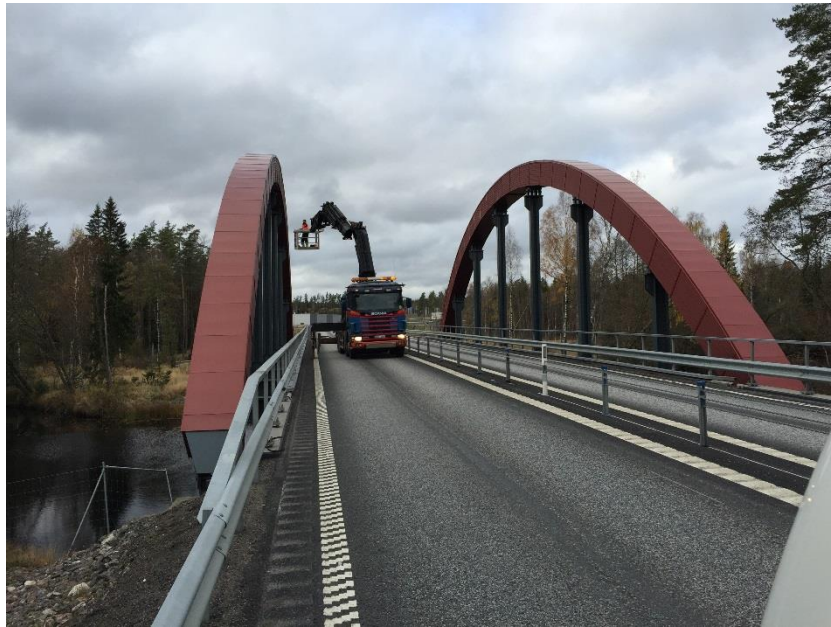
Fig. 7. Mounting a sensor on the south arch from the aerial work platform

The bridge was retrofitted with 16 MC sensors and two thermocouples. Figure 8 shows the location of the sensors; the thermocouples are installed at location 4 and 13. The process of attaching the cables for the sensor wires and installing the sensors on the Gislaved Bridge was completed in two days. To reach the arches and the bottom of the bridge, an aerial work platform was used. The work required the closure of one lane each day.

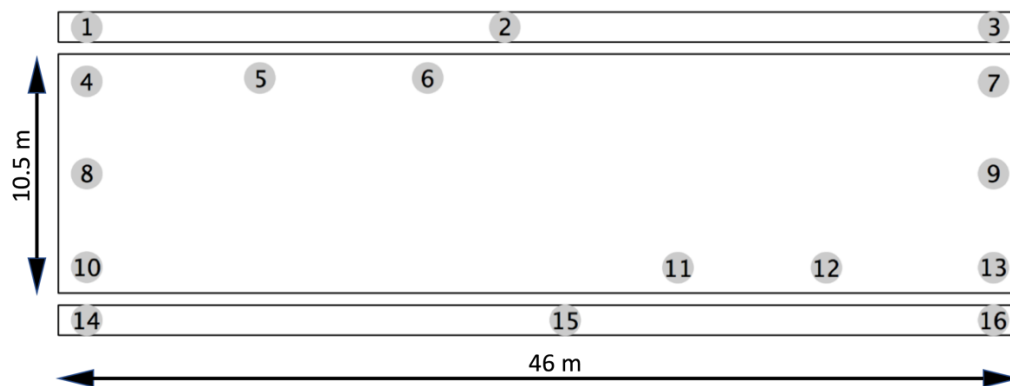
Fig. 8. Schematic top view of the Gislaved Bridge and sensor location.

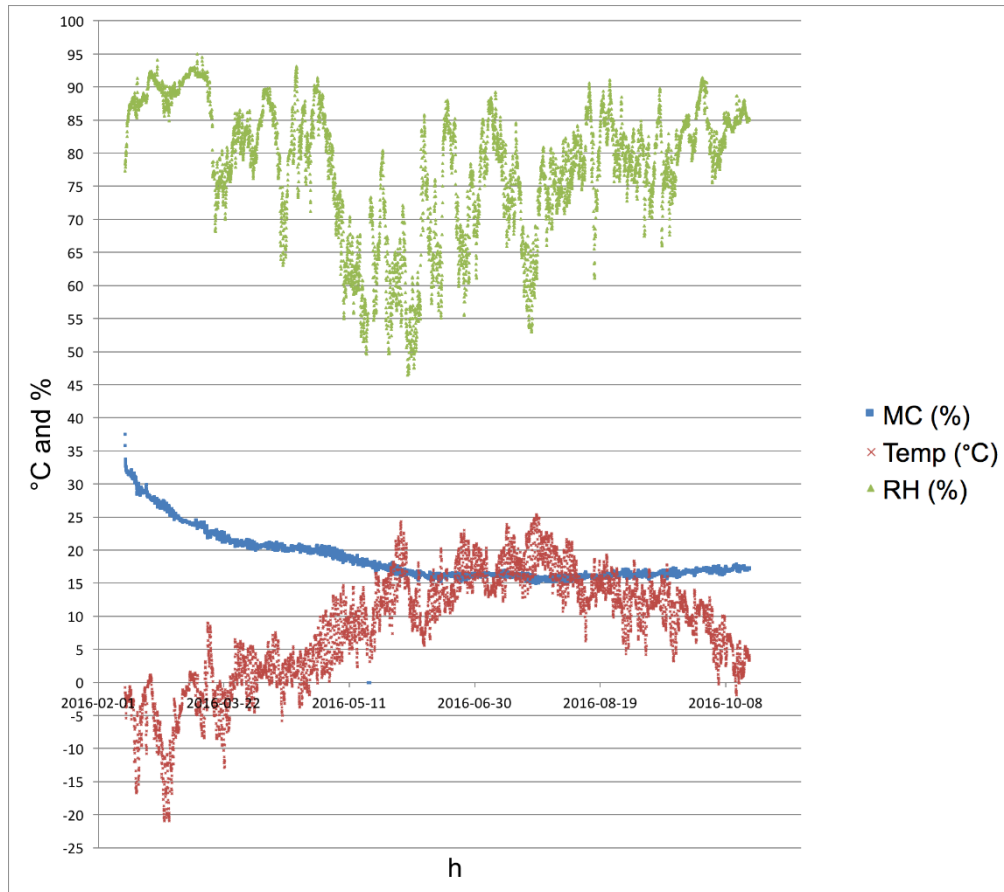
the data collection. The data were recorded every hour from February 2nd until October 17th, and results are shown in Fig. 9. The high MC found in sensor 1 Deck NW is from water vapor from the water below, which condenses on the bridge deck. Moisture also was attributable to the conditions under which the bridge was assembled. The monitoring of the MC also show that the bridge deck dries down to acceptable levels during the spring and early summer, and a slight increase in MC in the fall as the RH is increasing.

Fig. 9. Monitoring of point 1 at 45 mm depth at Sundbron; MC, RH, and temperature from February to October

5. The long-term monitoring of Sundbron showed that, after the bridge's wet start during the assembly, the surface moisture on the bottom of the bridge deck dried down to normal MC levels in the spring. The end of 2015 was mild and the water below the bridge had not frozen, which caused water vapor from the strait to condensate on the bottom of the bridge, together with the weather during the on-site assembly caused the initial high MC.
