Effect of Column Foot Tenon on Behavior of Larch Column Base Joints Based on Concrete Plinth

Keywords: Ancient timber structures; Wooden column; Larch; Column foot tenon; Hysteretic behavior; Concrete plinth

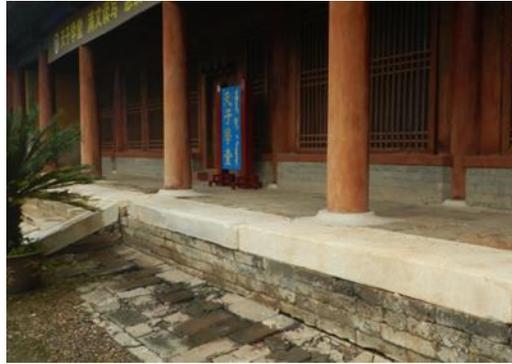
Fig. 2. Plinth of Qing Dongling (Zunhua, Hebei, China)

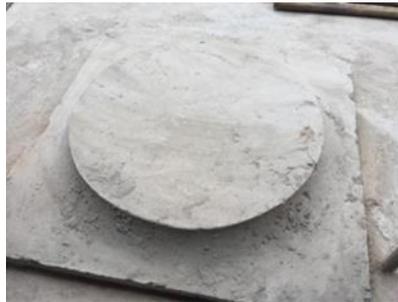
Fig. 3. Plinth ruins in the renovation of Nanjing Drum Tower (Nanjing, Jiangsu, China).

Secondly, the use of column foot tenons can be observed in the column foundation ruins of the ancient buildings on the site. Figures 3 through 8 illustrate the remnants of the plinth at the cultural relics site.

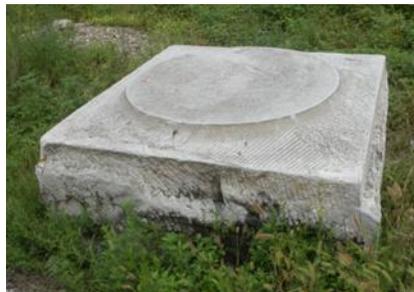
Fig. 4. Plinth ruins of Qing Dongling (Zunhua, Hebei, China)

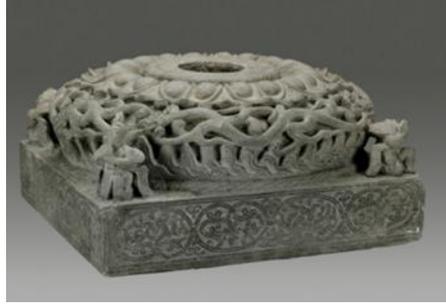
Fig. 5. Plinth of Sima Jinlong tomb in Northern Wei Dynasty (Datong, Shanxi, China)

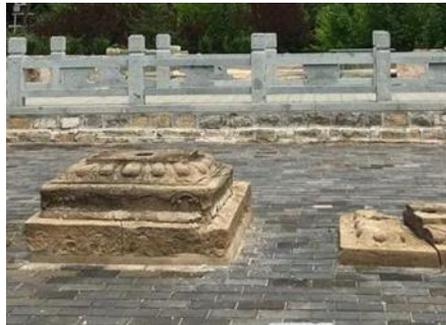
Fig. 6. Plinth of Shentong Temple in Sui Dynasty (Jinan, Shandong, China)

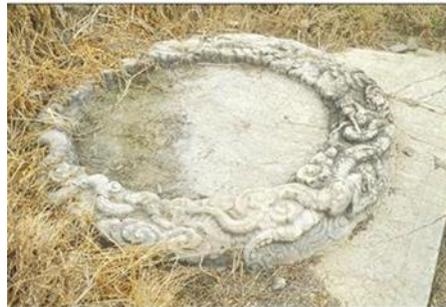
Fig. 7. Ruins of Panlong Plinth in the central capital of Ming Dynasty (Fengyang, Anhui, China)

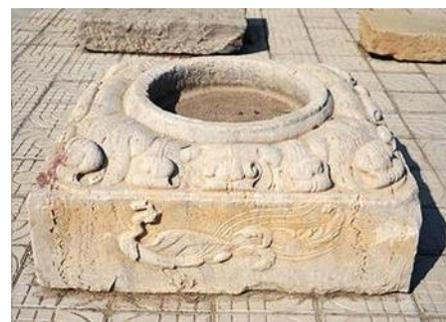
Fig. 8. Plinth of Shentong Temple in Sui Dynasty (Jinan, Shandong, China)

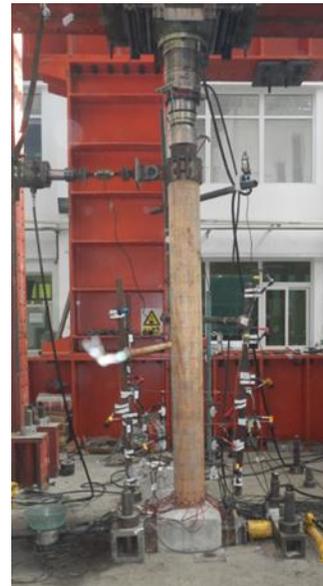
Fig. 13. Test loading site

The locations of the transducers are shown in Fig. 12, and the test loading site is shown in Fig. 13. The six vertical transducers (V_1 to V_6) were mounted to the side of the wooden column to measure the vertical displacement of the column. The lateral displacement of the column was obtained by seven horizontal transducers (H_1 to H_7). The lateral displacement of the column head was measured by the horizontal sensor H_8 . The original position of the column base was marked with blue before the test to observe whether the column base slipped during the test. If the column base slipped, the sliding position was marked with red.
