Racking Performance of Poplar Laminated Veneer Lumber Frames and Frame-shear Hybrid Walls

Yan Liu,^a Zizhen Gao,^b Hong-wei Ma,^{a,*} Meng Gong,^b and Honghe Wang^a

This study examined the racking performance of poplar laminated veneer lumber (LVL) frames using bolted steel filling plates to connect beam-column joints, poplar LVL frames using the embedment bars to connect beam-column joints, and frame-shear hybrid walls made of poplar LVL studs and oriented strand board (OSB) sheathing panels. A new design load spreader beam was used on the side of the top of a specimen to apply monotonic and cyclic loadings. It was found that the lateral force resistance, stiffness, and ultimate loads of poplar LVL pure frames with bolted steel filling plate connections and closed rod connections were much lower than those of the poplar LVL frame-shear wall hybrid structure. The highest initial stiffness of the poplar LVL hybrid frame-shear wall was 1.77 kN/mm, which was 24% and 22% lower than that of the conventional shear wall made with spruce-pine-fir studs and OSB or plywood sheathing panels, respectively. The poplar LVL frame-shear wall hybrid structure showed lower degradation in stiffness

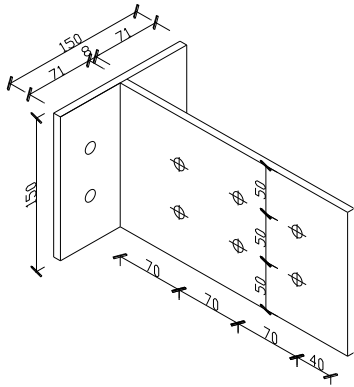
Fig. 1. Elevation of the steel filling plate

The KJ1 and KJ2 beam and column joint specimens were fabricated with bolted steel filling plates and rods, respectively. The connections of the beam and column joints for KJ3 were the same as those of KJ1. As shown in Figs. 1 and 2, 8-mm-thick Q235 steel plates and bolts with a nominal diameter of 8 mm and a strength of 8.8 grade were used to make bolted steel filling plate connections. Ten-mm-thick Q235 steel plates and bolts with a nominal diameter of 14 mm and a strength of 8.8 grade, as shown in Figs. 3 and 4, were adopted for the bolted steel filling plate connections at the LVL column foot. The rod connections of the beams and columns of specimen KJ2 are shown in Figs. 5 and 6. A threaded rod of 12 mm in diameter and a strength of 8.8 grade was used. The penetration depth of rods used should be greater than 15 times the diameter of the rods used to avoid brittle pulling-out failure. The penetration depth was 200 mm.

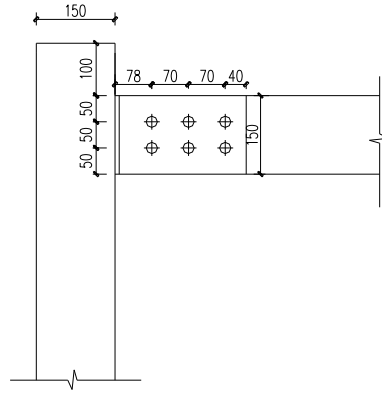
Fig. 2. Axonometrical drawing of the steel filling plate

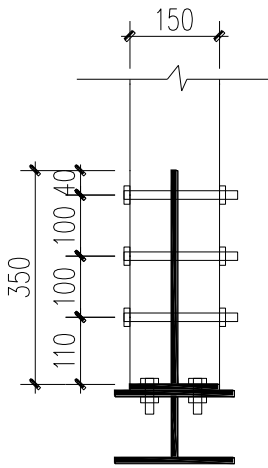
Fig. 3. Profile of the column base joints filling plate

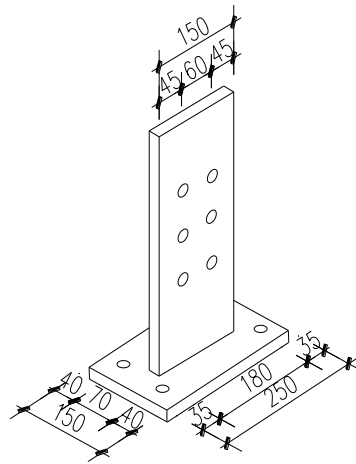
Fig. 4. Axonometrical drawing of the column steel filling plate

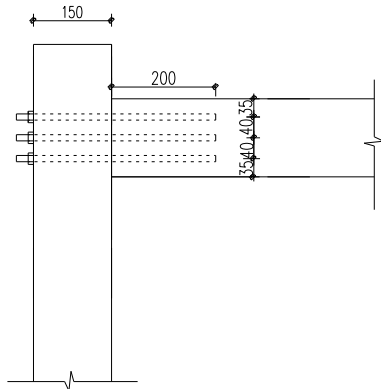
Fig. 5. Facades of the planting bar joints

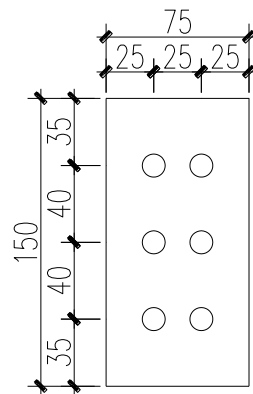
Fig. 6. Position site of the planting joints

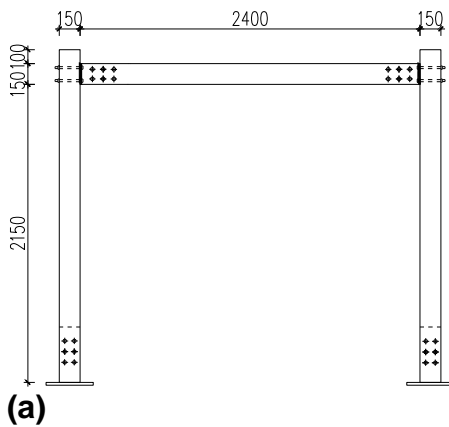
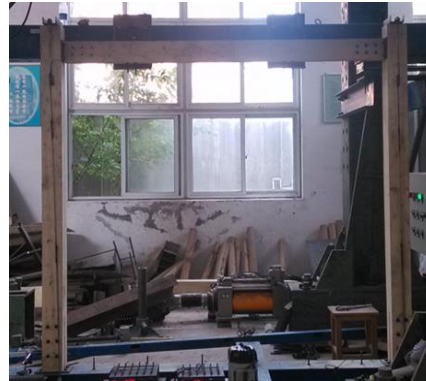
Fig. 7. Steel filling plate bolt connection of LVL frame KJ1: (a) Design; (b) Photo

For the racking resistance test, three types of specimens (KJ1, KJ2, and KJ3) were used. Each group had two specimens, which resulted in a total of six specimens, namely KJ1-a, KJ1-b, KJ2-a, KJ2-b, KJ3-a, and KJ3-b, where "a" denotes the specimen used for the monotonic load test, and "b" denotes the specimen used for the cycle load test. The specimens are illustrated in Figs. 7, 8, and 9.

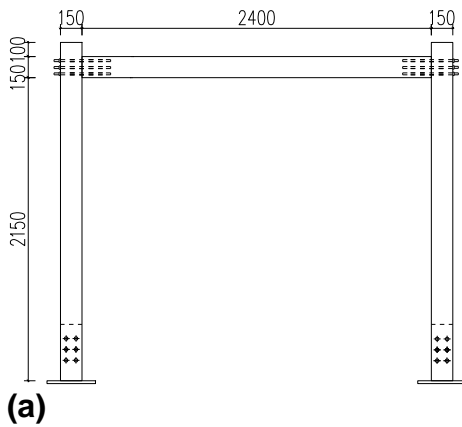
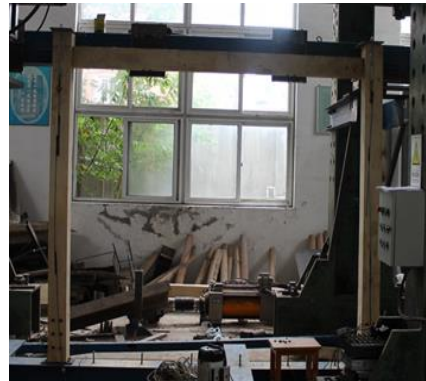
Fig. 8. Rod joint connection of LVL frame KJ2: (a) Design; (b) Photo

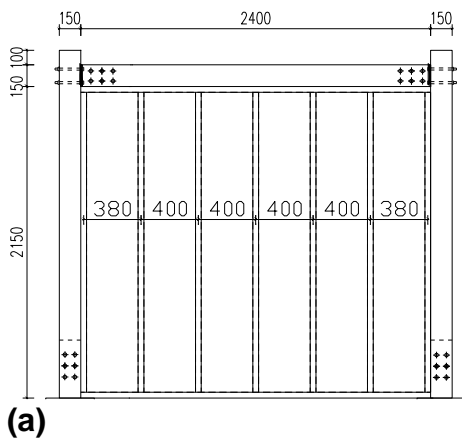
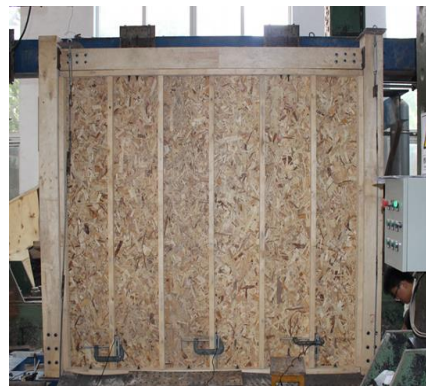
Fig. 9. Frame with frame-shear wall hybrid structure KJ3: (a) Design; (b) Photo

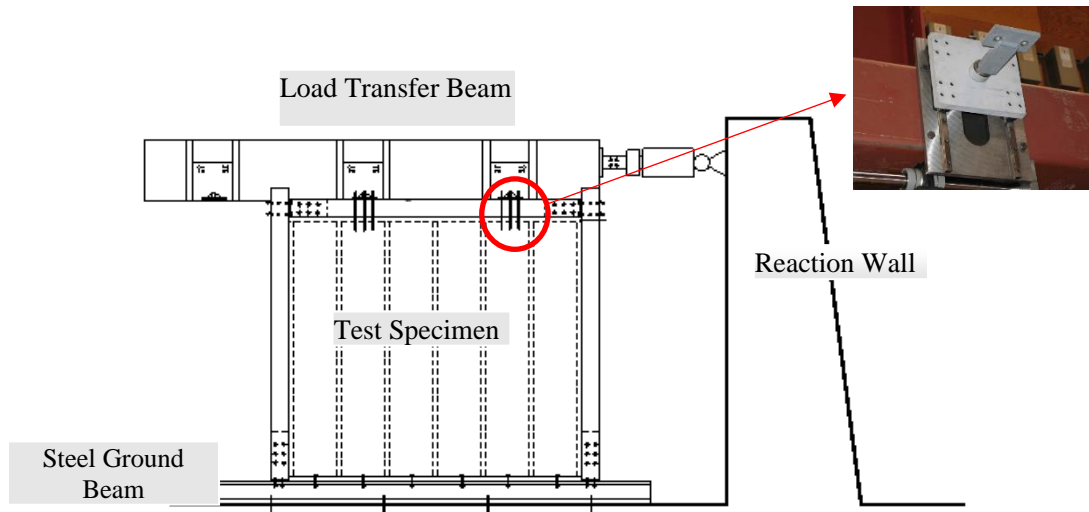
Fig. 10. Experimental setup for testing a wall

A novel lateral horizontal loading device developed by Liu *et al.* (2008) was used, which was available at the Structural Laboratory, Yangzhou University, Yangzhou, China. This device kept the applied load unchanged due to the load head at the lateral edge. The load head shifted along with and to offset the shifting of the specimen caused by the action of lateral force, as shown in Fig. 10. The novel loading beam does not restrict the lateral

and vertical movements of a specimen subjected to the lateral loading, and it can also ensure the effective transferring of lateral loads.

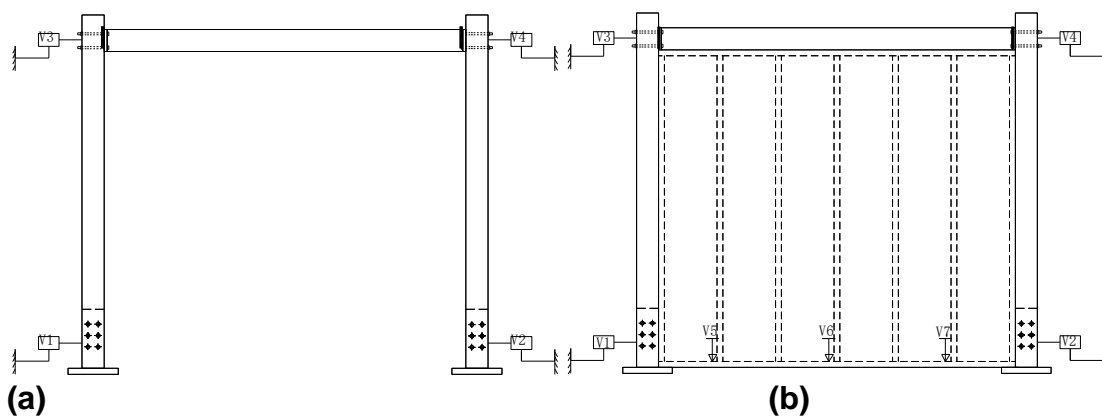
Fig. 11. Test point layout: (a) layout of the pure frame measurement points; (b) Wood frame-shear wall measuring point layout

For the pure LVL frame specimens (KJ1 and KJ2), two linear variable differential transducers (LVDTs) (V_1 and V_2) were mounted at the column foot, and two LVDTs (V_3 and V_4) were installed at the axis points at both ends of the beam. For the timber frame-shear wall hybrid structure specimens (KJ3), in addition to the four LVDTs (V_1 , V_2 , V_3 , and V_4) arranged at the column bottom and beam ends, three additional LVDTs (V_5 , V_6 , and V_7) were installed on the longitudinal wall bottom beam plate to measure the vertical relative displacement between the stud and steel foundation beam. To optimize the test and analyze the global and local deformation properties of the specimens, a dial indicator was also placed on the frame to measure the displacement of the specimen stud relative to both the top and bottom beam plates and the rotation angle relative to the frame. Figure 11 illustrates the detailed arrangement of the LVDTs (V_1 to V_7).

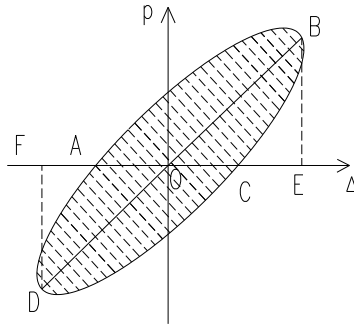
Fig. 12. Calculation of the equivalent viscous damping coefficient

where $S_{ABC+CDA}$ is the area enclosed by the hysteresis curve in one cycle (*i.e.*, the energy dissipated), and $S_{OBE+ODF}$ is the area enclosed by the hypothetical elastic line DB and the coordinate axis of displacement. The equivalent viscous damping coefficient is shown in Fig. 12.

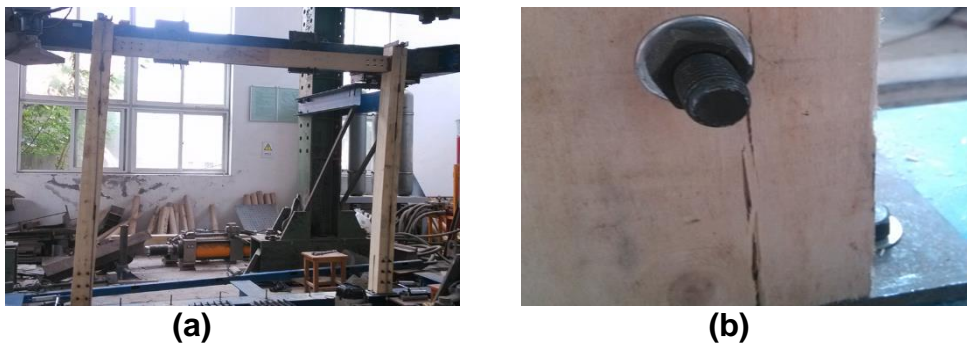
Fig. 13. Failure of KJ1-a: (a) Lateral deformation of KJ1-a; (b) Column foot splits and breakages of KJ1-a

During the monotonic loading test, the column bottom bolts and bolted steel filling plate connections continuously generated cracking sounds as the horizontal displacement rate decreased and they were squeezed into the timber. The failure of a specimen was initiated near the column bottom bolt holes; splitting occurred along the height of the poplar LVL column. Further, splitting cracks appeared at the column bottom of the bolted steel filling plate connection frame (KJ1-a) and the penetrated bar connection frame (KJ2-a) when the displacements reached 60 mm and 50 mm, respectively. Such splitting cracks at the column bottom extended but did not pass through the bolt holes as horizontal displacement increased. Figure 13 shows the failure observed in specimen KJ1-a.

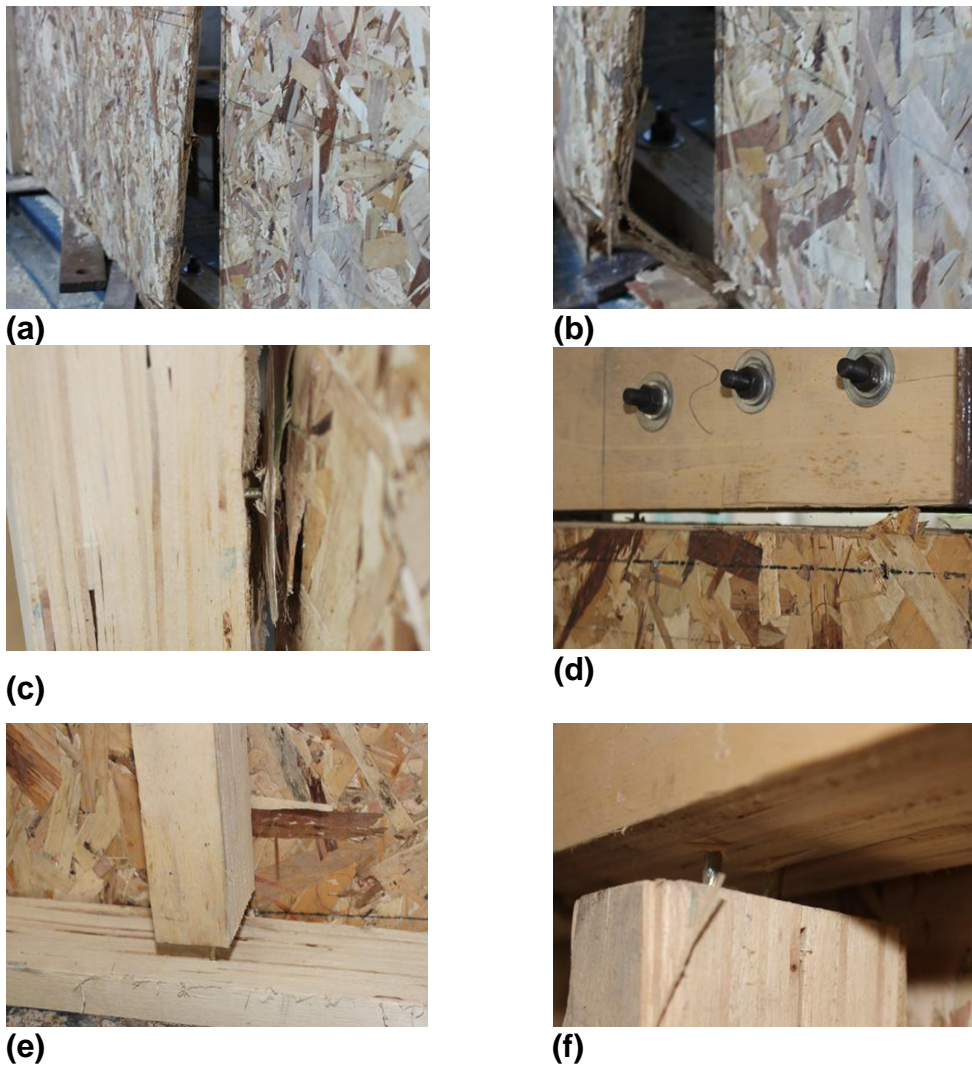
Fig. 14. Sample KJ3-b test: (a) and (b) panel torn apart; (c) nail piercing panel; (d) top beam detached from the frame beam; (e) the column detached from the wall; (f) the wall separated from the top beam

failure was observed at the beam or column ends of the LVL frame. When the LVL frame shear wall failed, the frame remained in good condition with a certain bearing capacity. For KJ3-a specimen, the stiffness was greatly increased since the OSB panels were used. As shown in Fig. 14, the main failure of KJ3-a occurred at the joints between the sheathing and studs, in which the specimens were considered being failed. Since the KJ1-a and KJ2-a specimens did not have sheathing and middle studs, the displacement to lead to failure of the joint between the post and beam were much larger than that of sheathing and studs. According to the standards, the specimens were considered as having failed when the displacement reached 200 mm. In this case, the KJ1-a and KJ2-a specimens during testing were stopped when the displacement reached 200mm although they did not collapse.

When KJ3-b was subjected to the low-cycle reversed load, dense sounds were audible throughout the test. When the displacement reached 30 mm, dislocations occurred between the OSB panels. As displacement increased, the nails at the panel side gradually penetrated the OSB panels and were pulled out. During loading, all studs were pulled up,

and the middle stud was pulled up most obviously. The lower end of the stud close to the loading end was also pulled up noticeably, whereas the studs at the upper end did not separate from the frame substantially. The lower ends of the two studs far from the loading end were not pulled up visibly, but the upper ends clearly disengaged from the frame. Outward warps were found on the OSB panels close to the loading end, and the nails at the sides penetrated the OSB panels. The nails at the joints between the LVL frame beams and the LVL shear wall were pulled out. The nails at the joints between the LVL frame columns and the studs in LVL shear wall were not pulled out. The damage phenomenon of KJ3-b is shown in Fig. 14. According to the results of Shenton's (1998) study, the failure modes of SPF shear wall with OSB sheathing, characterized by fatiguing of the exterior sheathing nails which eventually broke off or were pulled from the frame and a cracking sound, which the damage patterns and failure modes were similar to that of KJ3-a specimens in this study.

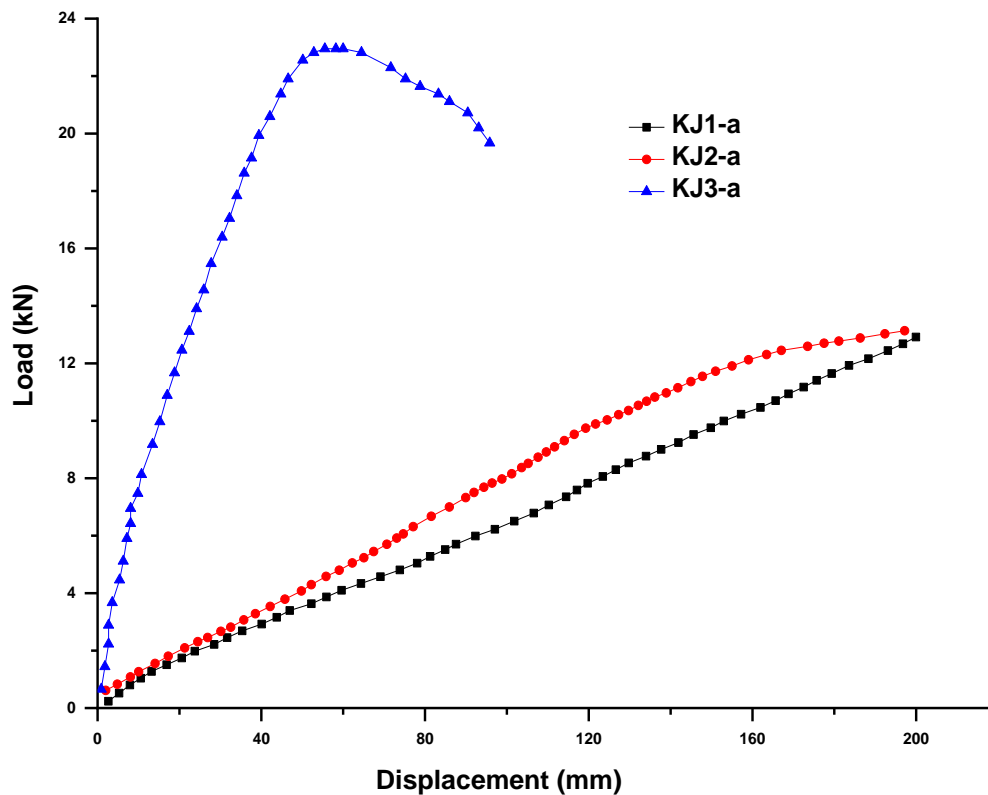
Fig. 15. Load-displacement curves of three types of specimens under monotonical loading

The ultimate loads of KJ1-a and KJ2-a were 13.2 and 12.2 kN, respectively. The ultimate displacements of KJ1-a and KJ2-a were 199.9 mm and 199.6 mm, respectively. The ultimate bearing capacity of the bolted wood-steel-wood connection in the pure frame (KJ1) was close to that of the embedment steel bar connection in the pure frame (KJ2). The initial stiffness of KJ2-a was, at the initial stage of loading, slightly higher than that of KJ1-a. During the middle and later loading stages, the stiffness of KJ2-a decreased gradually, whereas the stiffness of KJ1-a remained unchanged. The ultimate bearing capacity of KJ2-a was higher than that of KJ1-a. The frame-shear wall in the hybrid structure specimen (KJ3) had the highest ultimate load of 22.4 kN, which was approximately 1.7 times as large as the ultimate bearing capacity of the poplar LVL bolted wood-steel-wood connection in the pure frame. This may have been due to the frame being enhanced by the lateral force resistant performance of the LVL shear wall and the reduction of the lateral displacement of the LVL shear wall and stud lift-up. The ultimate loads and ultimate displacements of the hybrid structure shear walls with Douglas-fir studs and OSB sheathing panels were reported to be 23.7 kN and 51.7 mm, respectively (White *et al.* 2010). As shown in Table 3, the differences in the ultimate loads and ultimate displacements of KJ3 and Douglas-fir-OSB were under 10%. The load-displacement curves of the three different kinds of specimens tested are shown in Fig. 15.

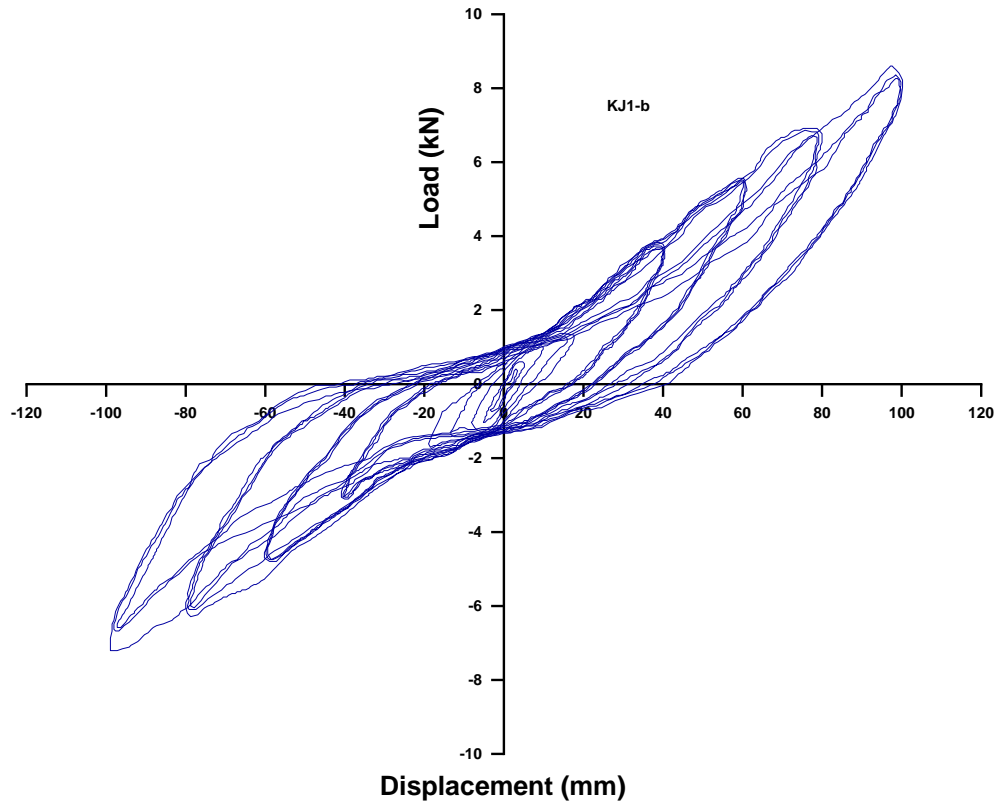
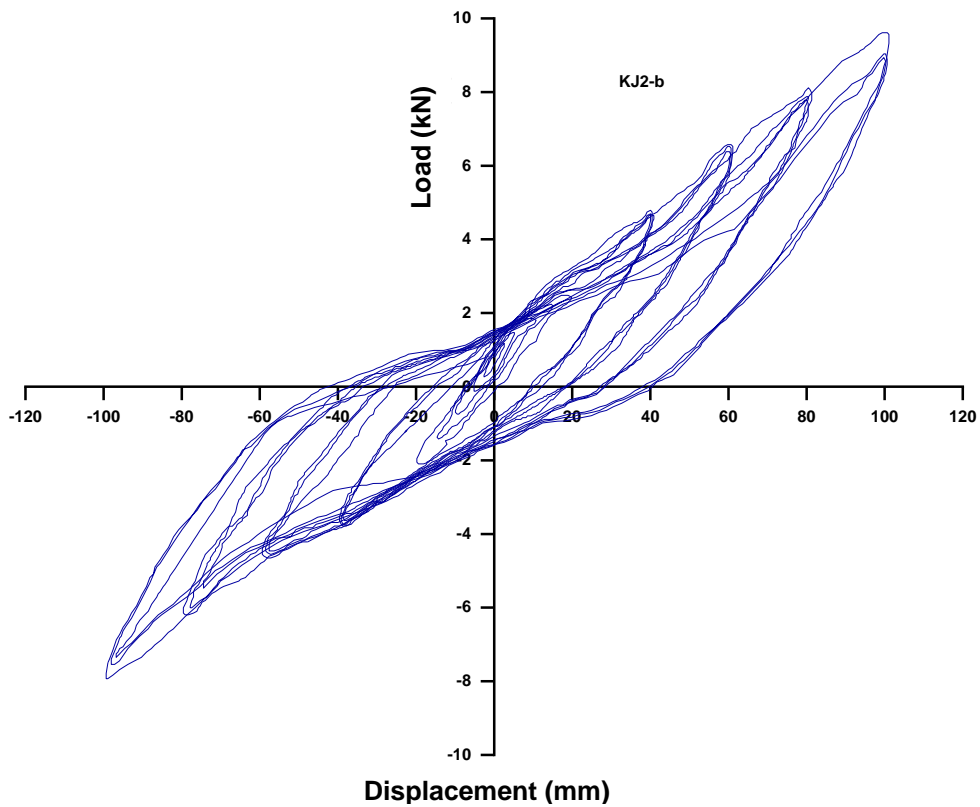
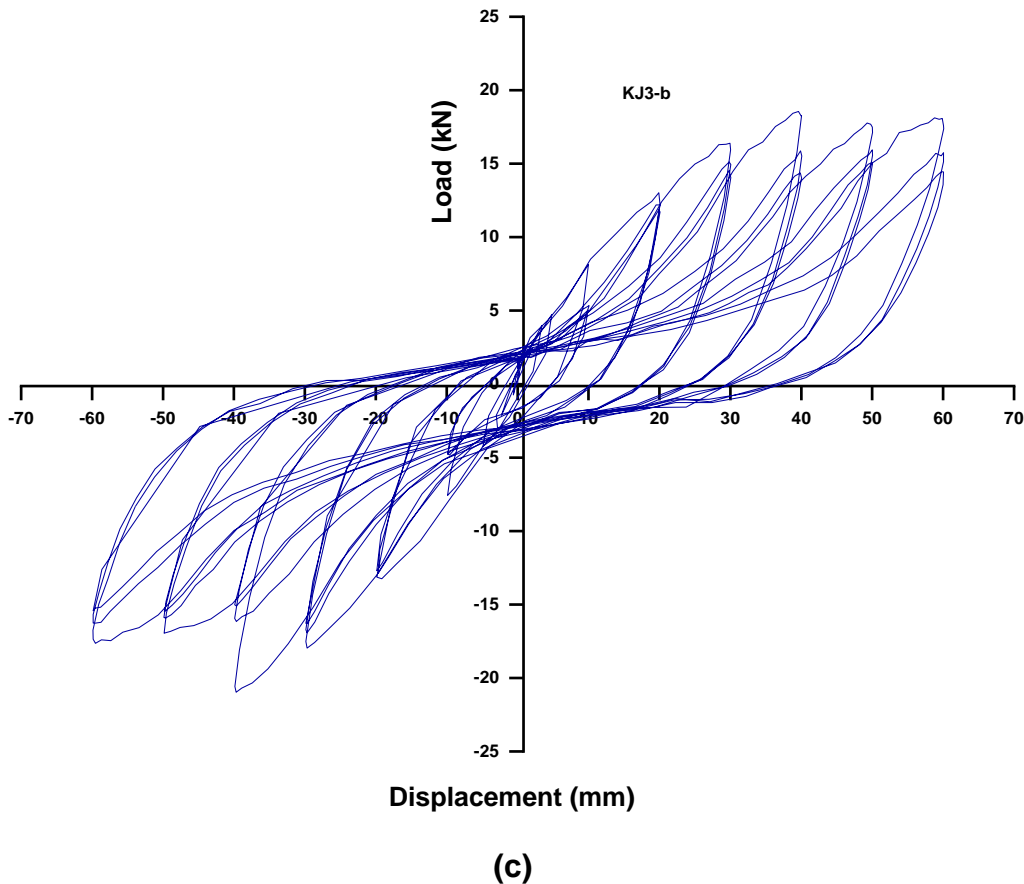
Fig. 16. Load-displacement curves of three types of specimens under reversed cyclic loading

Figure 16 shows the load-displacement curves of all three specimens under low-cycle reversed loading. The loading curves contained inflection points and exhibited an inverse S shape, which was demonstrative of the pinch phenomenon. A greater pinch phenomenon indicates lower ductility and energy dissipating ability. Specimens KJ1-b and KJ2-b had the most obvious pinch effects, whereas specimen KJ3-b had a smaller pinch effect than KJ1-b and KJ2-b. Accordingly, the load in the hysteresis curve of KJ3-b decreased noticeably with cyclic loading, whereas the loads of KJ1-b and KJ2-b still increased after the actuator reached the maximum range of measurement due to their low lateral stiffness. The ultimate lateral displacements of specimens KJ1-b and KJ2-b were approximately 3 to 4 times larger than that of specimen KJ3-b. For KJ1-b and KJ2-b, no obvious decreases in load were observed during the first and second stages. This could have been due to the low stiffness and large ultimate displacements among the pure frame specimens of KJ1-b and KJ2-b. Furthermore, the pure frame specimens of KJ1-b and KJ2-b had increases in their loads as displacement increased. For KJ3-b in the second stage of cycling, the bearing capacity decreased during cycling at the same displacement, and the peak bearing capacity decreased visibly. This decrease signified that the cyclic loading process caused structural damage to this specimen, which resulted in strength degradation. The curve slopes of the last two cycles were lower than that of the first cycle due to the degradation of stiffness in the specimen after the reversed cyclic loads.

The ultimate pushing loads had only minor differences, which were reflected in the hysteresis curves of KJ1-b, KJ2-b, and KJ3-b during the same cycle. However, the pushing loads and pulling loads were asymmetric to some extent, and the load under the pulling force was slightly lower than that applied by the actuator. Such a difference could have been caused by the loading course. When the tests started, the specimens were first subjected to a positive pushing load. After the pushing load, the poplar LVL timber frame was subjected to the reversed pulling load, which was accompanied by the residual stress caused by the pushing load. Therefore, the reversed load was reduced to some extent.

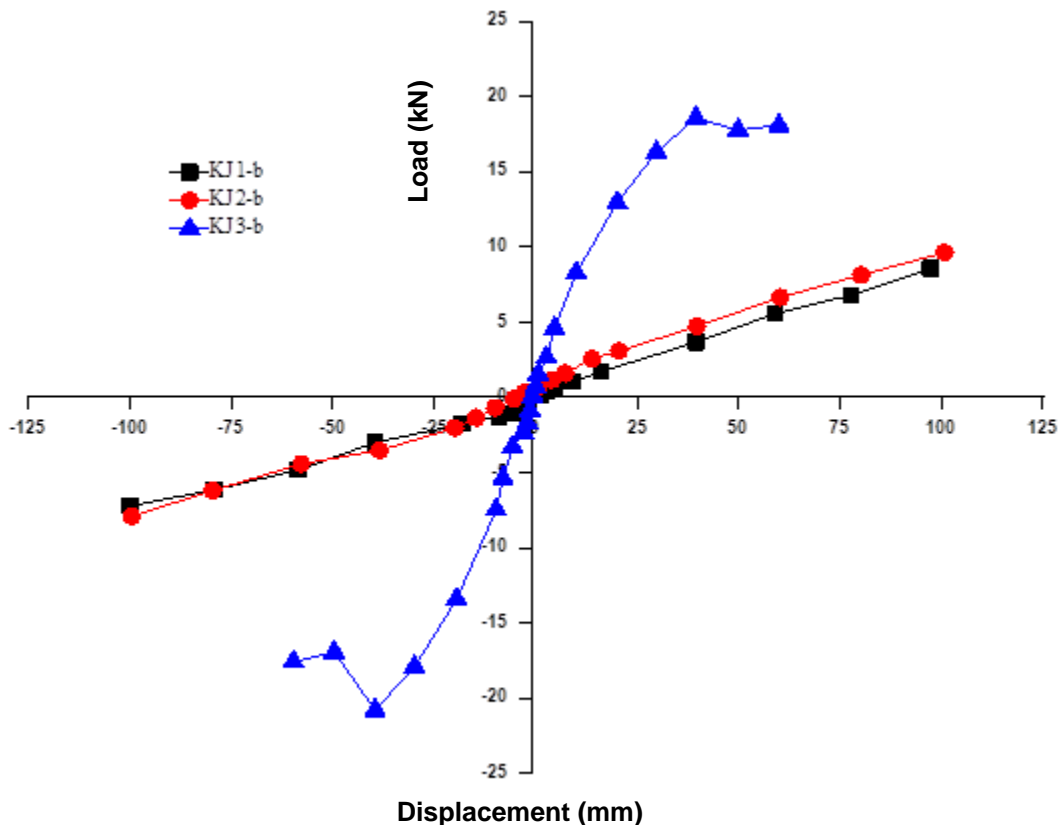
Fig. 17. Skeleton curves of three specimens tested

The stiffness, load capacity, energy dissipation, and other properties of the members at different stages of a low-cycle reversed loading test can be determined by analyzing the envelope curves. Figure 17 illustrates the envelope curves of KJ1-b, KJ2-b, and KJ3-b.

The envelope curves of specimens KJ1-b and KJ2-b remained at the elastic stage. In comparison, KJ3-b ultimately failed under the low-cycle reversed load after the elastic stage and yield hardening stage. For the bolted steel filling plate connection specimen KJ1-b, a gap existed between the steel plate and beam at the initial stage of loading. Thus, the envelope curve could pass through a small slippage stage and gradually turn into an oblique line, and the specimen then entered the elastic stage. According to the comparison of the envelope curves of different specimens, KJ3-b had the highest initial stiffness, and the

embedment bars connection pure frame specimen KJ2-b had an initial stiffness that was marginally higher than that of the bolted-steel-plate connection in the pure frame specimen KJ1-b. The envelope curves of the pure frame specimens KJ1-b and KJ2-b increased slowly at their elastic stages, and the ultimate lateral displacements were far larger than that of the frame-shear wall hybrid structure specimen KJ3-b. Due to the strengthening of the frame by the shear wall, the bearing capacity of KJ3-b was approximately twice as large as that of the pure frame, which indicated the presence of a yield stage after the elastic stage.

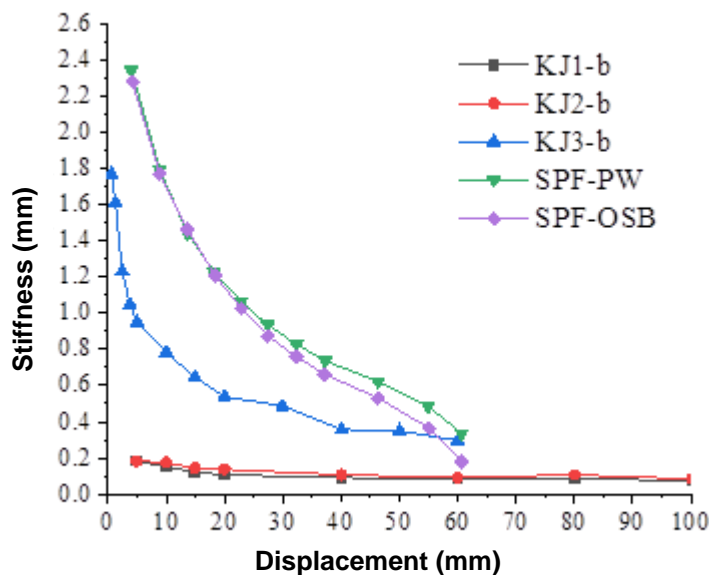
Fig. 18. Stiffness degradation curves of three specimens

The stiffness degradation of the specimens is shown in Fig. 18. Specimen KJ3-b had the highest initial stiffness of 1.77 kN/mm. The stiffness degradation of the hybrid structure shear wall with SPF studs and that of the OSB and plywood sheathing panels reported by Shenton, III *et al.* (1998) are also shown in Fig. 18 for comparison. The highest initial stiffness of the hybrid structure shear wall with SPF studs and that of the OSB and plywood sheathing panels were 2.34 kN/mm and 2.28 kN/mm, respectively (Shenton, III *et al.* 1998). However, as loading displacement gradually increased, they showed larger degradation in stiffness than KJ3-b. Specimen KJ1-b had a non-obvious stiffness degradation with a trend similar to that of KJ2-b, and the degradation in stiffness largely remained at the ideal elastic stage as displacement increased. For KJ3-b, the stiffness degradation was obvious during the initial loading stage. As load increased, the shear wall gradually lost bearing capacity. The load was then held by the external frame, and the degradation in stiffness leveled off progressively similar to specimens KJ1-b and KJ2-b. It

can be found from Fig. 18 that the stiffness of KJ1-b and KJ2-b samples made of LVL frames was relatively small; thus these samples could not be directly used in a structure albeit the degradation of stiffness was not obvious. However, as for KJ3-b sample, the studs and OSB sheathing panels were added to the LVL frame, producing a large increase in stiffness. The comparison of using plywood and OSB as sheathing panels in the samples tested suggested the similar degradation of stiffness. This could be due to (1) The different testing methods. The transferring of load in SPF-PW and SPF-OSB samples was stiff, resulting in the upper limit of test values. The tests conducted in this manuscript adopted the novel loading beam, producing the lower limit of test values (Liu *et al.* 2008); (2) The different loading schemes. SPF-PW and SPF-OSB samples were tested in accordance with the draft standard for dynamic testing recently proposed by SEAOSC (Shepard 1996). The method used in this study followed the standard ISO-16670 (ISO 2003); and (3) The different test materials used. All these possible reasons could impact the test results to some degree.

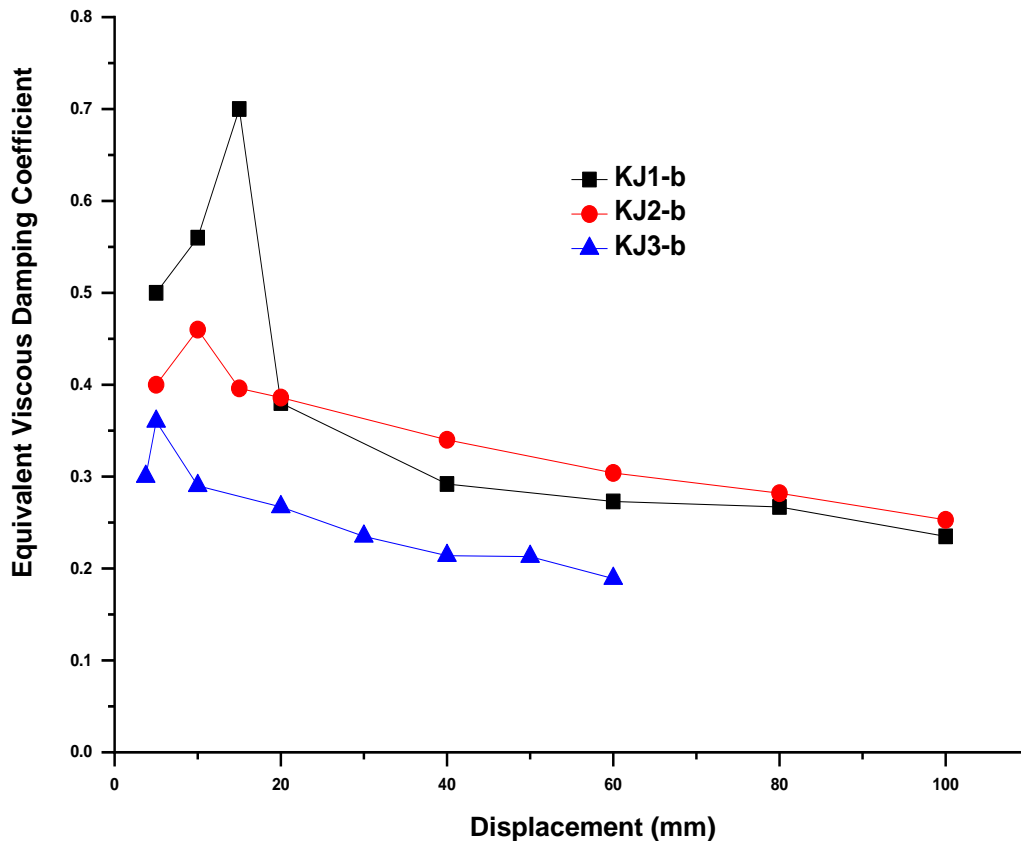
Fig. 19. Equivalent viscous damping factor of three types of specimens tested

At the various levels of low-cycle reversed loads, the equivalent viscous damping coefficients of all three specimens at each displacement-control cycle are shown in Fig. 19. At the initial loading stage, the equivalent viscous damping factor (EVDF) of the three types of specimens increased to some extent and then decreased as displacement increased. This suggested that the pinch effect of the load-displacement curves became more obvious when the displacements of the structures increased.

The EVDF of KJ1-b increased more obviously at the initial loading stage, dropped drastically when the displacement reached 20 mm, and became stable when the displacement reached 40 mm. The EVDF of KJ2-b increased marginally at the initial loading stage and then dropped evenly after the displacement reached 17 mm. For KJ3-b, the plastic deformation occurred when displacement reached 40 mm with little change in the damping coefficient, and the EVDF reduced gradually after the failure load.
