# Mechanical Performance of Three Types of Connections Used in Orthogonal Ribbed Beams Made of Poplar Laminated Veneer Lumber

Yan Liu,<sup>a,\*</sup> Jing Chen,<sup>a</sup> Hongwei Ma,<sup>a,\*</sup> Meng Gong,<sup>b</sup> and Linfeng Zhang<sup>a</sup>

This study elucidated the mechanical performance of different connections used in orthogonal ribbed beams made of poplar laminated veneer lumber (LVL). Three types of connections (namely, U-, T-, and L-shape) were fabricated and used to connect the second beam and the middle part of a main beam to form an orthogonal rib beam. A concentrated load was applied to the intersection between the main beam and the second beam. The results showed: (1) all three types of ribbed beam connection specimens showed good connecting performance and the ductile failure, including the pull-out of partial self-tapping screws, crushing of LVL at the end of the ribbed beam, and connection failure; (2) the variation of load capacity of JD2-type specimens was approximately 3.2%, which was smaller than that of the JD1- and JD3-type specimens, slightly less than 10%; (3) the ultimate bearing capacity of a connection specimen was proportional to the number o

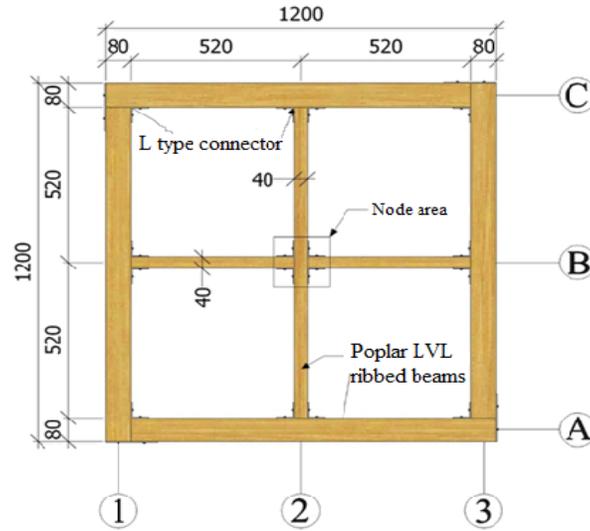
Fig. 1. Schematic of a connection specimen

Three types of poplar LVL-ribbed beam connections were designed and manufactured, each of which had 3 replicates, generating a total of 9 specimens. The design parameters of each type of connection are detailed in Table 1. Each specimen had a width of 1200 mm and a depth of 1200 mm. The inner part was composed of a primary beam and two secondary beams connected by connections to form an orthogonal ribbed beam joint. The section sizes of the three ribbed beams were 40 mm by 235 mm and the section size of the four ribbed beams of side fixing frame were 80 mm by 235 mm, which is illustrated in Fig. 1. The ribbed beams at the connection area were connected with three types of connections, *i.e.*, U-shape, T-shape, and L shape, as shown in Fig. 2, all of which were made of Q235B steel. The mechanical performance of the Q235B material was measured by Ma *et al.* (2018, 2019). According to relevant Chinese standards GB/T 50708-2012 (2012) “Technical code of glued laminated timber structures” and GB50005-2017 (2017) “Standard for design of timber structures”, the screwing patterns and numbers of self-tapping screws were selected. The self-tapping screws were made of 304 stainless steel countersunk head screws with a specification of M4×20, with a yield strength of 205MPa and a tensile strength of 520MP. The sizes of the specimens are given in Fig. 2.

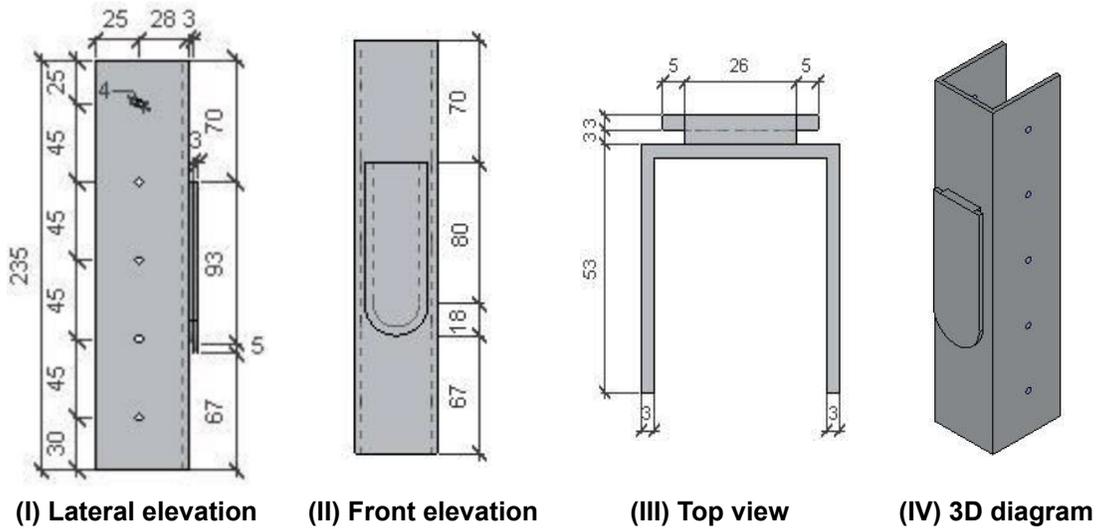
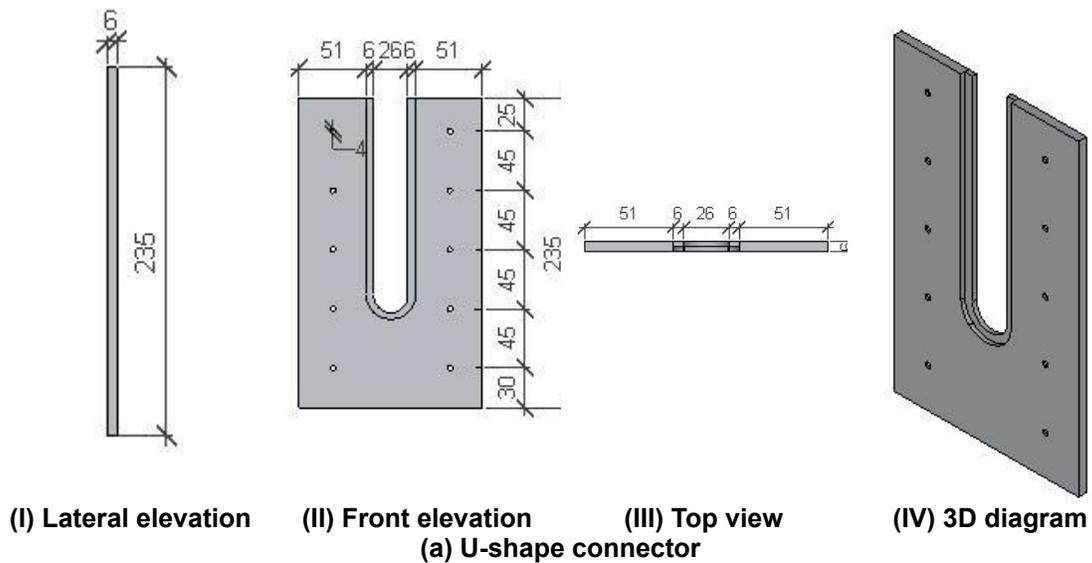
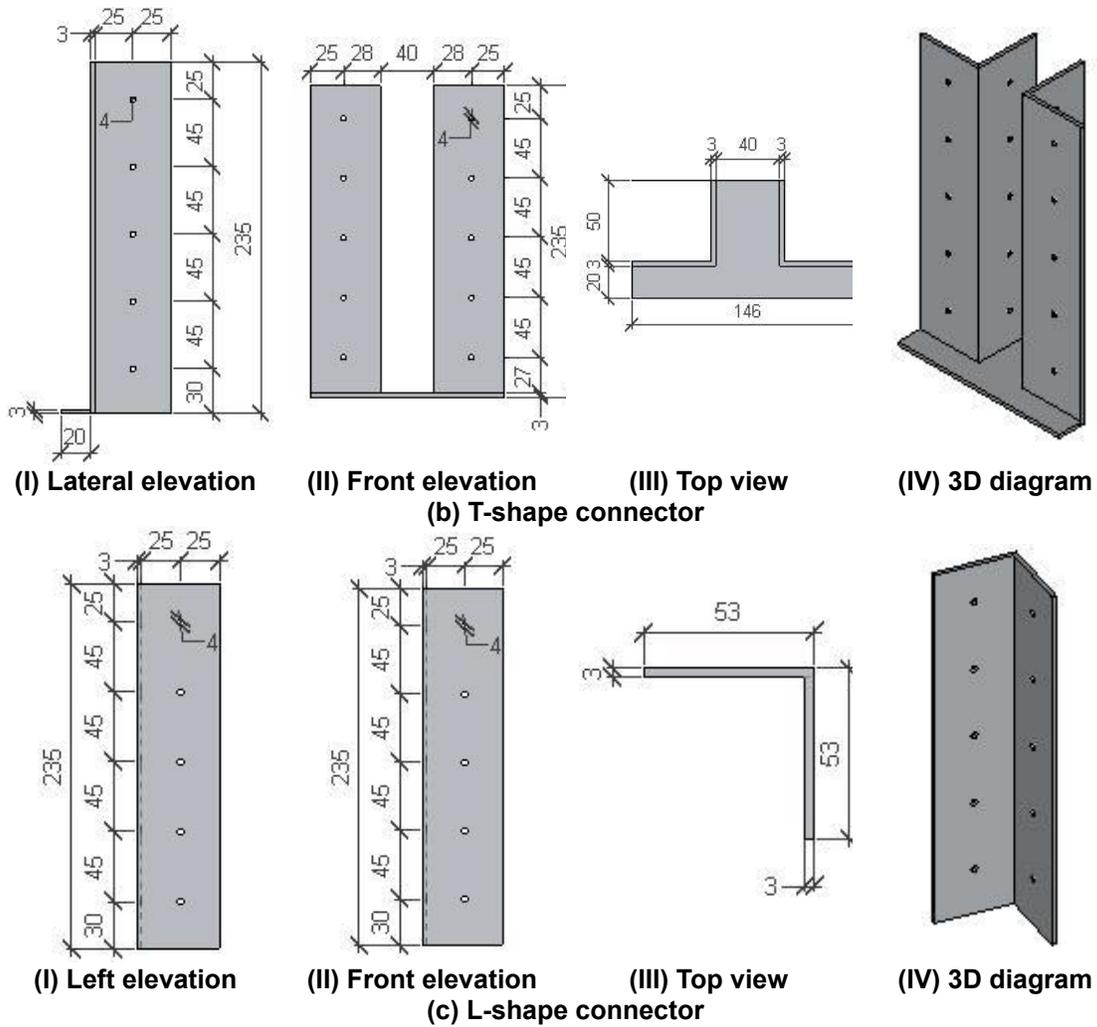
Fig. 2. Dimensions and construction of the connectors

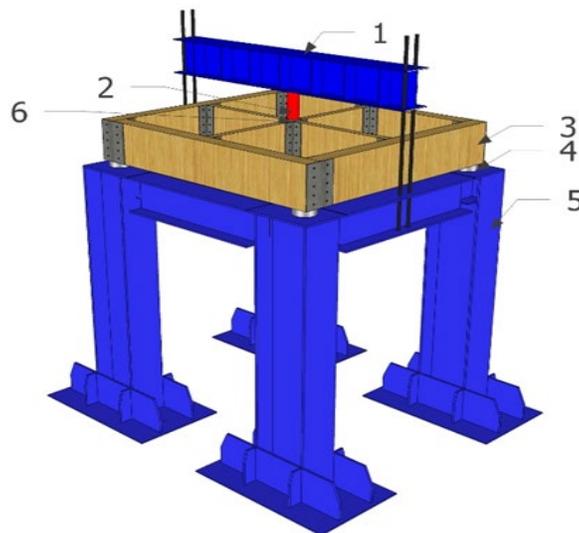
Fig. 3. Schematic of the experimental setup (Note: 1- Reaction frame; 2- Pressure jack; 3- Connector; 4- Pressure sensor; 5- H-Steel support; and 6- Four ribbed beam specimen)

A hydraulic jack was used to apply a concentrated load at the mid-span of a ribbed beam connection. The testing procedure referred to the methods for testing timber structures stipulated in the Chinese standard GB/T50329-2012 (2012) and ASTM E2322 (2015). The loading setup is shown in Fig. 3. First, the ultimate load of a specimen was estimated according to the formulas for calculating the shear bearing capacity and compression failure bearing capacity of a pin fastener provided in the Chinese standard GB50005-2017 (2017). A preload was applied to the specimen before actually starting the loading. The load was kept for 5 min when the load was added to 5% of the ultimate load and then unloaded. All measuring equipment was zeroed prior to loading. A hierarchical loading scheme was followed, *i.e.*, the first stage was loaded with approximately 10% of the ultimate load, and the second stage was loaded with approximately 5% of the ultimate load until it was damaged. The holding time for each loading stage was 5 min.

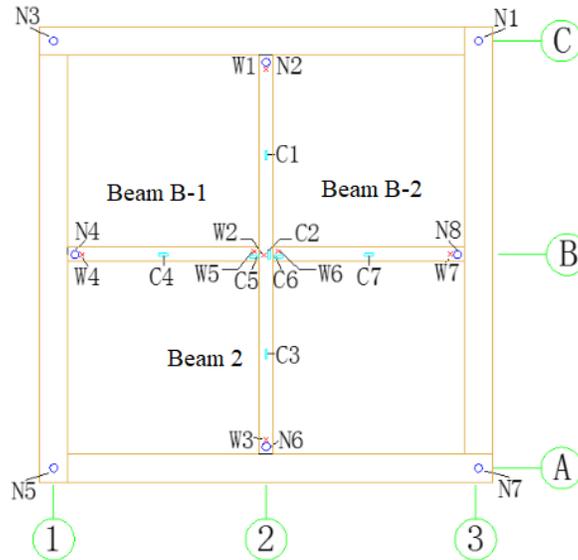
**Fig. 4.** Arrangement of the measuring locations

In order to measure the changes of the connection deflections and rib strains of each specimen during the loading process, the displacement meters and strain gauges were arranged at the bottom of the connection rib beam, and load cells were placed at the end of the rib beam and the corner of a specimen to measure the load distribution of a connection rib specimen. The arrangement of the measuring points is shown in Fig. 4, among which W1 through W7 represent the displacement meter numbers, C1 through C7 represent the strain gauge numbers (note: the JD2 specimens were not measured at the measurement points C2, C5, and C6 due to the connection construction), and N1 through N8 represent the load cell number.

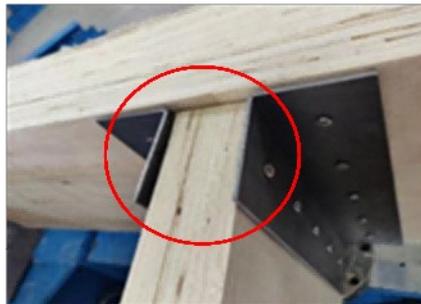
**(a)** Slip at the end of Beam 2

When the load reached 51 kN, the self-tapping screws between Beam 2 and the slot were slightly pulled out. When the load reached 55 kN, the end 2 of the beam slid down, and the subsidence distance reached 4 mm, as shown in Fig. 5a. When the load reached 60 kN, the wood in contact with the load cell was crushed, as shown in Fig. 5b. At this time, the end of Beam B-2 was separated from the 3-axis side beam, and the clearance reached 10 mm, as shown in Fig. 5c. When the final load reached approximately 68 kN, the self-tapping screws between Beam 2 and the slot was pulled out, and the connection separation gap reached approximately 14 mm, making the specimen fully fail, as shown in Fig. 5d.

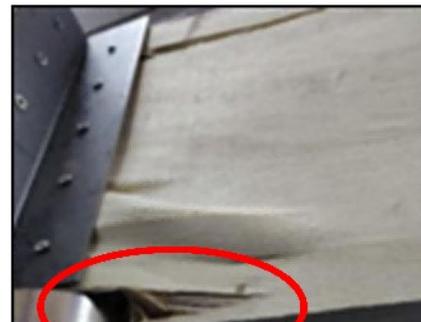
**(b)** Cracking of the LVL

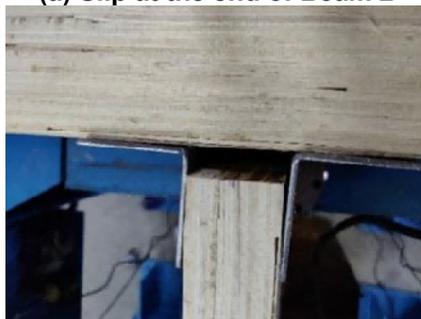
**(c)** Separation between the end of Beam B-2 and the side beam

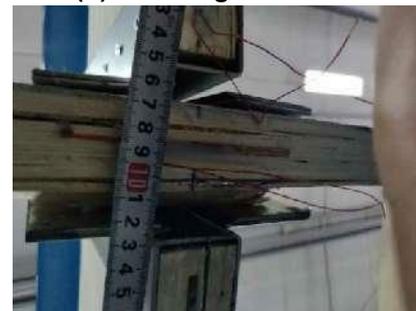
**(d)** Pull-out of the self-tapping screws at the connection

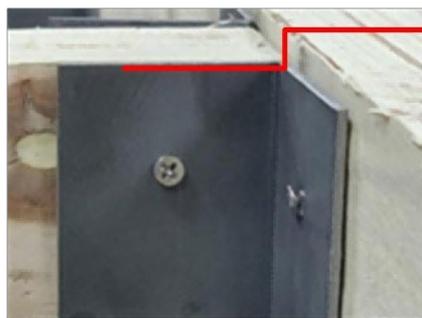
(a) Slip at the end of Beam 2

Before the load was loaded to 42 kN, the specimen showed no obvious failure. When the load reached approximately 52 kN, the specimen emitted a slight squeezing sound. When the load reached approximately 55 kN, the two T-type connectors at the connection began to separate. As the load continued to increase, the end 2 of the beam connected to the axis side of Beam A appeared to slide down, as shown in Fig. 6a.

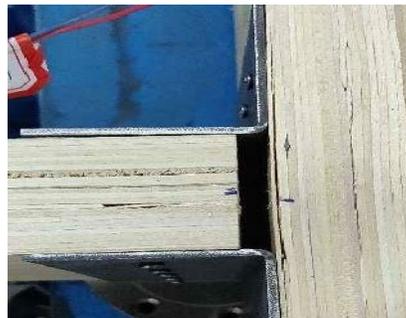
(b) Slip at the right end of Beam B-2

At this time, the right end of Beam B-2 appeared to sag 5 mm at the connection along the axis side of Beam 3, as shown in Fig. 6b. When the load reached approximately 65 kN, the gap between the end of Beam B-1 and Beam B-2 at the connection and Beam 2 was approximately 10 mm, as shown in Fig. 6c, and the spacing between the two connectors reached approximately 7 mm, as shown in Fig. 6d. Finally, the specimen failed.

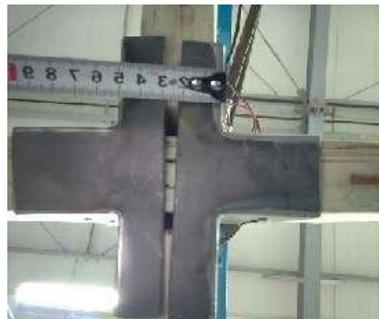
(c) Separation between the connectors

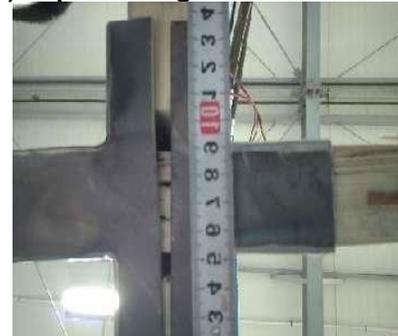
(d) Separation between the connectors

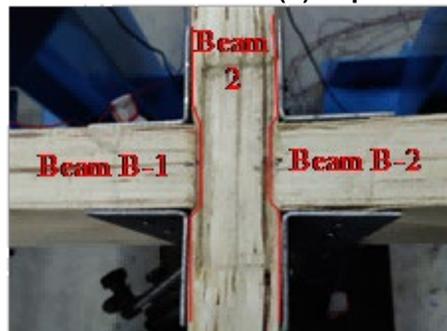
(e) crushing of Beam 2 against Beams B-1 and B-2

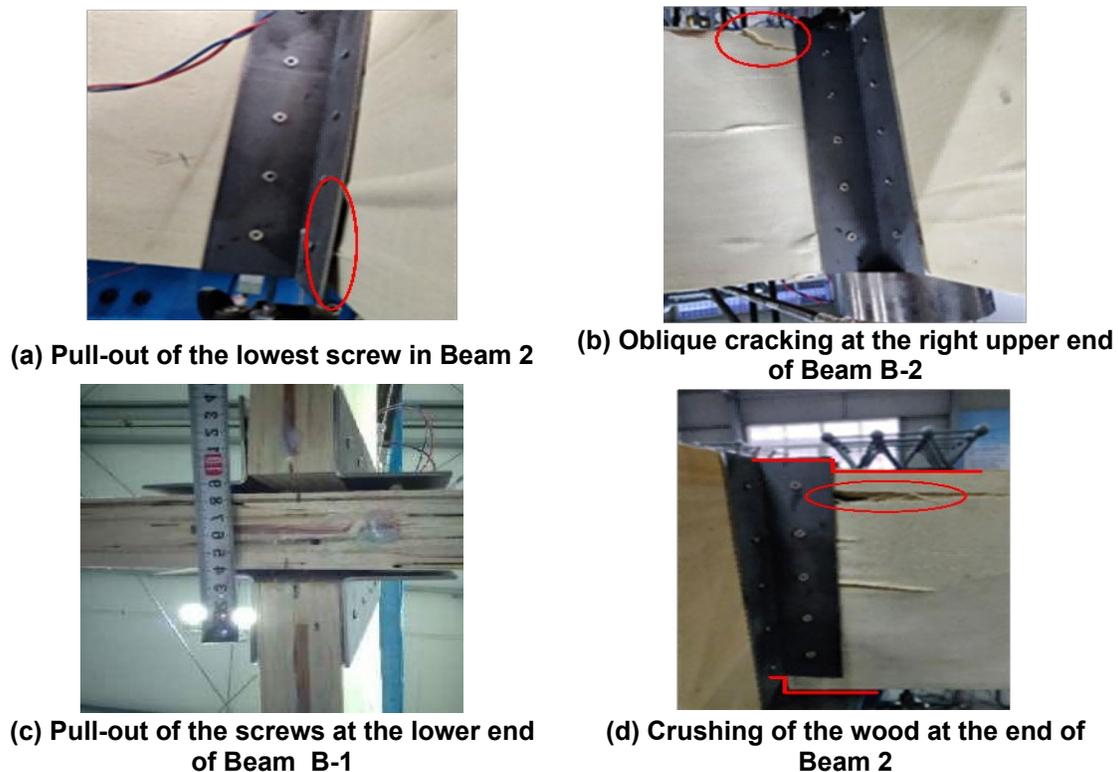
Fig. 7. The failure morphology of specimen JD3

When the load reached approximately 12 kN, the specimen produced a slight sound due to the crushing of the wood. When the load reached approximately 27 kN, Beam 2 produced a fiber tearing sound in the wood, and the right end of Beam B-1 and the left end of Beam B-2 began to sag. When the load reached approximately 36 kN, obvious deflection occurred at the midpoint of Beam 2. When the load reached approximately 42 kN, the tearing sound of the wood fibers became quite loud, and the self-tapping screws at the lower part of the connector at the 2 connections of the beam were pulled out, as shown in Fig. 7a. As the load continued to increase, the support at the end of Beam 2 began to slide down. When the load reached approximately 50 kN, oblique cracks appeared at the right upper end of Beam B-2 where it met the connector, and the wood was pulled apart, as shown in Fig. 7b. When the final load reached approximately 60 kN, the screws at the lower end of Beam 2 were pulled out, and the gap between Beam 2 and Beam B-1 was approximately 10 mm, as shown in Fig. 7c. Meanwhile, the end of Beam 2 connected to the axis side beam of A was compressed approximately 3 mm, and the wood at the upper end of Beam 2 was torn, as shown in Fig. 7d. The specimen finally failed.

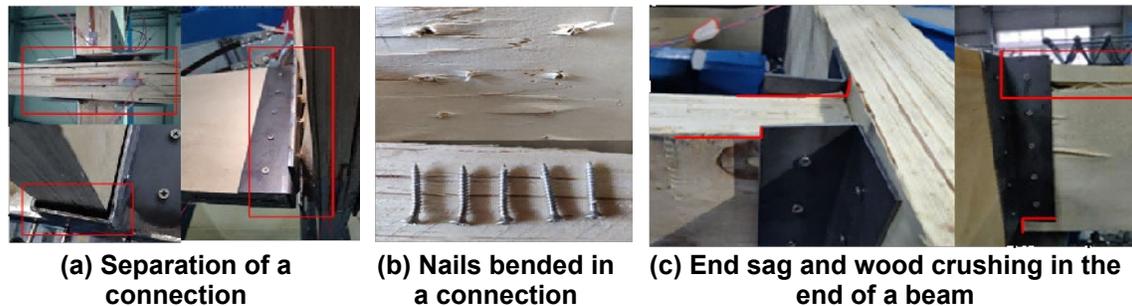
Fig. 8. Failure evolution of a nodal specimen

According to the above description on the failure of each specimen, the overall initiation and propagation of failure in a specimen was as follows: (1) pull-out of the self-tapping screws at the lower part of the specimen; (2) separation of the connection and the ribbed beam; (3) crushing of the wood at the end of the ribbed beam; and (4) failure. In summary (as shown in Fig. 8), first of all, the screws connected on both sides of the lower end of Beam 2 at the connection were pulled out. Some of the screws began to fracture, the bearing capacity of the connection began to decrease, the deflection at the connection increased, the end of each rib beam was stressed, the end of the beam slid down, and finally the end wood in contact with the support was crushed.

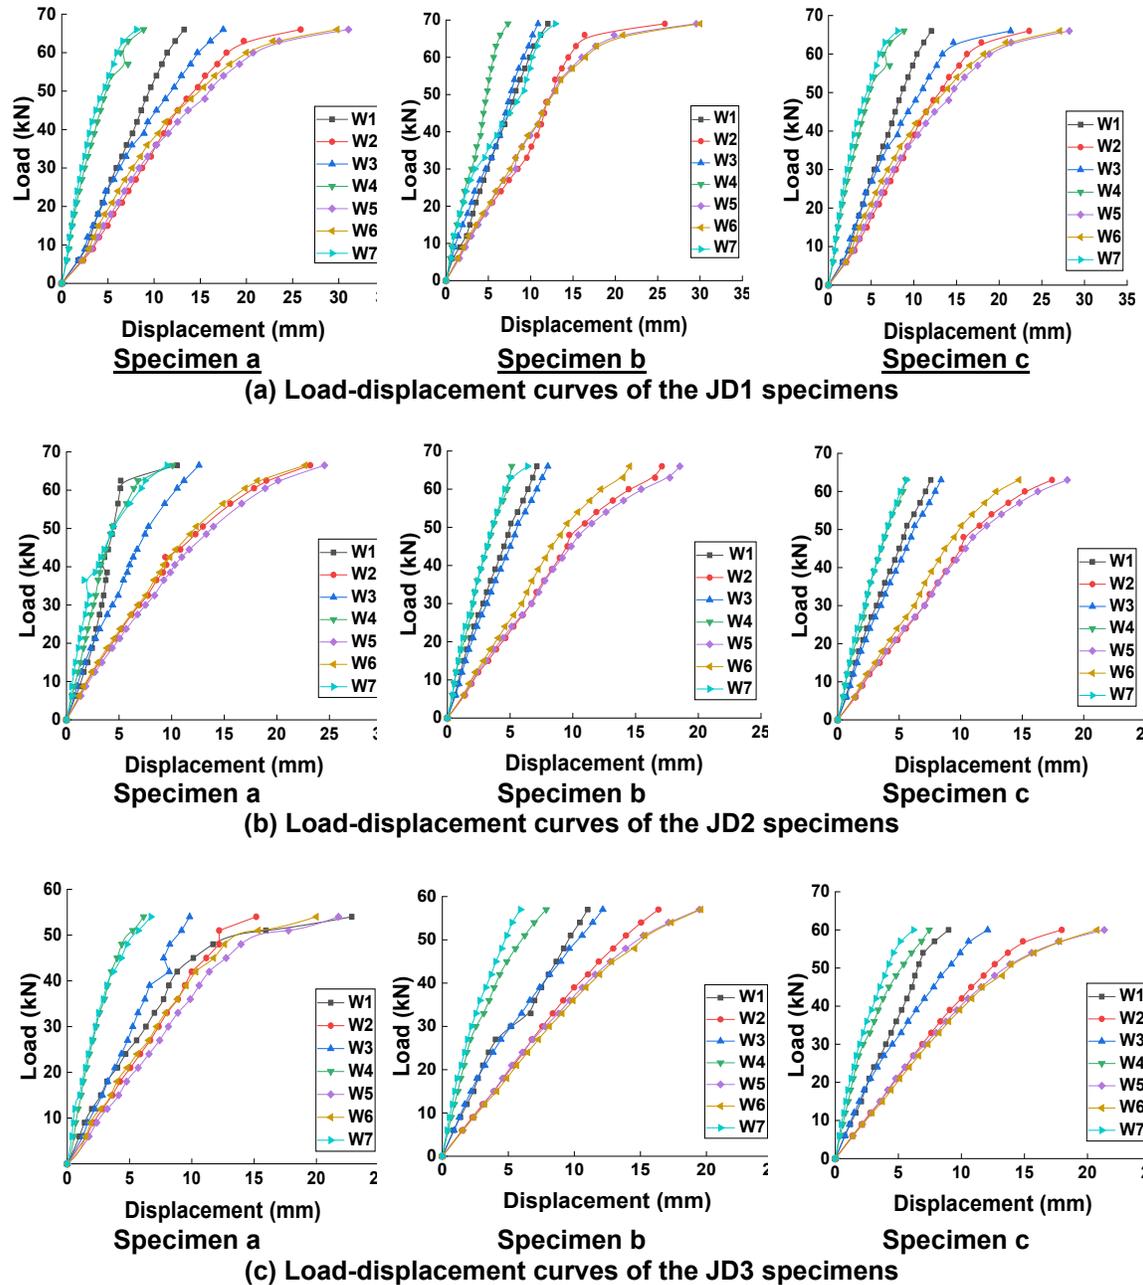
**Fig. 9.** Load-displacement curves of three types of specimens tested

The load-displacement curve of each specimen was plotted (Fig. 9). The displacement linearly increased as the load increased at the initial stage of loading. When the load reached 80% of the ultimate load, the displacement growth rate of the specimen was accelerated, and the load-displacement curve becomes nonlinear. When the load continues to increase, the displacement growth rate was further accelerated due to the pull-out of some screws in the specimens. Before the failure of a specimen, the ductile behavior appears obvious. Throughout the whole loading process, it is not surprising that the midpoint of a specimen exhibited the maximum displacement. During the loading process, some screws in the mid-span connection area were pulled out, weakening the connection performance of the specimen, and reducing the load transfer from the 2-axis ribbed beam to the B axis ribbed beam. During the course of the loading process, some screws were pulled out from the connection, reducing its load capacity. Therefore, the displacements at the supports of Beam B-1 (point W4) and Beam B-2 (point W7) were smaller than the displacements at the support of Beam 2 (points W1 and W3). For specimens JD1 and JD3, the displacements of the ribbed ends in two directions were 6.10 mm and 5.49 mm, respectively, while for type JD2, the displacement of the ribbed ends in two directions was only 1.87 mm. This was because of the presence of the T-plate at the bottom of specimen type JD2, which increased the overall deformation performance of the connections.

From the load-displacement curve in Fig. 9, it can be seen that before 0.8 of the ultimate load of the specimen ( $P_{max}$ ), it basically behaved in the linear elastic way. Therefore, the slope of the straight line corresponding to  $0.1P_{max}$  and  $0.8P_{max}$  was used to calculate the bending stiffness of each specimen.

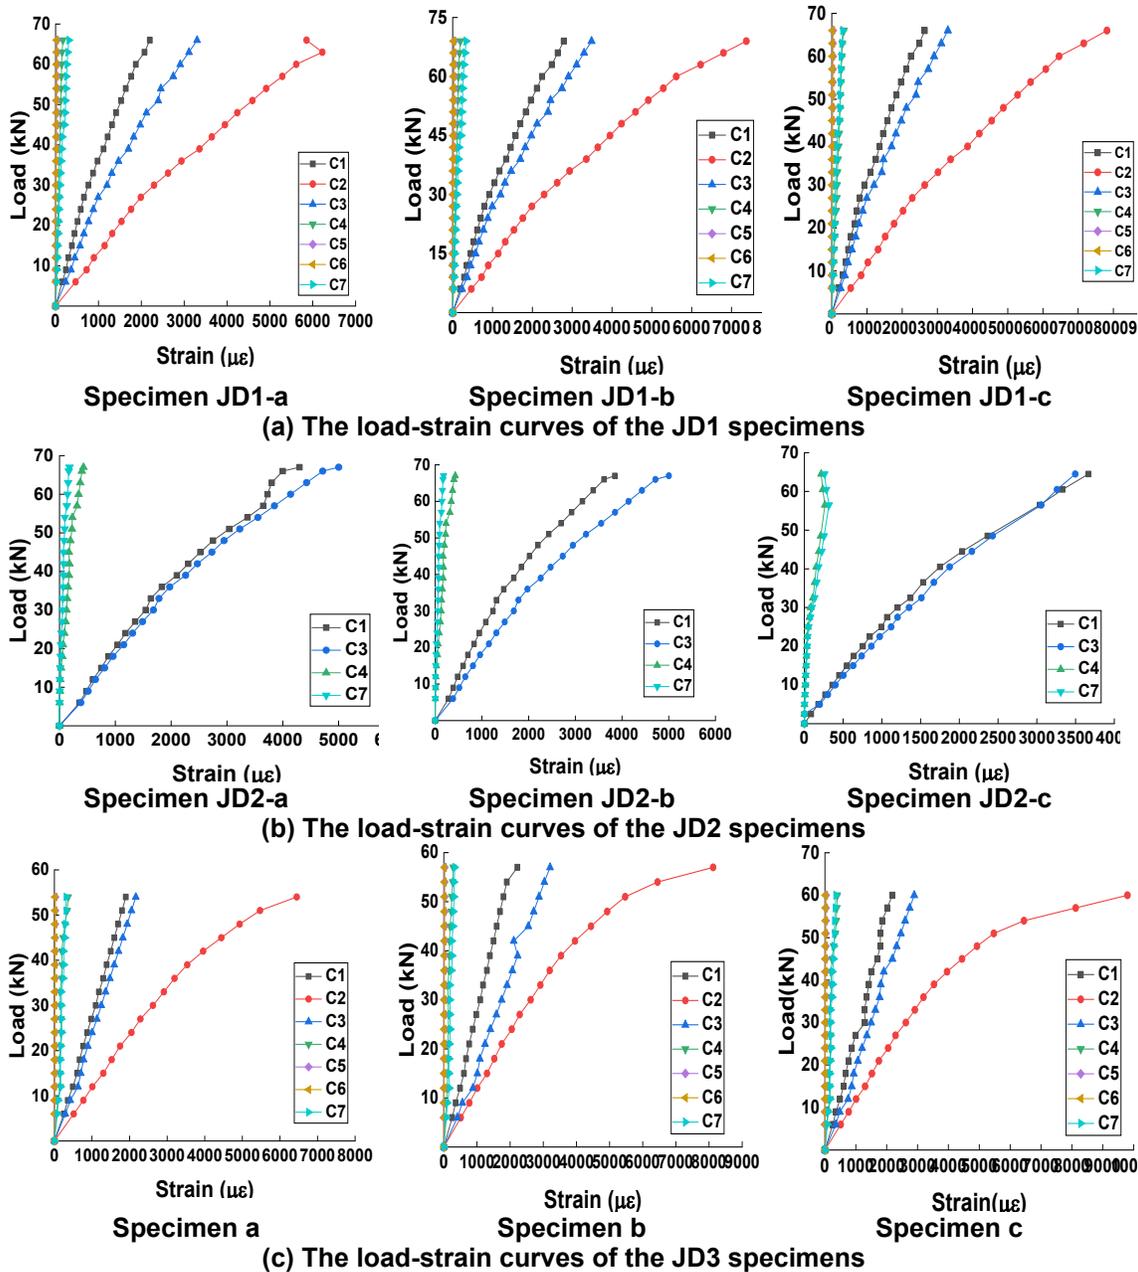
Fig. 10. Load-strain curves at various points of all the specimens tested

The load-strain curve at each measuring point is shown in Fig. 10. It can be found that these curves almost linearly increased throughout the whole loading stage. Under load, the strain change at the middle point of Beam 2, *i.e.*, point C2, was the largest, and as the load increased, the strain change at point C2 began to show a nonlinear increase. For Beam B-1 and Beam B-2, the strains at their midpoints C4 and C7 and the end points C5 and C6 of the beam were very small. This could be because the self-tapping screws at these points were pulled out, and the bottom end of Beams B-1 and B-2 were detached from Beam 2 near the connection points.

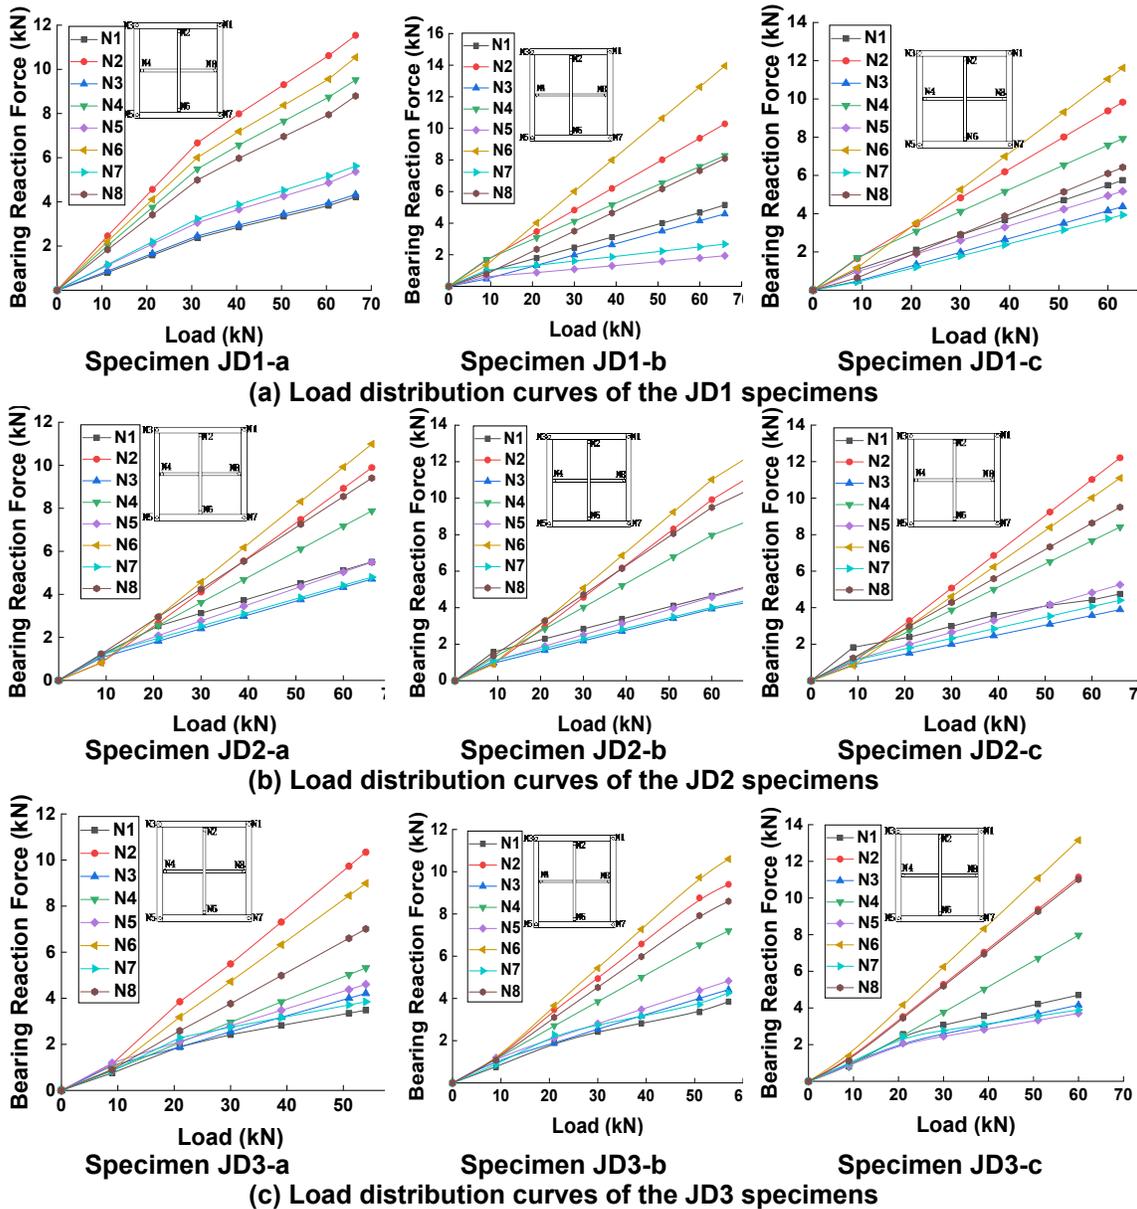
Fig. 11. The load distribution curves at various points of all the specimens tested

Throughout the course of the loading process, load cells were used to measure the load values at the end of the points of a ribbed beam, *i.e.*, N2, N4, N6, and N8, and at the four corners, *i.e.*, N1, N3, N5, and N7, of all three types of specimens. The load distribution curves are shown in Fig. 11. It can be seen that the bearing reaction linearly increased, during the whole loading process, with the increase of the load. The values of the bearing

reaction at the four corners of the specimen closely varied, while the bearing reaction at the end of the connection-ribbed beam appeared discrete with the increase of the load. As the load continued to increase, some screws in the connections began to fail and the connections became detached, which reduced the overall performance of the connections. The load distributed on Beam B-1 and Beam B-2 decreased, and the load value at the end of Beam 2 increased faster than the load value of Beam B-1 or Beam B-2.

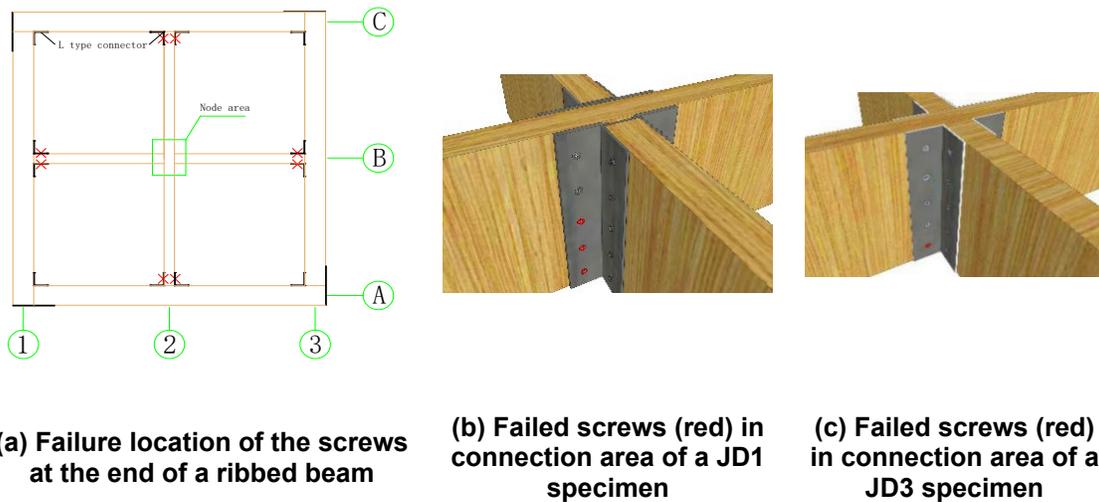
**Fig. 12.** The schematic diagrams showing the failure locations of self-tapping screws

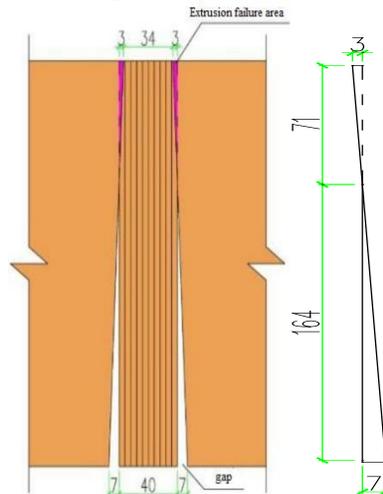
**Fig. 13.** Schematic showing compressive stresses at the top of a ribbed beam of a JD2-type specimen
