# Experimental Study on Flexural Behavior of Box Floors with Orthogonal Rib Beams Made of Poplar Laminated Veneer Lumber

This study examined the flexural behavior of the poplar laminated veneer lumber (LVL) box floor with orthogonal rib beams. Four 3.6 m × 4.8 m box floor samples made of poplar LVL orthogonal rib beams and oriented strand board (OSB) plates were tested under vertical uniform loading, from which the bearing capacity, stiffness, and failure characteristics were analyzed. There was no damage in all box floor samples at the normal service load of 2.5 kN/m<sup>2</sup>, and the maximum deflection was far less than the allowable value. When the maximum load was applied, the load-displacement curve of each floor sample exhibited a linear relationship without obvious failure. However, localized failure was manifested as the dislocation slip of the rib beams relative to the upper and lower floor slabs at the corner nodes and the joint expansion and staggered floors at the bottom plate, with obvious failure signs. The rib beam height had the most significant impact on the floor stiffness, followed by the spacing of short-side rib beams, whereas the OSB plate thickness had le

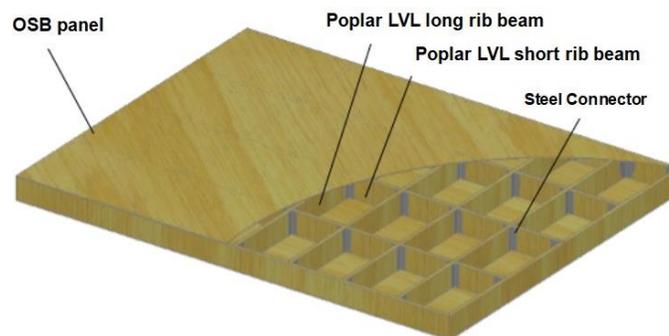
Fig. 1. Orthogonal rib beam box floor made of poplar LVL

Figure 1 illustrates the floor structure designed in this study. Four types of 3600 mm × 4800 mm planar poplar LVL box floor samples were designed and manufactured by the research group according to the Standard for Design of Timber Structures (GB 50005 2017). Each type had one sample that was built and tested. The distance between the long-side rib beams was 600 mm in all samples. The other structural parameters and component layout are illustrated in Table 1 and Fig. 2.

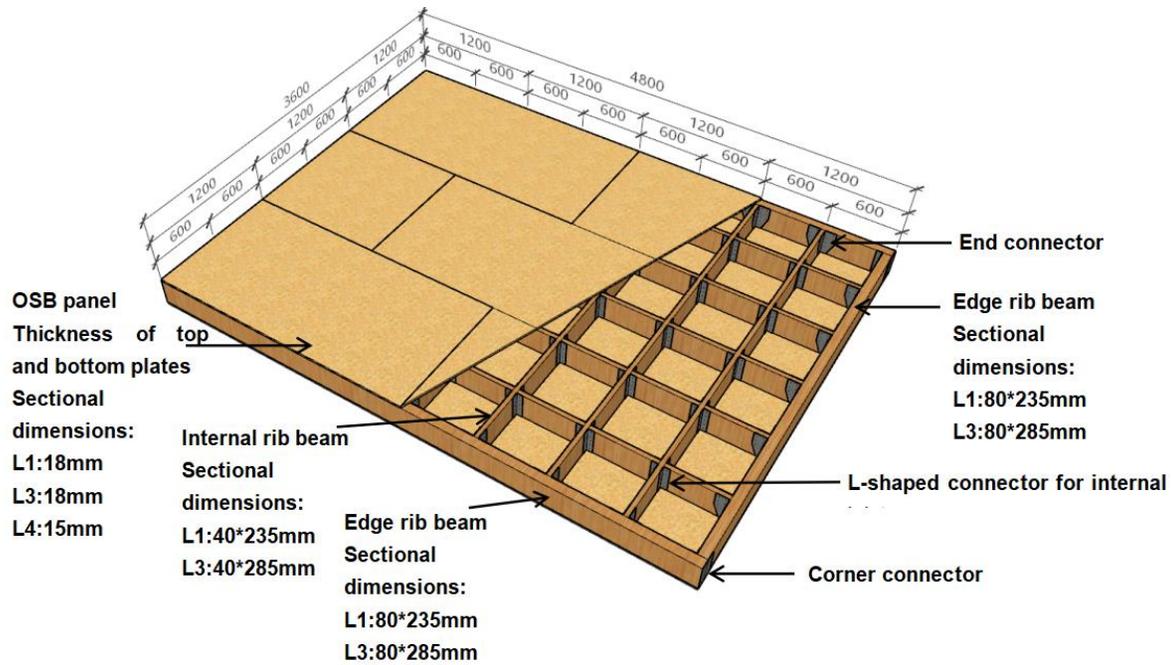
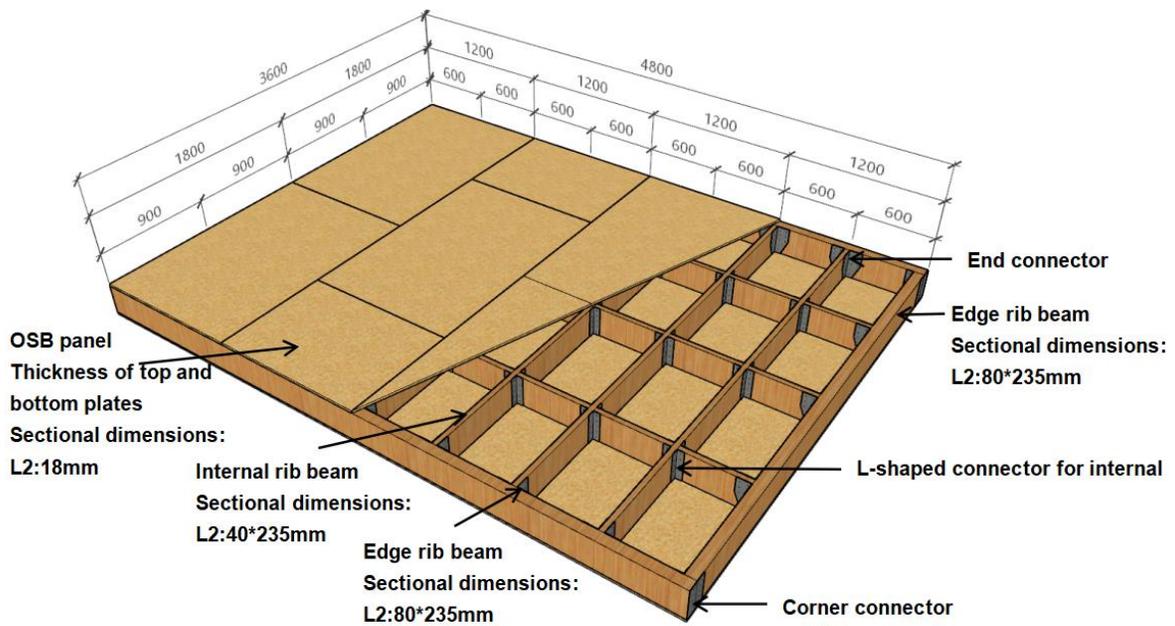
(a) Samples L1, L3, L4

(b) Sample L2

**Fig. 2.** Layout details of the floor components

No.	Short-side Rib Beam Spacing (mm)	Rib Beam Cross-section Size (mm)	OSB Plate Thickness (mm)
L1	600	40 × 235	18.3
L2	900	40 × 235	18.3
L3	600	40 × 285	18.3
L4	600	40 × 235	15.1

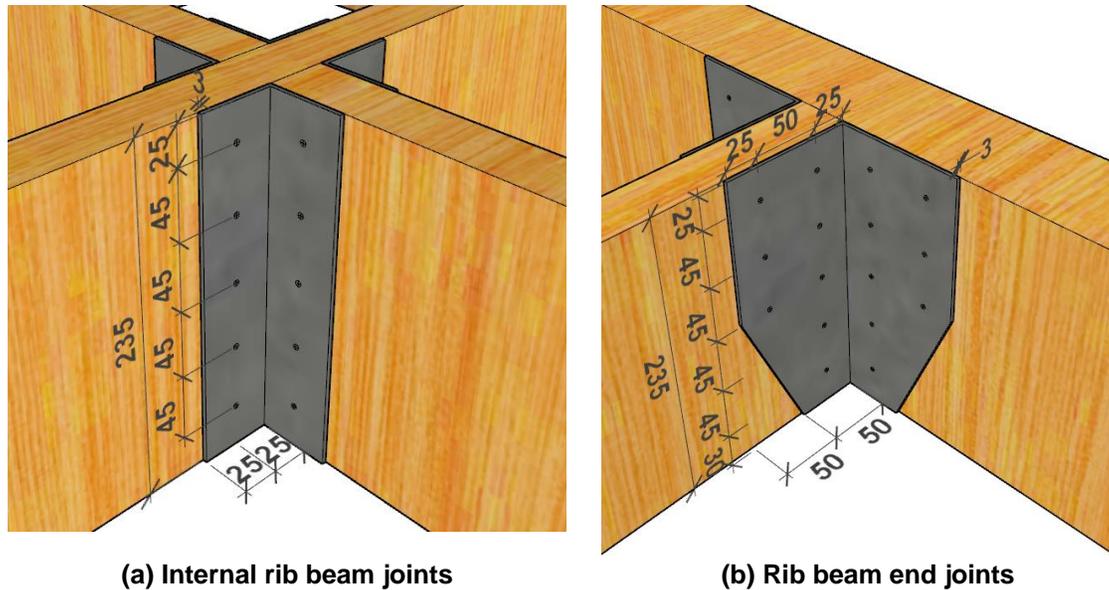
(a) Internal rib beam joints

(b) Rib beam end joints

**Fig. 3.** Structural details of the node connector

The internal rib beam joints of each sample adopted the 3 mm thick Q235 steel L-shaped connector, which was connected by  $M4 \times 20$  mm cross-countersunk self-tapping screws. The size of connectors and the number of screws were increased at the end nodes of the rib beam, which were connected to the edge-sealing rib beam by  $M4 \times 40$  mm cross-countersunk self-tapping screws (Liu *et al.* 2022). The node structure is detailed in Fig. 3.

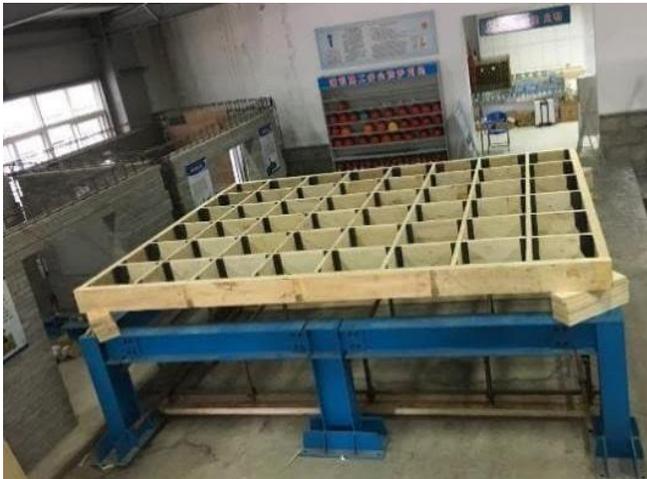
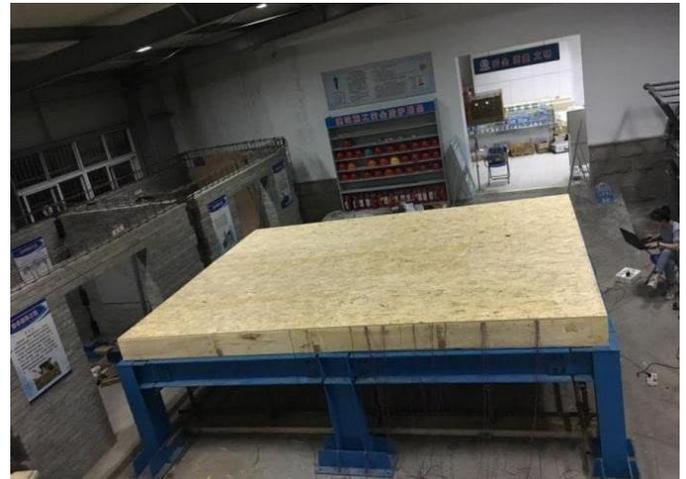
(a) Sample rib beam

(b) Sample after installation of top and bottom plates

**Fig. 4.** Floor sample after installation

OSB plates were used as the upper and lower floor slabs of the box floor, which were connected to the rib beam by  $2.8 \times 50$  mm round nails. The spacing between the round nails was 150 mm and 300 mm at the edge-sealing rib beam and the internal rib beam, respectively. The installed floor sample is displayed in Fig. 4.

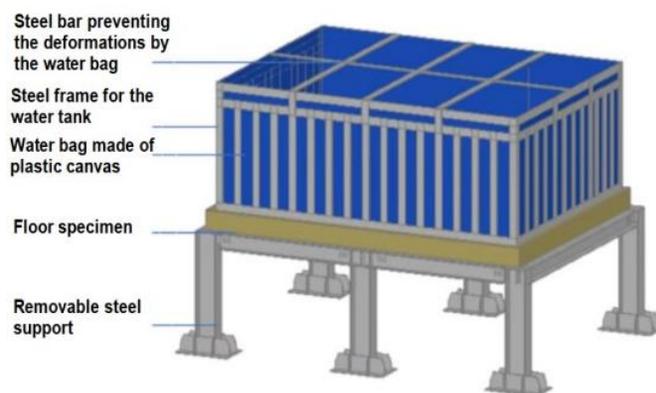
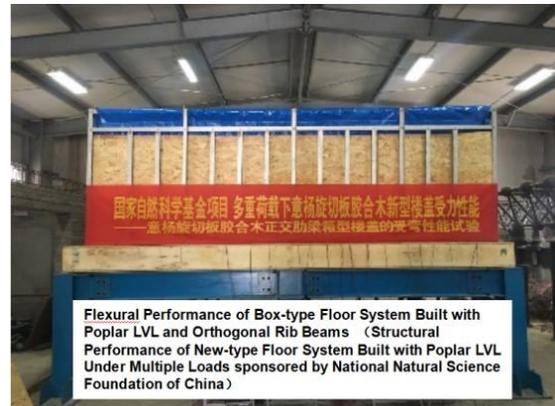
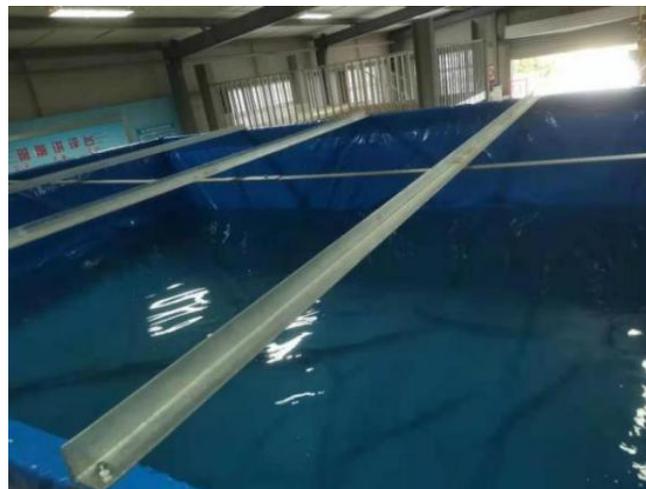
(a) Schematic of the loading device

(b) Installed loading device

(c) Interior of the water tank when loading

**Fig. 5.** Loading device

A self-designed water tank was used for the loading test, which was composed of a steel frame and a thickened flexible plastic canvas water bag, as displayed in Fig. 5. The clear height of the steel frame was 1500 mm, and the clear height of the canvas water bag was 1600 mm. The reserved 100 mm height difference could allow fitting of the water bag and roof during the loading process so that the load could act evenly on the floor sample and roof during the loading process so that the load could act evenly on the floor sample and allow the bag to deform with the floor (Xing 2012).

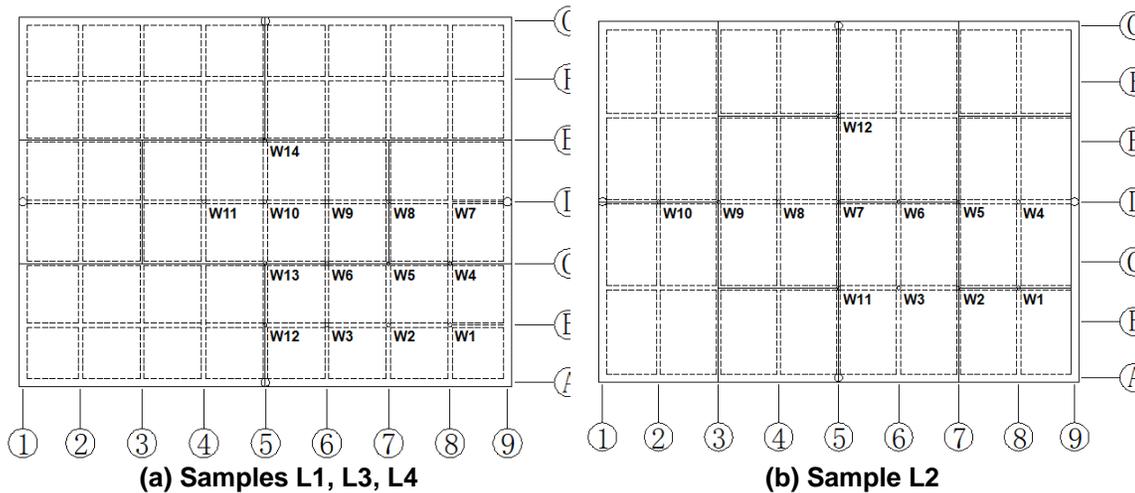
Fig. 6. Layout of displacement measuring points

The symmetry in load and structure of the box floor was considered in the test. All the displacement gauges were arranged below the rib beam node, and the layouts of displacement gauges for samples L1 through L4 are illustrated in Fig. 6.

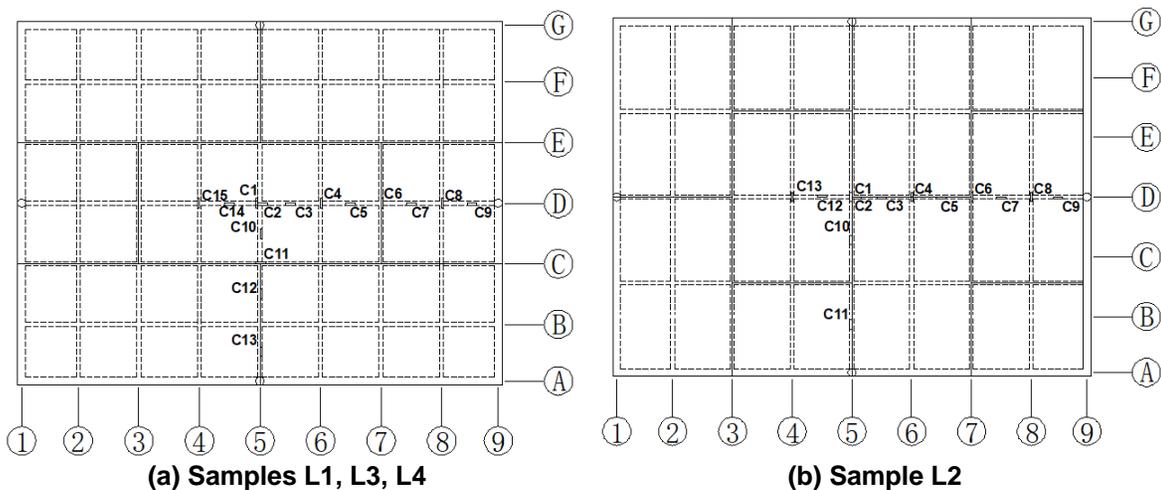
Fig. 7. Layout of strain measuring points

Strain gauges were installed on the bottom plate, which were arranged at the central axis considering the sample symmetry, as displayed in Fig. 7.

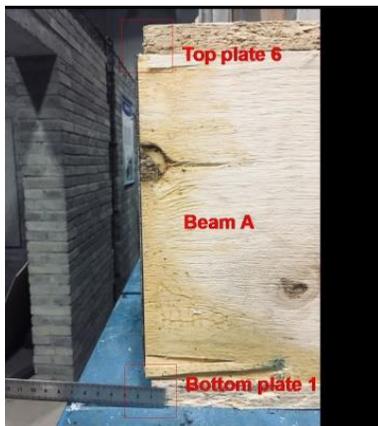
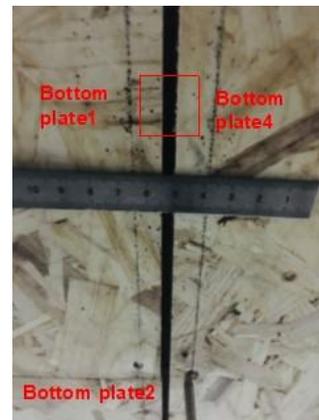
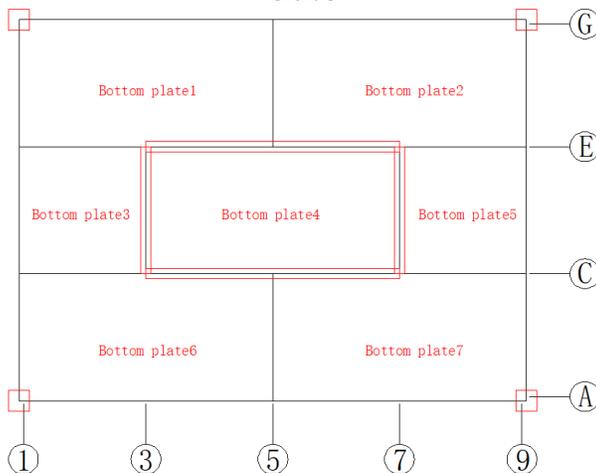
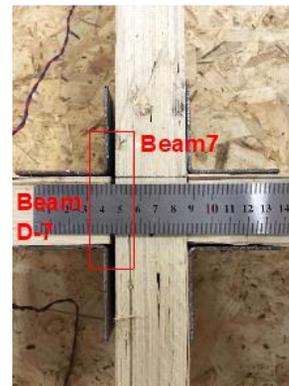
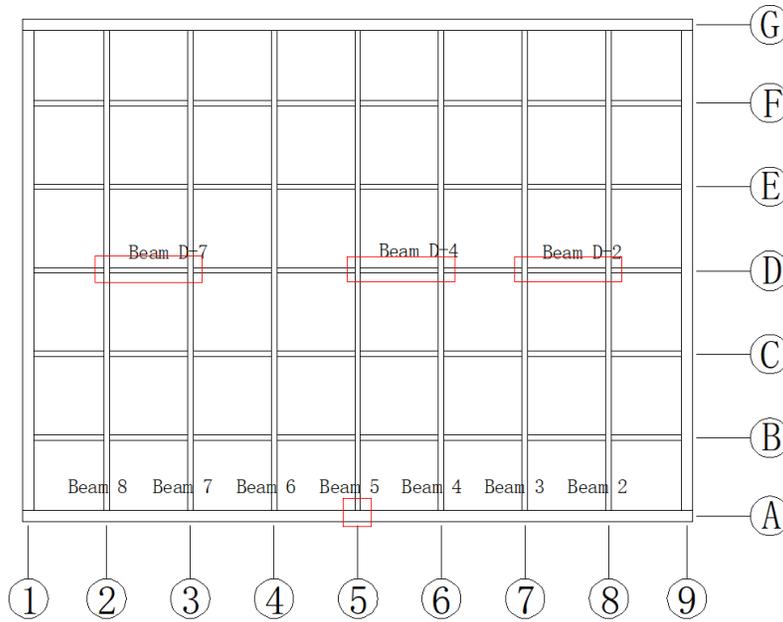
(a) Dislocation slip of upper and lower floor slabs

(b) Floor joint expansion

(c) Locations of floor joint expansion

(d) The connector was separated from the rib beam and the screws were pulled out

(e) The position where the connector was separated from the rib beam

Fig. 8. Locations and failure in Sample L1

1) Sample L1: When the load reached  $12 \text{ kN/m}^2$ , a few nail joints at the bottom of the midspan of the specimen began to fail, and a continuous sound came from the floor slab. With the increase of flexural deformation as the load was increased to  $15 \text{ kN/m}^2$ , dislocation slip appeared between the beam ends at the four corner nodes and the upper and lower floor slabs, as illustrated in the red square boxes in Fig. 8a. All local damage parts are also labelled using the red boxes in the following figures. In the meantime, expansions with a width of 5 to 7 mm appeared at the joints of multiple bottom plates (Fig. 8b), and their positions are displayed in Fig. 8c. Many connectors were separated from the rib beam, and the screws at A-5 were pulled out (Fig. 8d) after unloading and removing the upper and lower floor slabs. The specific locations are displayed in Fig. 8e.

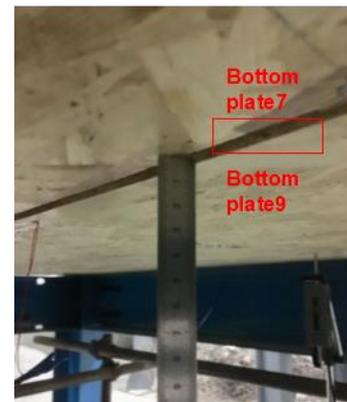
(a) Locations of floor joint expansion

(b) Staggered layers at the bottom plate joints

**Fig. 9.** Location and failure in Sample L2

2) Sample L2: When the load was 13 kN/m<sup>2</sup>, expansions with a width of 4 to 7 mm occurred at several bottom plate joints, as displayed in Fig. 9a. The camera placed inside the floor observed that the bottom plate was separated from the rib beam, resulting in staggered layers of about 3 mm at multiple joints (Fig. 9b). After removing the upper and lower floor slabs, many connectors were separated from the rib beam. Some gaps appeared at the rib beam joints, and the screws at A-5 were pulled out. The specific locations are displayed in Fig. 9c.

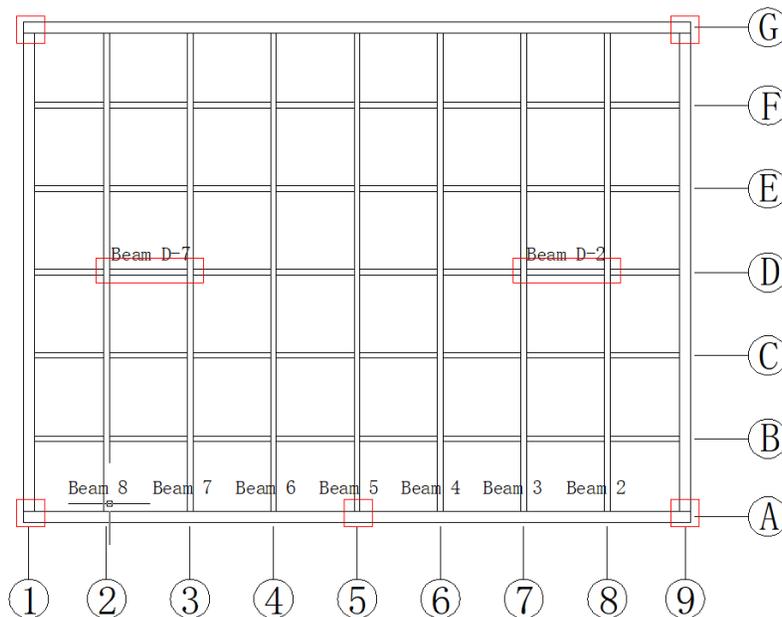
**Fig. 10.** Location of failure in Sample L3

3) Sample L3: The overall stiffness increased as the height of the rib beam increased in this sample. Therefore, when the load was  $15 \text{ kN/m}^2$ , no obvious damage appeared except for the dislocation slip of about 4 mm between the beam ends and the upper and lower floor slabs at the four corner nodes, as shown in Fig. 10. After removing the upper and lower floor slabs that the beam end gap, the connector separated from the wood beam D-7 and beam D-2, and partially pulled screws at A-5 were present close to the edge-sealing rib beam rather than the middle rib beam node.

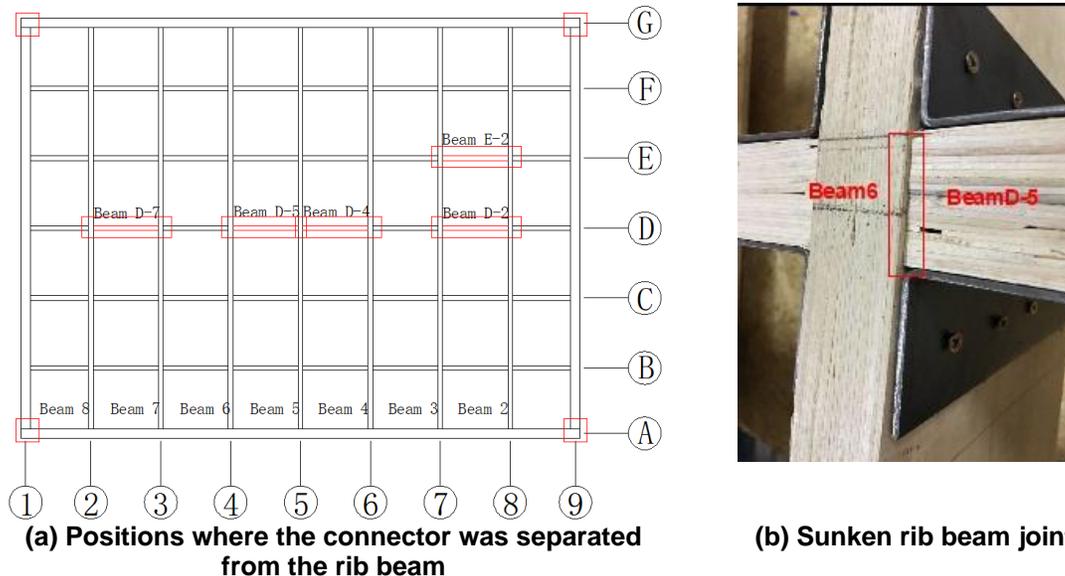
Fig. 11. Location and failure in Sample L4

4) Sample L4: The failures of sample L4 were similar to those of sample L1. When loaded to  $15 \text{ kN/m}^2$ , dislocation slip occurred between the beam ends and the upper and lower floor slabs at the four corners, as illustrated in Fig. 11a, and expansions in the range of 5 to 7 mm appeared at the joints of multiple floor slabs. However, the OSB plate in this sample was thinner than that of sample L1. After removing the upper and lower floor slabs, in addition to the beam end gap, the separation of the connector from the wood beam and partially pulled screws at the positions displayed were observed. Sunken rib beams were also observed at the joints between beam D-5 and beam 6, beam D-4 and beam 4, with a sunken distance of 2 and 3 mm, respectively (Fig. 11b).

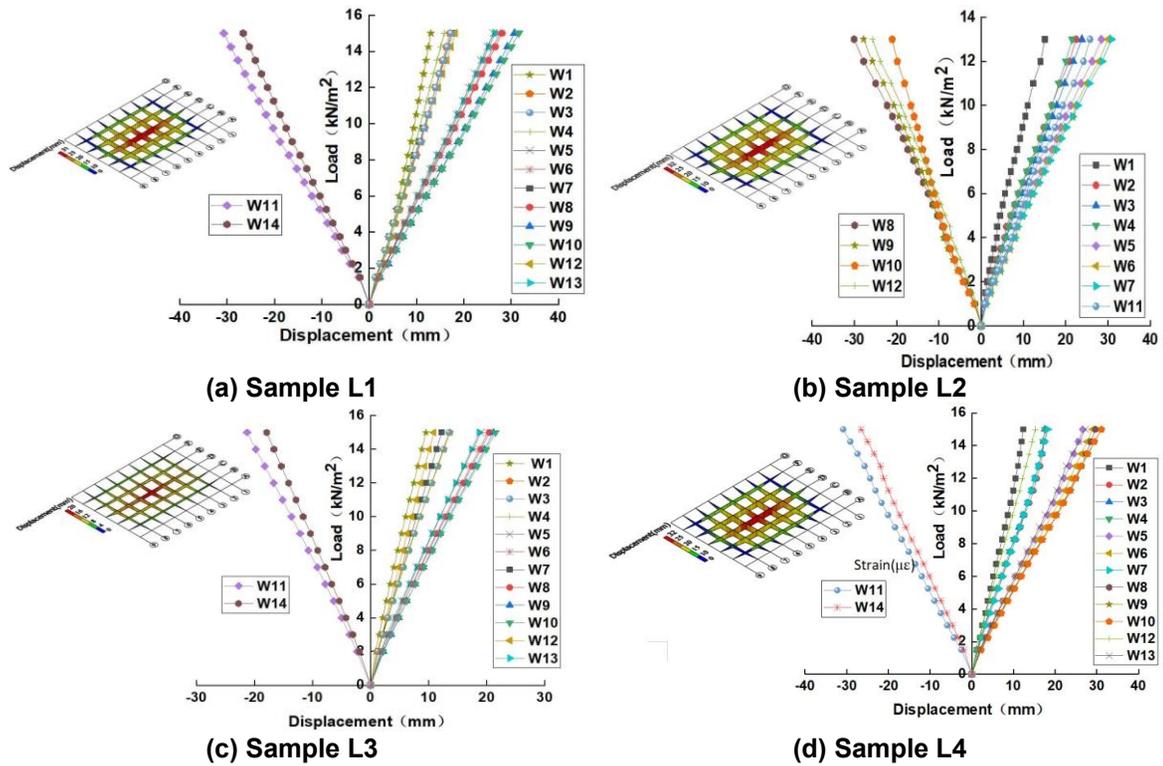
Fig. 12. Load–displacement curves and deflection distributions of the floor samples

Figure 12 presents the load displacement curves of samples L1 and L4 and the deflection distributions after symmetrical expansion when loaded to  $15 \text{ kN/m}^2$ . The deflection of symmetrical measuring points were basically the same for each floor sample, reaching the maximum deflection in both directions at the midpoint and gradually decreasing from the midpoint to the four sides. This bowl-shaped change indicated that the two-way slab effect was relatively significant. Furthermore, the load displacement curve was basically linear when loaded to the maximum value, indicating that the poplar LVL box floor sample exhibited high stiffness and good integrity.

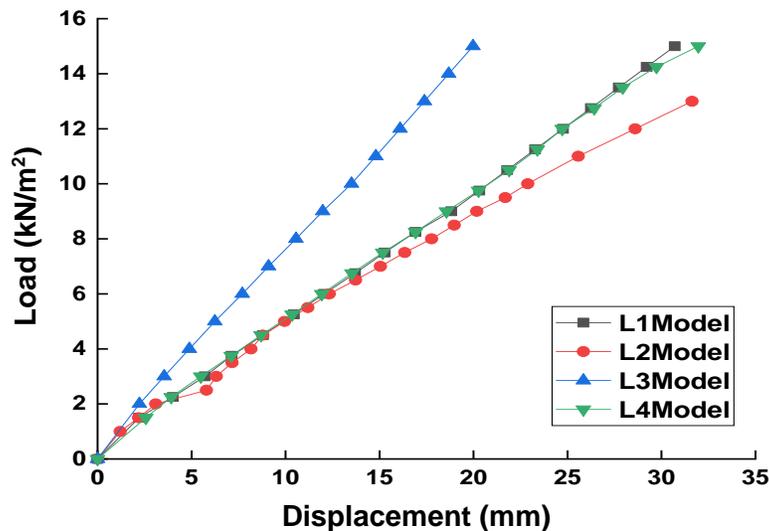
Fig. 13. Comparison of load–displacement curves of the samples

Figure 13 compares the load displacement curves at the midpoint of the samples, displaying the following characteristics: 1. When the load was 2.5 kN/m<sup>2</sup>, the standard value of normal floor service load, the maximum deflections of samples L1 and L4 were 4.57, 5.79, 3.00, and 4.80 mm, respectively, which were far less than the allowable value of  $1/250 = 14.40$  mm by GB 50005-2017 (2017) Standard for Design of Timber Structures; 2.

Compared with sample L1, under a load level of  $2.5 \text{ kN/m}^2$ , the deflection changes of samples L2–L4 were +26.7%, –34.4%, and +5.0%, respectively, indicating that the change in rib beam height had the greatest impact on floor stiffness, followed by the spacing between short-side rib beams, and the OSB floor slab thickness had little impact. Since the flexural deformation under uniform load was close to the first-order vibration mode of the floor, the first-order natural frequencies of samples L1 and L4 could be calculated as about 21.64, 20.33, 25.70, and 22.10 Hz, respectively, according to the measured deflections. These values met the requirement that the natural frequency for floor comfort should not be less than 3 Hz specified in Reference JGJT 441-2019 (2019).

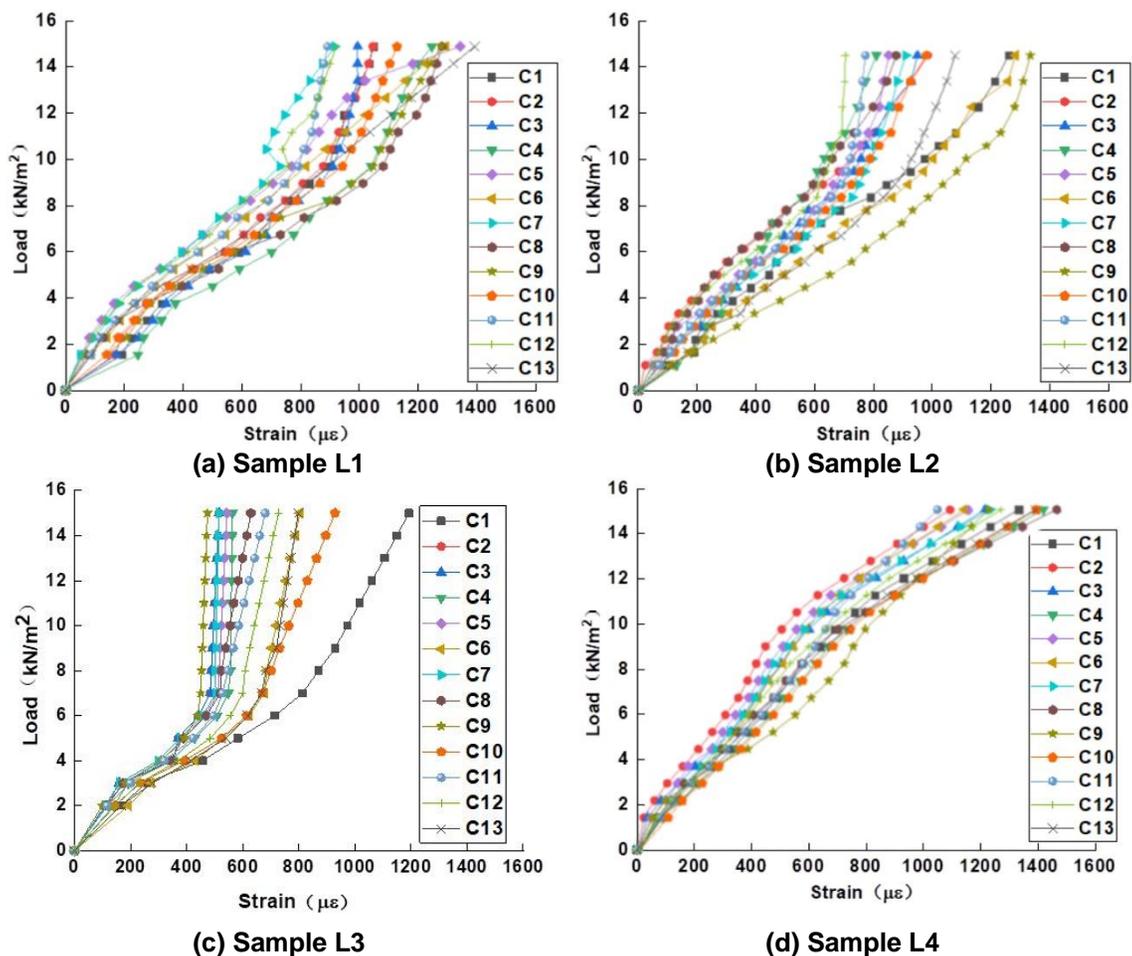
Fig. 14. Load–strain curves of measuring points at the bottom plates for the floor samples

Figure 14 shows the load-strain curve of the measuring points at the base plate of each sample. The comparison led to the following conclusions: 1. The stiffness of each sample's base plate material decreased after loading to  $3.0 \text{ kN/m}^2$ . For samples L1, L2, and L3, when the load level reached 9.5, 10.0, and  $6.0 \text{ kN/m}^2$ , respectively, the rise in strain began to slow down with the increasing load. Combined with the test phenomena of joint expansion and staggered layers between the bottom plates, it meant that some nails in the bottom plate began to be pulled out, resulting in the relative slip between the bottom plate and rib beam and their weak collaborative deformation ability. As for sample L4, when the load reached  $10.0 \text{ kN/m}^2$ , the increase in strain started to accelerate with the increase in load. This was because the decrease in OSB plate thickness increased the embedded depth of nails, strengthening the nail joints and making the bottom plate enter the yield phase.
