# International Supply Chain Handling Practices and the Quality of Heat-treated, White Oak Veneer Logs

The most promising alternative to the methyl bromide fumigation of exported logs is steam-heating the log in a vacuum. Research has confirmed that steam heating to 56 °C for 30 minutes kills all viable propagules of oak wilt pathogen (*Bretziella fagacearum*) in the sapwood of oak logs. The purpose of this study was to determine whether this heat-treatment method has any effect on the quality or value of white oak veneer logs shipped between the US and EU. Seventeen steam- and vacuum-treated and seventeen untreated control logs were shipped from Baltimore, Maryland to the Czech Republic, for processing into veneer, between December 2021 and February 2022. The treated and untreated logs were sawn into flitches, soaked in hot water vats, sliced, dried, and the veneer from each log was graded for quality. Each log was assigned a value based on the veneer quality and yield. The average value of treated log was 1,547 €/m<sup>3</sup>, and the average value of the untreated logs was 1,539 €/m<sup>3</sup>. The null hypothesis was statistically confirmed. Therefore, it is concluded that t

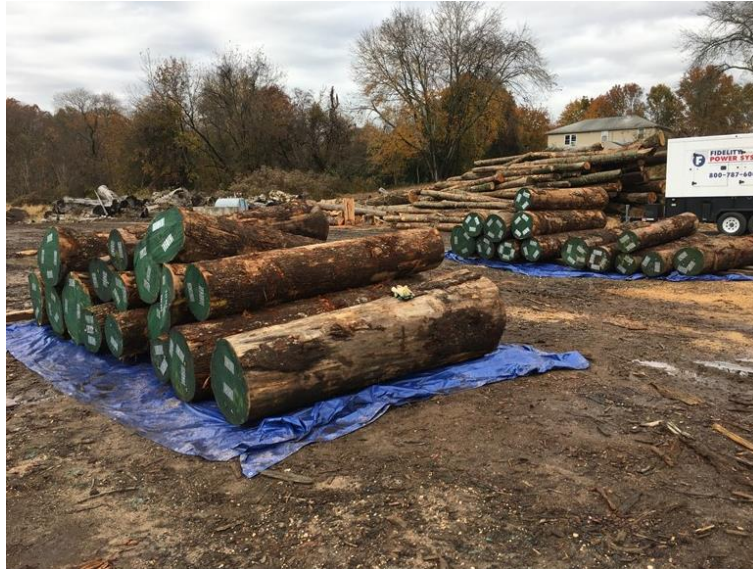
**Fig. 1.** Logs were sorted into two groups of approximately the same size distribution, plated, and end coating applied

The logs were all 2.5 m long. The small end diameter (SED) ranged from 35.6 to 59.7 cm, and the large end diameters (LED) were from 39.4 to 78.7 cm. The logs were randomly separated into two groups of 17 each, as shown in Fig. 1. One group was used for HT and the other were untreated control logs. An attempt was made to have logs of a similar size distribution in each group. Tables 1 and 2 contain the size and volume, based on the Doyle log scale, of the logs in each group. The logs were placed into temporary storage using plastic tarpaulin. The logs were end-coated with Anchorseal, and 10 × 15 cm metal connector plates were applied to the end of the logs and located, depending on visible splits.

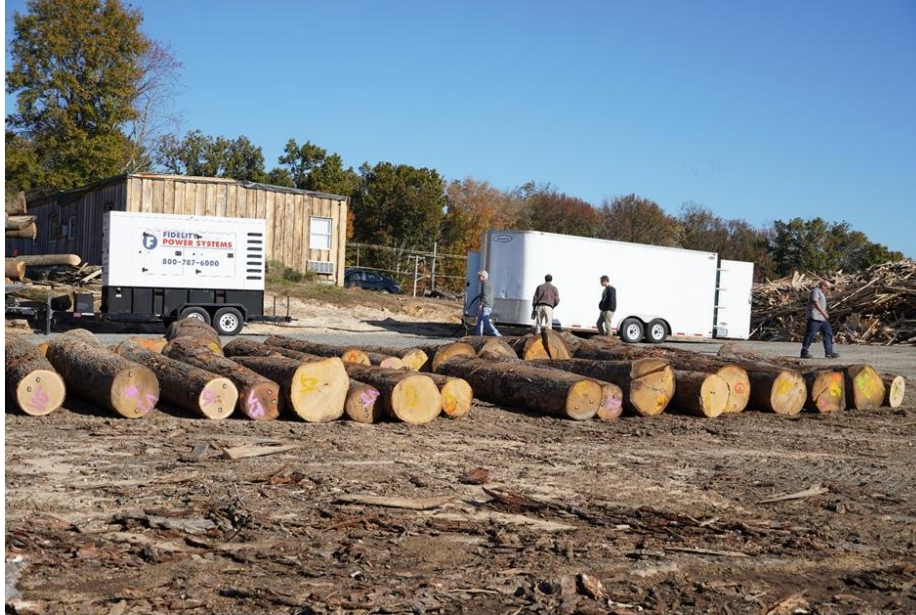
**Fig. 2.** The electric generator and portable steam/vacuum treating system at Polo Pallet/Mill Creek Lumber, Elkton, Maryland

Steam and vacuum heat treatments of the 17 logs began on November 9<sup>th</sup> in groups of 3 or 2 logs per treatment. Figure 2 shows the treatment system layout with generator and the 6 m trailer containing the vacuum chamber, vacuum pump, electric boiler, process controller, and data acquisition system.

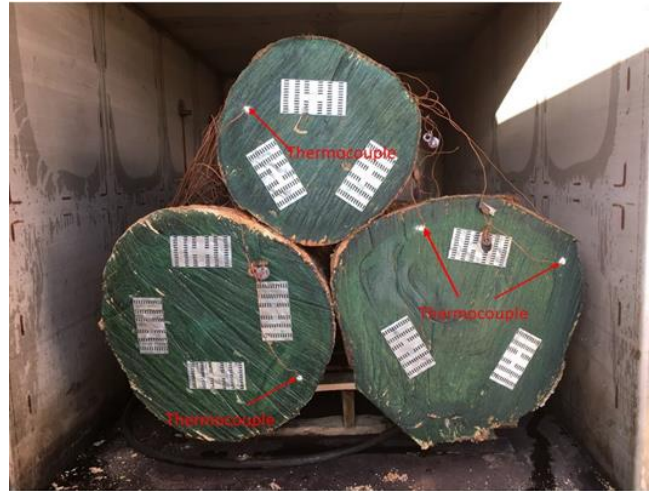
**Fig. 4.** Logs after treatment in the steam/vacuum chamber showing end plates and thermocouples

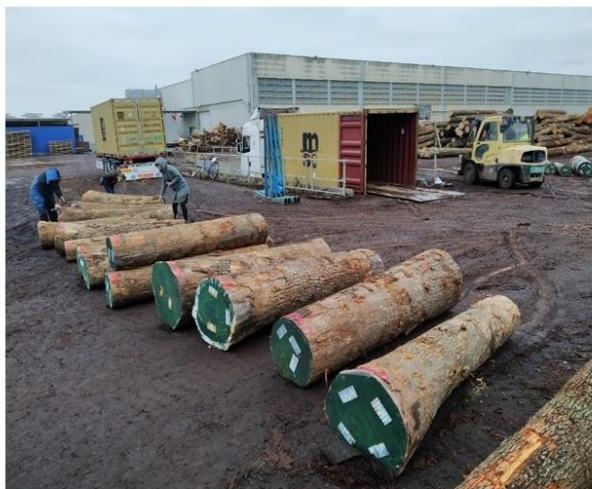
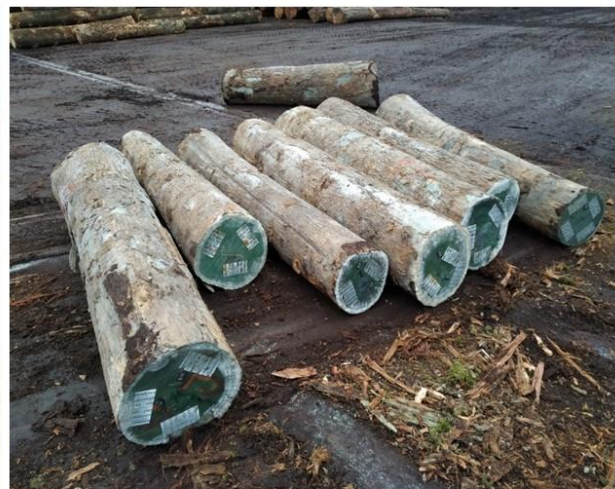
Untreated control white oak veneer logs

Treated white oak veneer logs

**Fig. 6.** Logs being inspected after delivery to Danzer Bohemia, Melnik, Czech Republic on January 25, 2022

The two containers of logs arrived at the Danzer Bohemia facilities in Melnik on January 25, 2022. The containers were opened, and the logs were removed from the containers, inspected, and set into the log yard for temporary storage. Most logs exhibited white mold on all surfaces. The treated logs exhibited more surface mold than the control logs, as shown in Fig. 6. The staff of Danzer Bohemia confirmed that mold often occurs on logs and the mold observed, was typical.

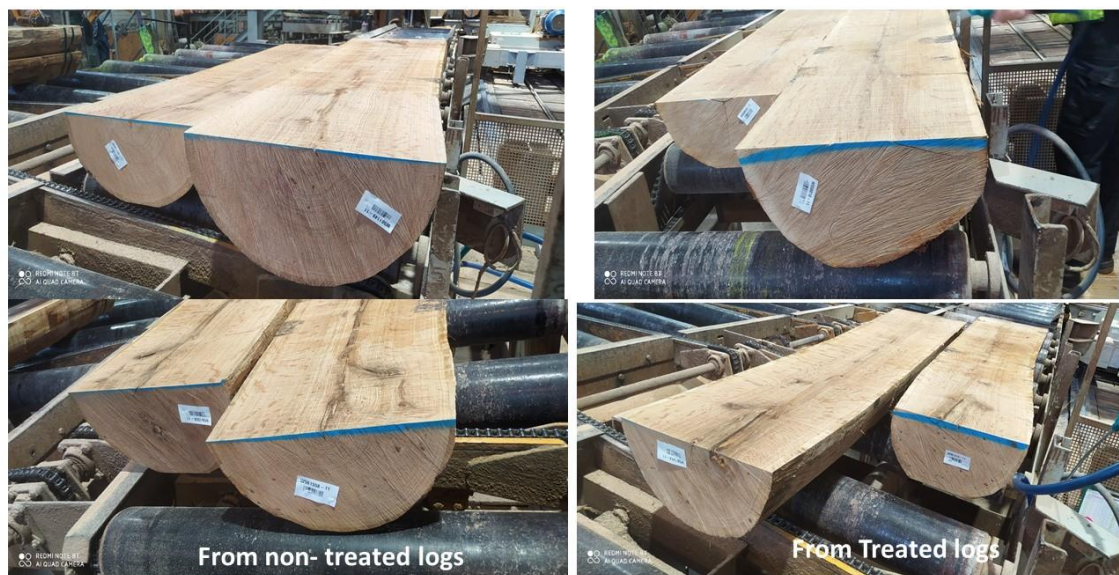
**Fig. 7.** Typical flitches sawn from the white oak veneer logs

Figure 7 shows images of typical white oak flitches prior to soaking in the hot water vats. The surface mold had no effect on wood quality and color. The heartwood color variation was typical of white oak. A few logs from both the treated and untreated logs showed some past insect activity and some dirt embedded in the surface from handling and storage. No live or dead insects were found in any of the treated or untreated logs. Both sets of logs exhibited the typical variation in color and quality.
