Reuse of Wooden Utility Poles Through the Combination of New and Old Elements

Alfredo Manuel Pereira Geraldias Dias,^{a,b} José Saporiti Machado,^c Fernando Júnior Resende Mascarenhas,^{a,b,*} Telmo Filipe Marques Morgado,^d Nelson Gomes Pedrosa,^d Lucas Cardoso Pereira Carneiro,^b and André Filipe Silva Marques^b

Keywords: Wooden utility poles; Maritime Pine; Reuse; Steel tube connection; Finger joint

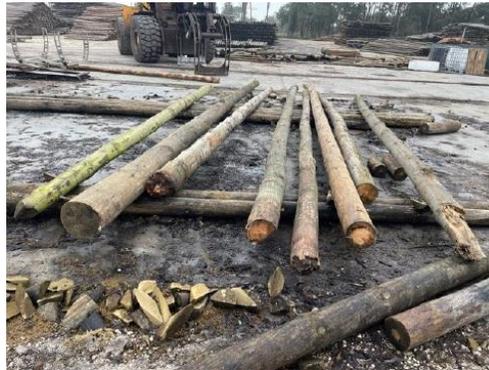
Fig. 1. Used wooden poles

The choice of wooden poles removed from service began based on certain criteria, namely, having information on the type of treatment used, time in service, and reason for removal from service. Figure 1 shows examples of poles that met such criteria, allowing their usage in the present study.

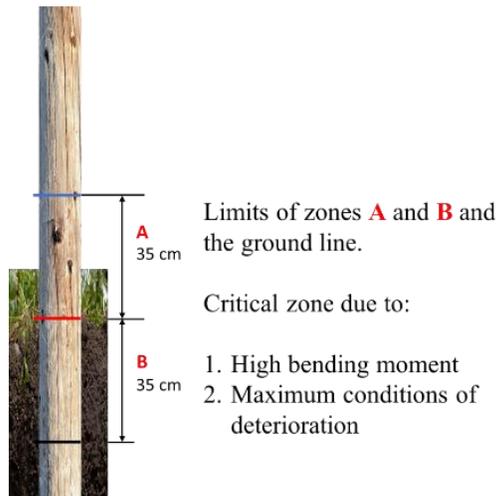
Fig. 2. Procedure to identify the degradation in the wooden poles **Fig. 3.** Measurements made with Resistograph

A Resistograph (IML-RESI PD400; Instrumenta Mechanik Labor System GmbH, Wiesloch, Germany) equipment was used to define the deteriorated area for identification of the replacement length (deteriorated wood pole volume). Six holes were made in the wooden poles in different positions: a) 1 m from the height of the post (not indicating rot) – Reference profile; b) in the superior limit of zone A; c) at ground level; d) in the inferior limit of zone B; and e) in the zone above ground (zone A) where visual assessment did not detect signs of rot. In this zone, holes were made in the region still showing signs of rot and 10 cm above the zone with signs of rot (Fig. 2). The holes were made in areas that do

not contain defects, such as knots or resin pockets. At each height, two holes were drilled in orthogonal directions in the transverse plane of the pole.

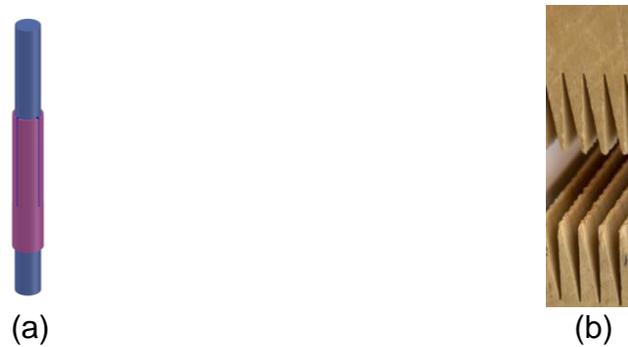
Fig. 4. Studied solutions: (a) wood pole members inserted in a cylindrical steel tube; and (b) finger joint

The choice of the possible connections to be used followed three requirements: to be resistant to bending moment, to present a good fatigue behavior, to have adequate cost, and to require a low execution complexity. Then, as a first approach, several possible connection systems were considered, with existing timber structure solutions as a starting point. Each solution was analyzed, leading to two final solutions: timber members inserted in a cylindrical steel tube and finger joint configuration (Fig. 4).

The finger joint connection offers the benefit of avoiding metallic elements, which when subjected to prolonged intense fire tend to have lower fire resistance than wood. While steel loses strength and stiffness rapidly when subject to high temperatures, wood subject to the same conditions undergoes a charring process that, when advancing at a constant rate, will lead to the gradual loss of wood cross-section and thus, depending on the cross-section, provide a slower loss of strength and stiffness over time and therefore a higher resistance to fire of the wood pole. In addition, depending on the glue used, it may have fire-retardant properties, which improves the fire performance of the connection compared to the solution involving the cylindrical metal tube. Additionally, it requires less processing of the ends to be joined, making it a simpler connection to implement compared to the steel tube connection, which requires the top ends to be processed to perfectly rounded sections.

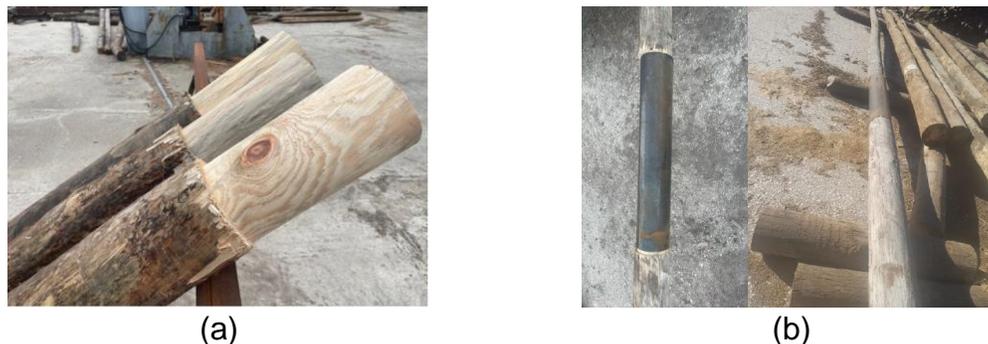
Fig. 5. The wooden poles (a) before insertion; and (b) with the cylindrical steel tube

Concerning the external steel tube connection, commercial steel tubes with external diameters of 168.3 mm and 600 mm long were used in both sets of tests (Fig. 5). The difference was in the thickness of the tube, 4 and 3 mm, and the type of commercial tube and its internal diameter were linked to the thickness. The tubes with 4 mm thickness had an internal diameter of 160.3 mm and steel of class S275. Contrastingly, the tubes with 3 mm had an internal diameter of 162.3 mm and steel of class S235.

In the tests, 4-mm and 3-mm-thick steel tubes were used in the preliminary and final test series, respectively. The wooden poles with the members inserted in a cylindrical steel tube of 4 mm (preliminary tests) had an average cantilever length of 6389 mm. Those with 3 mm (final tests) had an average cantilever length of 6390 mm. It was decided to reduce the thickness of the tube and change the resistance class from the preliminary tests (P_ST) to the final ones (F_ST) because with the 4 mm tube, the ruptures were always caused by the wood, and in this way, it is possible to increase the section of wood. Additionally, by reducing the thickness of the tube, there is a reduction in the connection cost.

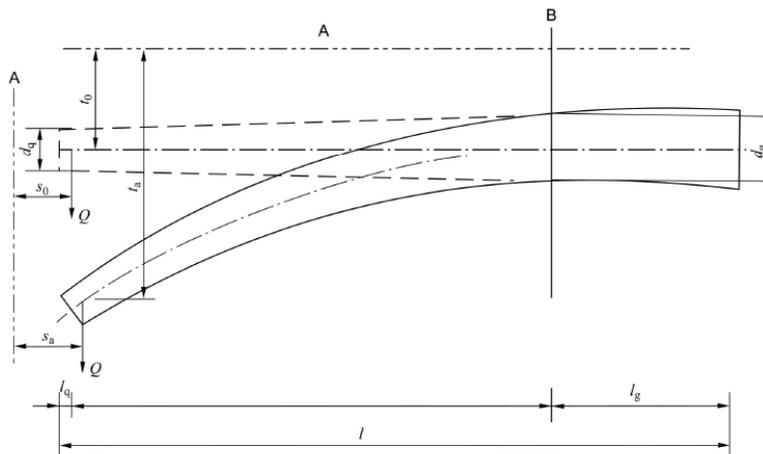
Fig. 8. Bending test diagram in accordance with EN 14229 (2010)

$$\text{MOR} = \frac{32 \cdot Q \cdot (l - l_{max} - (s_a - s_0))}{\pi \cdot d_{max}^3} \quad (3)$$

$$\text{MOE} = \frac{Q \cdot (l - l_{max} - (s_a - s_0))^3 \cdot d_q^3}{3 \cdot I_q \cdot (t_a - t_0) d_{max}^3} \quad (4)$$

In the preceding equations, Q is the applied load; l_{max} is the distance from butt to section of maximum stress or ground line, whichever is the greater; $s_a - s_0$ is the movement of load application point parallel to longitudinal axis of the pole during testing; d_{max} is the nominal diameter at section of maximum stress; l_q is the distance from tip to position of applied load; $t_a - t_0$ is the deflection at point of load application.

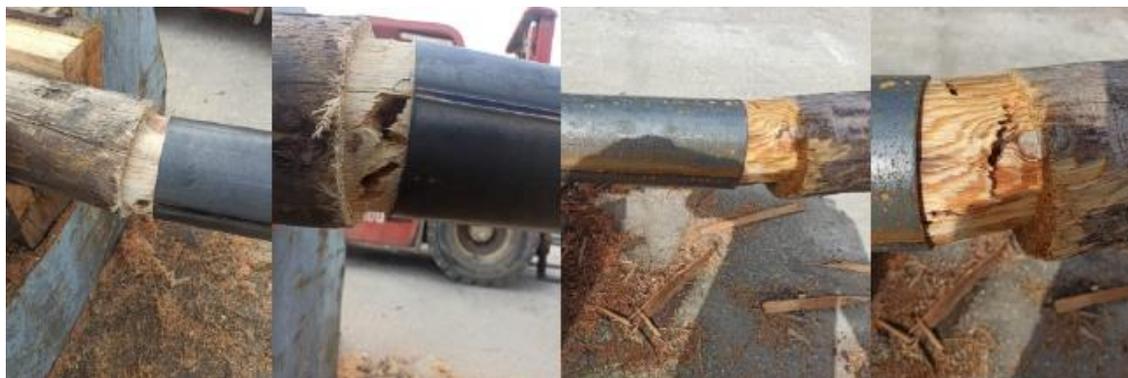
**Fig. 9.** Ruptures observed in the wooden elements inserted in the steel tube

Table 5 shows the results of the final tests of 10 wooden poles inserted in a cylinder steel tube (F_ST) with 3 mm of thickness, and Fig. 9 shows some of the ruptures that were observed. In all wooden poles with steel tubes, the rupture occurred due to exceeding the tensile strength of the wood, and in all cases, the metallic element did not show any damage. The coefficient of variations of both diameters were small, as well as the COV of MOR and MOE decreased compared to those from the P_ST tests, showing that there was a reduced variability among the tested poles.

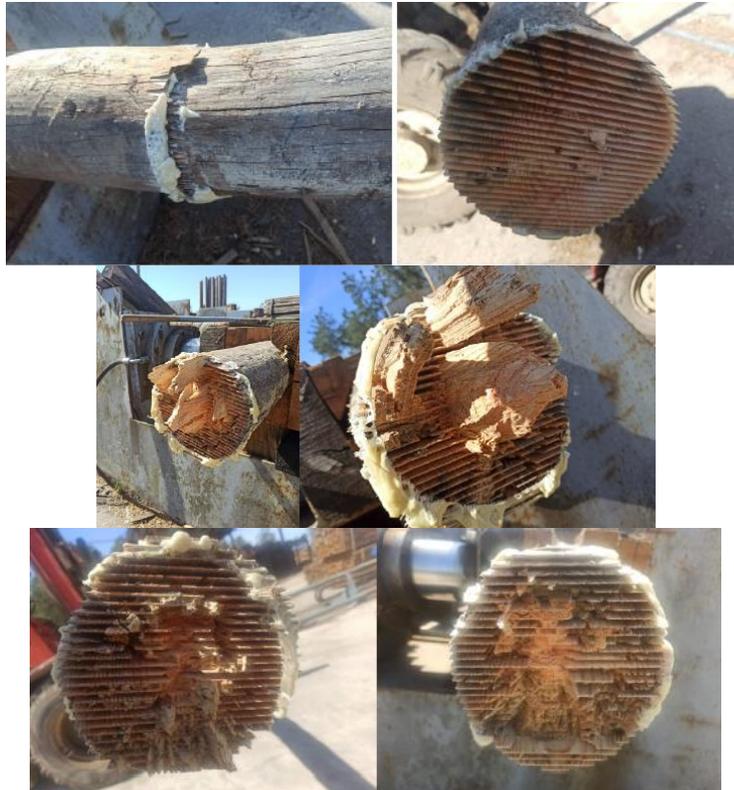
**Fig. 10.** Ruptures observed in the finger joint connections

From the analyses of the ruptures, it was observed that the finger configuration in the preliminary tests was not correct. The fingers were thinner than the desired configuration, which was probably caused by the vibration of the machine developed to make the finger joints in round sections. Moreover, according to the manufacturer, the PUR glue used on the P_FJ for optimal performance on maritime pine requires the application of a primer, which was not available at the time of the study. The glue was changed to a PRF type for the F_FJ, and the finger joint machine was modified to reduce vibrations during work. Hence, Table 10 shows the results of the final tests in the 12 wooden poles with finger joint configuration (F_FJ), and Fig. 10 shows some rupture modes that occurred.
