Effect of Material Properties on the Paper Cup Manufacturing Process

Juho Bonifer,* Panu Tanninen, and Ville Leminen

DOI: 10.15376/biores.19.4.8493-8511

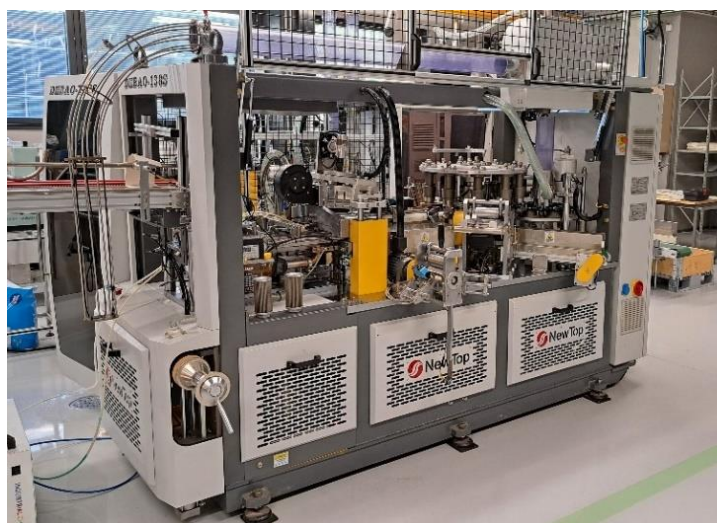
**Fig. 5.** A cup manufacturing machine was used for the study

A Debao NewTop 138s commercial, high-speed cup forming machine (New Debao Machinery, Zhejiang, China), which has a maximum production speed of 140 CPM, was used to convert the coated paperboard blanks into 8 oz/250 ml hot beverage cups. The machine is shown in Fig. 5.

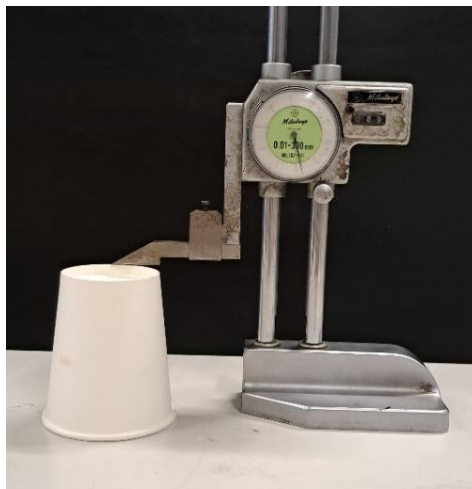
**Fig. 6.** The device that was used to measure cup height

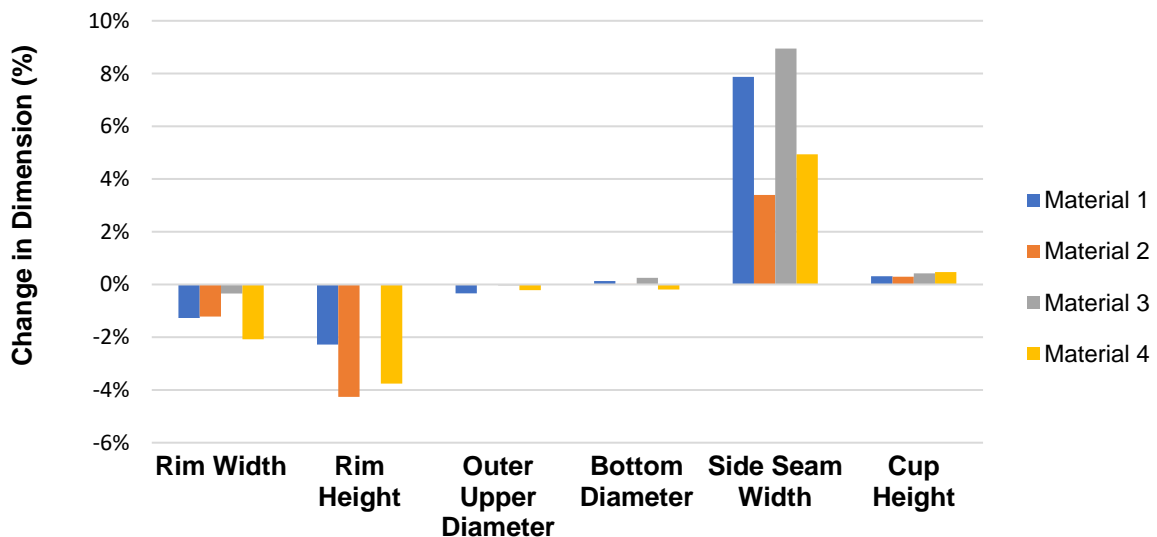
Fig. 7. Percentual change of cup dimensions between the preliminary and second run

The change in top and bottom diameter as well as cup height compared to the first trial run was negligible at 0 to 0.5% for all materials. The degree of change in the width of the side seams was noticeably different between materials: the higher the COF of the material, the higher the change in side seam width, which is displayed in Fig. 8. Bending stiffness in the cross-direction could also have some effect on the carryover of the adjustment, as seen in Fig. 9. The height of the rim rolls was affected more by the adjustments than their width and, similar to the side seam, seemed to be affected by the COF of the materials, as shown in Fig. 10. Overall, the height of the rim rolls was reduced by 2 to 4%, while for Material 3, which also had the highest COF, the rim roll height remained unchanged. Material 2, which experienced the largest decrease in rim roll height had the lowest COF but also the highest bending stiffness in MD. The low COF is most likely the main reason for the change, as it allows the rim roll to be tucked more easily due to less resistance. The effect of bending stiffness on rim roll forming is presumably insignificant compared to COF and possibly the delamination strength of the paperboard.

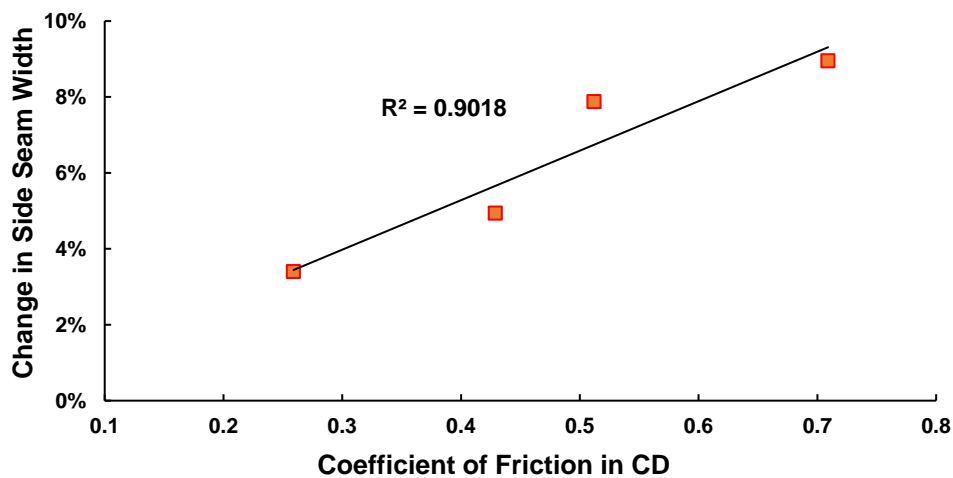
Fig. 8. Percentual change in side seam width in relation to COF of the materials in CD

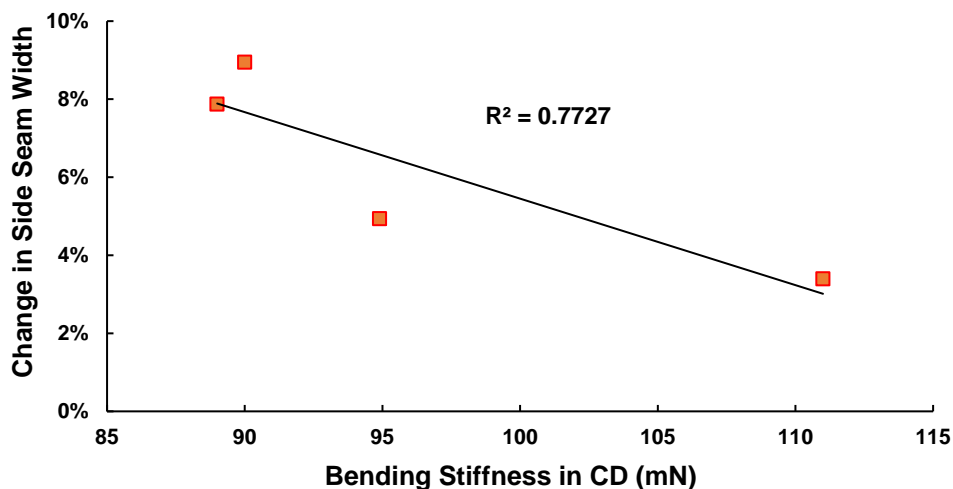
Fig. 9. Percentual change in side seam width in relation to the CD bending stiffness of the materials

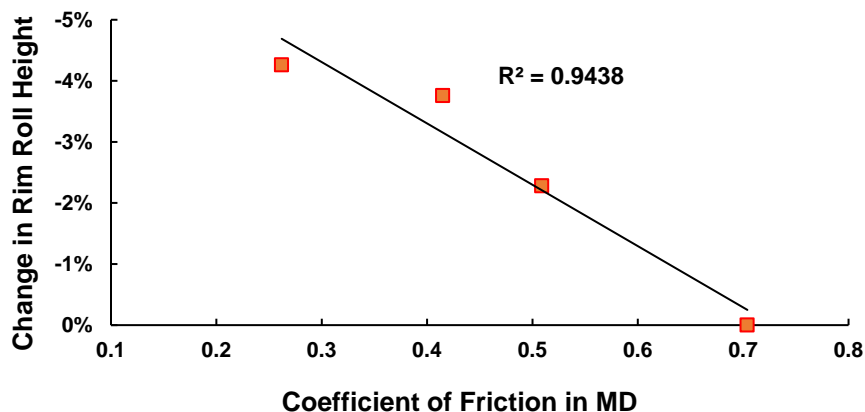
Fig. 10. Percentual change in rim roll height in relation to COF of the materials in MD

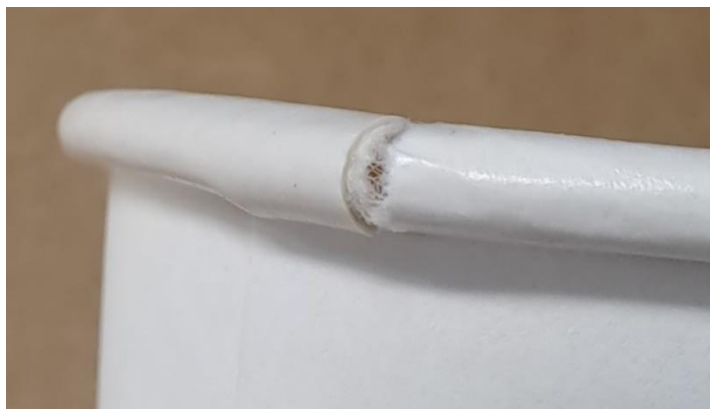
Fig. 11. The rim roll of the cup has split near the side seam, exposing the fiber structure of the paperboard

- Split rim: The cup's rim roll has split, exposing fibers and affecting the roundness of the rim roll negatively. Split rims are often caused by low moisture content due to the reduced tensile properties of the material, a geometry too restricting for the material, or a combination of both. —shape defect.
- Rim roll tuck failure: The tuck of the rim roll has fallen short, possibly due to friction or failure of the side seal near the rim—visual and shape defect.

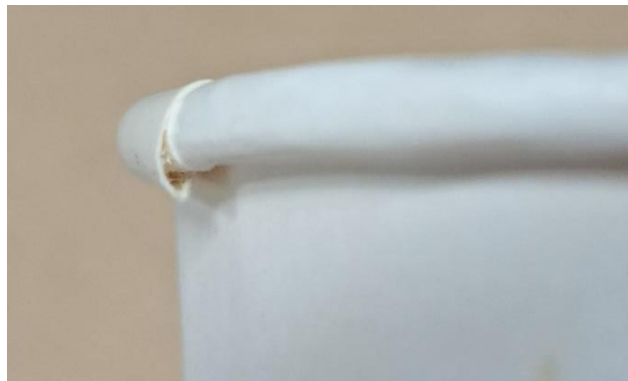
- Rim delamination: The rim roll has partially opened due to delamination of the paperboard layers in the top side seam layer, leaving the bottom half attached and tucked to the rim roll—visual defect.

Fig. 13. Delaminated rim roll with exposed fibers

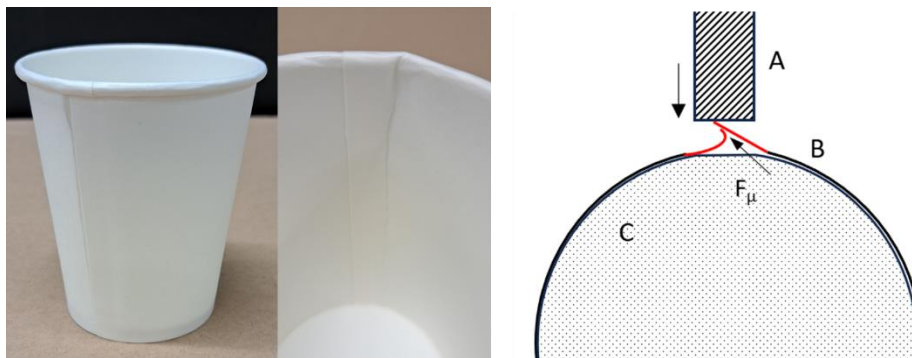
- Major buckling of the side seam area: Wall material adjacent to the side seam has noticeably collapsed inwards, affecting the roundness of the cup, likely caused during the side seaming stage, as displayed in Fig. 11. As the displayed failure mechanism can also increase the circumference of the cup by reducing the overlapping area in the seam. Subsequent tools could push the side seam inwards, causing similar buckling—shape defect.

Fig. 14. Cup with a majorly buckled side seam (Material 1) and suspected mechanics of defect formation. A: Sealing tool, B: Wall blank, and C: Mandrel

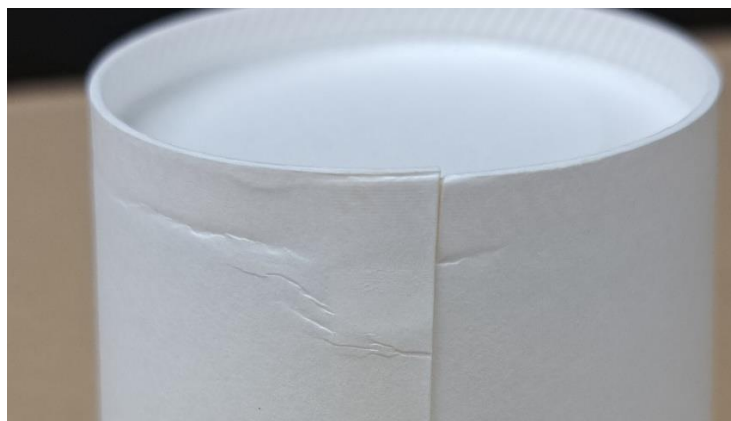
- Buckling: The side seam near the bottom fold has collapsed, causing a noticeable horizontal wrinkle. The cause could be incorrect fit on the bottom forming tools combined with high COF and low hot tack strength, causing them to push up on the cup and thus subjecting the side seam seal to shear while still hot. It possibly affects liquid tightness near the bottom. Visual or potential leak defect—4/5 cups leaked coffee.

Fig. 16. Buckling of the side seam area near the bottom

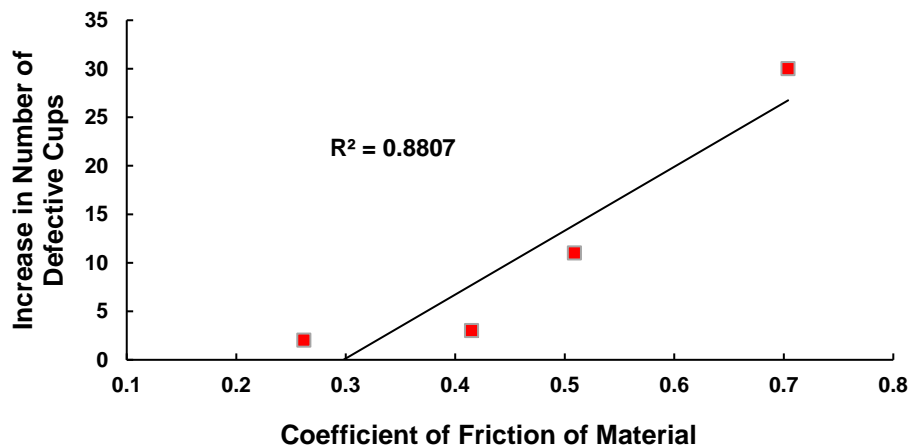
Fig. 18. Correlation between COF and increase in the number of defective cups after adjustments
