# Effect of Natural Degradation on Wood Samples Used in Late Ottoman Period Architecture: A Case Study from Kahramanmaraş (Southern Türkiye)

This article examines the chemical deterioration of wooden materials on the exterior surfaces of a historical mansion in Kahramanmaraş, constructed using the Bağdadi Wall Construction Technique, which is a rare example of Late Ottoman-Turkish architecture. The study employed various analyses to demonstrate that environmental factors, such as air, temperature, light, rain, and biological decay, have aged the wood. Fourier transform infrared analysis revealed a decrease in holocellulose peak density and lignin degradation. X-ray diffraction analysis indicated that the amorphous components of hardwood had diminished, leading to an increase in crystallinity, while the crystalline cellulose content in softwood had decreased, thereby weakening the structure. Thermal analysis uncovered changes in thermal stability between the wood's outer and inner surfaces. Ultraviolet analysis indicated a 21% color change on the exterior compared to that in the interior. Despite the deterioration of the exterior, the interior surfaces remained intact. Appropriate

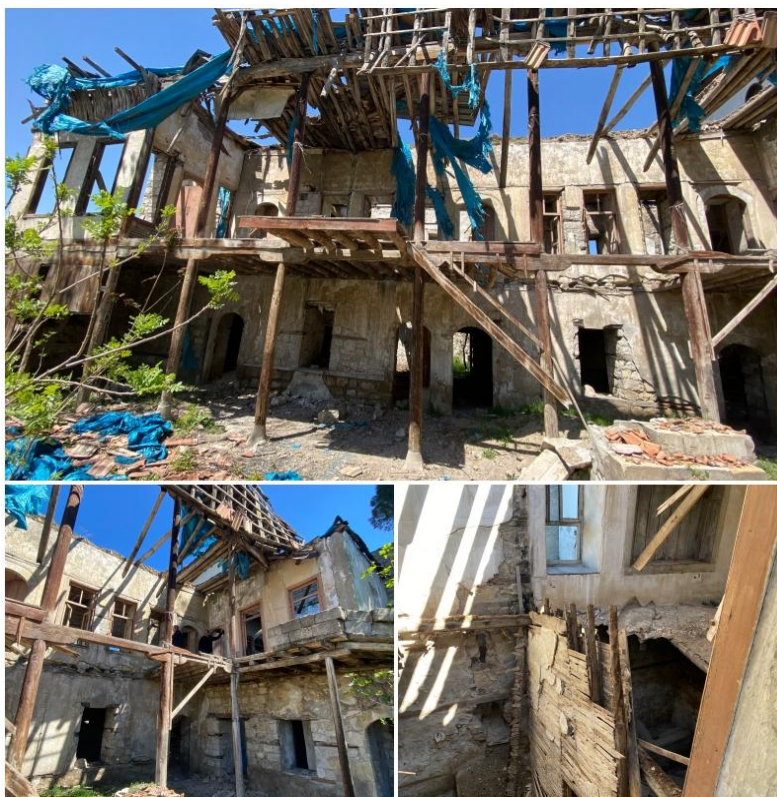
**Fig. 1.** View of the Historic Turkish Mansion

The mentioned structure is located within the boundaries of the Dulkadiroğlu district. Situated on the slopes of a prominent hill, approximately 400 m from the Kahramanmaraş Castle, it represents one of the finest examples of Late Ottoman Period architecture. The ground floor of the structure is built using a stone masonry system, while the walls of the rooms are constructed with the “Baghdadi wall construction technique”. In the Baghdadi wall construction technique, wooden slats are horizontally placed at regular intervals on a wooden frame. The dimensions of the slats used in this technique are typically  $10 \times 12 \text{ cm}^2$ , with a thickness of 1.5 cm to 2 cm, and a width of 2.5 cm to 3.5 cm. The slats are plastered with lime mortar on both the interior and exterior surfaces (Erman 2000; Tayla 2007). The timber material used in the wall construction has a fibrous and porous structure, which despite being lightweight, demonstrates high strength due to these characteristics (Eriç 1978). However, significant deterioration is observed in the timber frame walls constructed using the Baghdadi technique. Additionally, the timber columns supporting the roof have collapsed, leading to the roof’s failure (Fig. 1). Based on its architectural and structural features, the building is believed to have been constructed in the late 19<sup>th</sup> century.

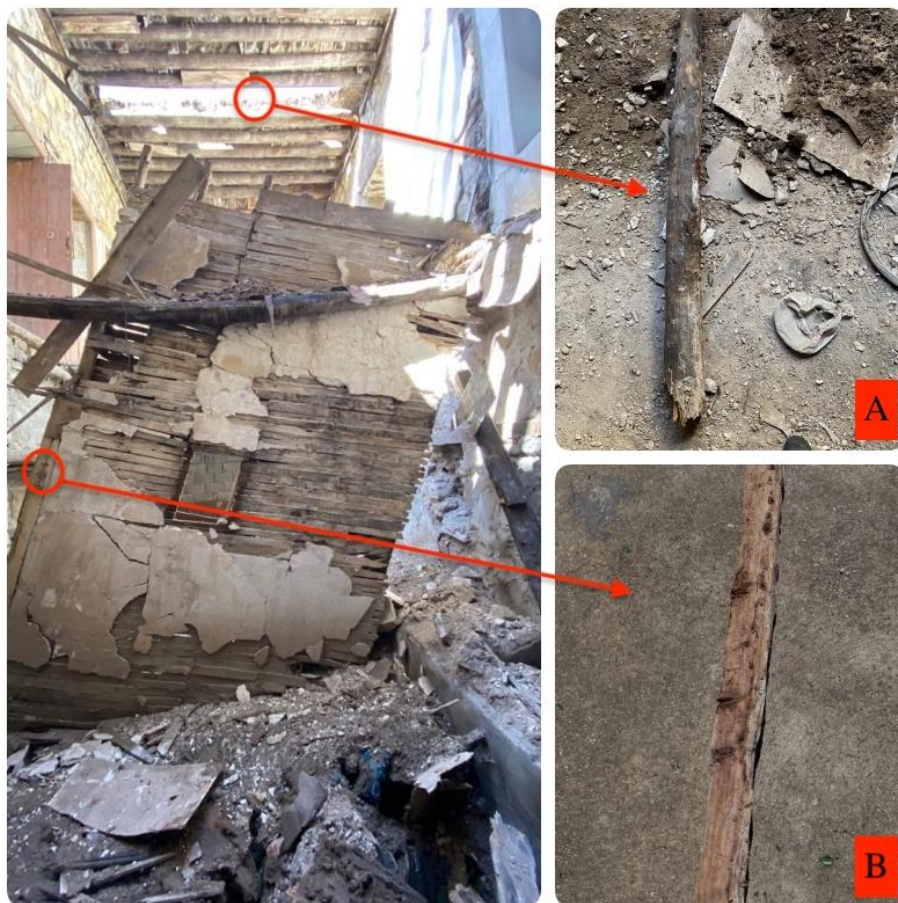
**Fig. 2.** The locations from which the wooden samples were extracted are as follows: A) The first sample was taken from the wooden ceiling of the ground floor; B) The second wooden sample was taken from the timber frame

Two samples were extracted from the mentioned structure for analysis, ensuring they were derived from the original wooden components of the building. The first sample

was obtained from the roofing planks of the second floor, while the second sample was taken from the wooden beams interspersed between the walls. The wood used for the roofing material and the beams between the walls is presumed to be from a coniferous tree species (Fig. 2).

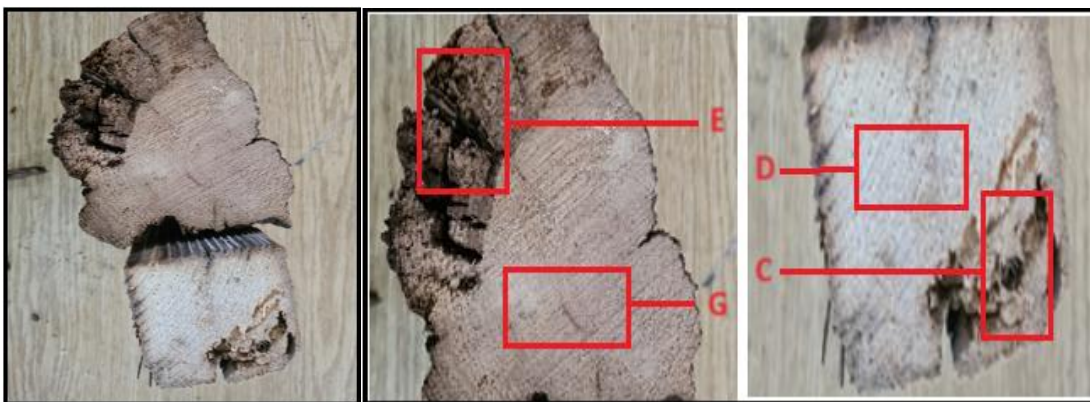
**Fig. 3.** The analysis sections (internal - external) of the wooden samples (E, G, C, D)

The portions of the samples obtained for chemical analysis from the wooden structures used in the roofing and beam elements of the historic mansion are provided below. Upon macroscopic examination of the wooden sample used in the roofing, the portions analyzed include the heavily degraded outer surface (E) and the undamaged inner surface (G). For the wooden beam sample, the portions analyzed include the heavily degraded outer surface (C) and the undamaged inner surface (D) (Fig. 3). For each sample, sections were taken from both the outer layer, where degradation was clearly visible (approximately 2 cm thick), and the core area of the wood.

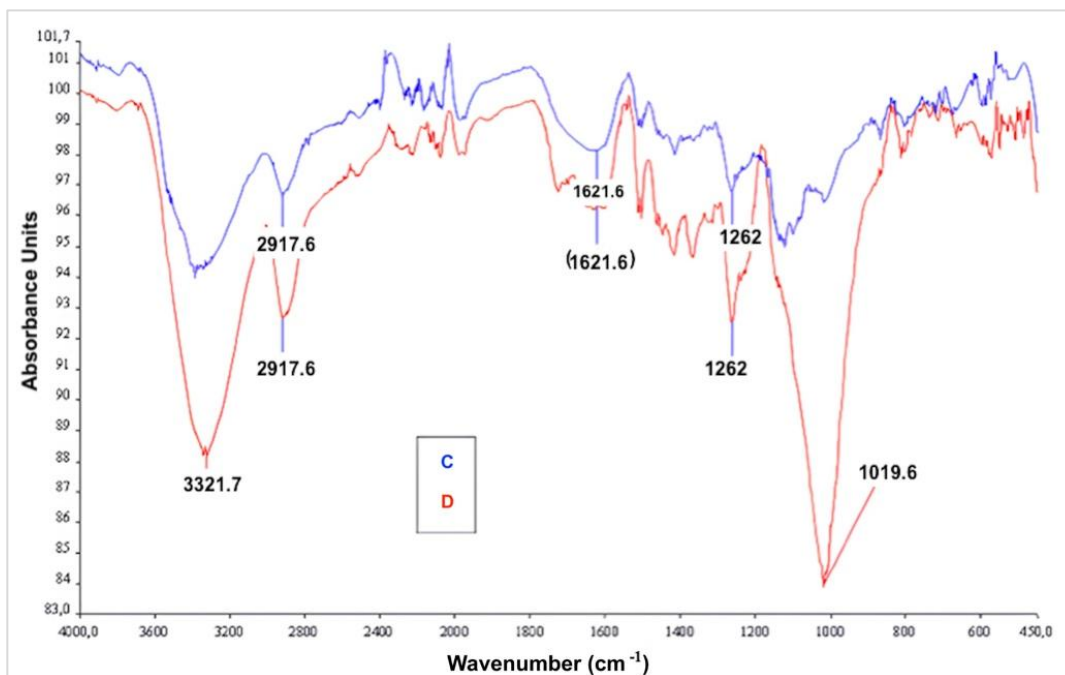
**Fig. 4.** The FTIR graphs of the C and D sections of the wooden samples

When the FTIR analysis of the C and D sections of the wooden samples obtained from the historic mansion was examined, an asymmetric stretching vibration peak of methyl and methylene groups located in cellulose, hemicellulose, and lignin was obtained at the wavelength of  $3321\text{ cm}^{-1}$  (Faix 1992; Pandey and Pitman 2003; Carrillo *et al.* 2004; Schwanninger *et al.* 2004; Bodirlau and Teaca 2009). At the wavelength of  $2917\text{ cm}^{-1}$ , symmetric stretching vibrations of methyl and methylene groups present in holocellulose were detected (Pandey and Pitman 2003; Carrillo *et al.* 2004; Schwanninger *et al.* 2004). A vibration peak related to the stretching of C=C and C=O groups in the lignin structure was identified at the wavelength of  $1621\text{ cm}^{-1}$  (García-Iruela *et al.* 2020; Ghavidel *et al.* 2020a). At the wavelength of  $1262\text{ cm}^{-1}$ , the C-O stretching vibration of guaiacyl lignin ring and the -OH and -CH bending vibrations of the holocellulose unit were determined. The stretching vibration peaks of C-O and C-C in holocellulose were obtained at the wavelength of  $1019\text{ cm}^{-1}$  (Faix 1992; Pucetaite 2012; Pedersen *et al.* 2021) (Fig. 4).

Upon comparison of the outer surface (C) of the wooden samples with the inner surface (D), where degradation was less or absent, it was observed that the intensity of the peak decreased at the wavelength region of  $800\text{ to }900\text{ cm}^{-1}$ . These wavelengths are related to the cellulose content of the wood (Derbyshire and Miller 1981; Hoffmann and Jones 1990). A significant peak loss was detected at the wavelength of  $1019\text{ cm}^{-1}$ , clearly indicating the loss of holocellulose in the wood. There was a decrease in peak intensity between wavelengths of  $1250\text{ and }1500\text{ cm}^{-1}$ . This decrease was associated with the lignin

content, and on this surface (C), where degradation is more pronounced, lignin degradation was observed.

In a study examining archaeological wood samples using FTIR analysis, the loss at wavelengths of  $1235\text{ cm}^{-1}$  and  $1646\text{ cm}^{-1}$  was attributed to the vibrations of the C=O and C=C groups in the lignin structure (Ghavidel *et al.* 2021a, 2021b). A peak loss was identified at  $1700\text{ cm}^{-1}$ , which is associated with hemicellulose component (Ljungdahl and Eriksson 1985; Lucejko *et al.* 2020; High and Penkman 2020). A decrease in intensity was determined at  $3320\text{ cm}^{-1}$ , indicating a reduction in holocellulose content at this wavelength (Fig. 4).

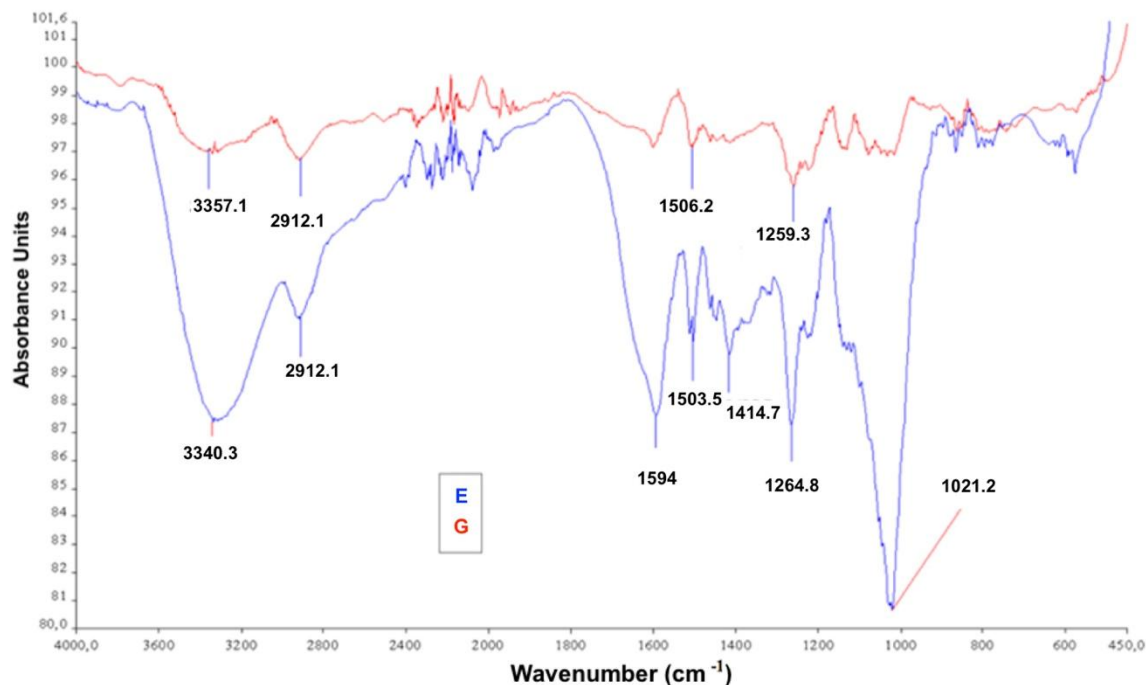
**Fig. 5.** The FTIR graphs of the E and G sections of the wooden samples

When the FTIR analysis of the E and G sections (Fig. 5) was examined, peaks of O-H stretching vibrations originating from cellulose and hemicellulose content were detected at wavelengths of  $3357$  to  $3340\text{ cm}^{-1}$ . At  $2912\text{ cm}^{-1}$  wavelength, the peak of asymmetric stretching vibrations of methyl and methylene-bound C-H stretchings in cellulose, hemicellulose, and lignin were obtained. At  $1599$  and  $1503\text{ cm}^{-1}$ , peaks due to stretching vibrations in the aromatic structure of the lignin component were found (Pucetaite 2012; Emmanuel *et al.* 2015; Moosavinejad *et al.* 2016). At  $1415\text{ cm}^{-1}$ , a peak of vibrations in the aromatic structure within lignin was observed (Pandey and Pitman 2020). At  $1264\text{ cm}^{-1}$ , the stretching vibrations of C-O in guaiacyl ring in lignin and the swinging peaks of OH and CH in hemicellulose were obtained. At  $1021\text{ cm}^{-1}$  wavelength, peaks of stretching vibrations of C-O and C-C in hemicellulose were obtained (Faix 1992; Pucetaite 2012).

In the E samples with degraded outer surfaces, the peak of OH vibrations originating from hemicellulose and cellulose content at  $3340\text{ cm}^{-1}$  was found more intensely in the G samples obtained from the more intact inner surfaces at  $3357\text{ cm}^{-1}$ . This is thought to be due to the brown-rot fungi damaging the outer surfaces of the wood, and additionally, photodegradation occurring on the outer surfaces. The peak of C=C stretching vibrations in the aromatic structure within lignin observed at  $1594\text{ cm}^{-1}$  in the E samples was found to be more intense at  $1599\text{ cm}^{-1}$  wavelength in the G sample with intact wood. This is believed to be due to photodegradation occurring on the outer surfaces of the wood affecting the lignin content.

At  $1415\text{ cm}^{-1}$ , a peak of vibrations in the aromatic structure within lignin was obtained in the E samples, which is not observed in the G samples. This peak is the vibrational peak associated with the aromatic structure in the lignin content. It is thought to be intensely observed on degraded surfaces due to the reduction in the hemicellulose content in the wood caused by the damage inflicted by brown rot fungi, which consequently leads to a relative increase in lignin content.

Between wavelengths of  $1050$  and  $1100\text{ cm}^{-1}$ , the peak intensity decreased on the outer surfaces (E) with intact degradation. The reason for this may be that while the peak of C-C and C-O vibrations in hemicellulose content was observed in the sample taken from the inner surface (G) at these wavelengths, the intensity decreased in the degraded outer surfaces (E). This is attributed to photodegradation and the action of brown rot fungi on the wood's outer surfaces.

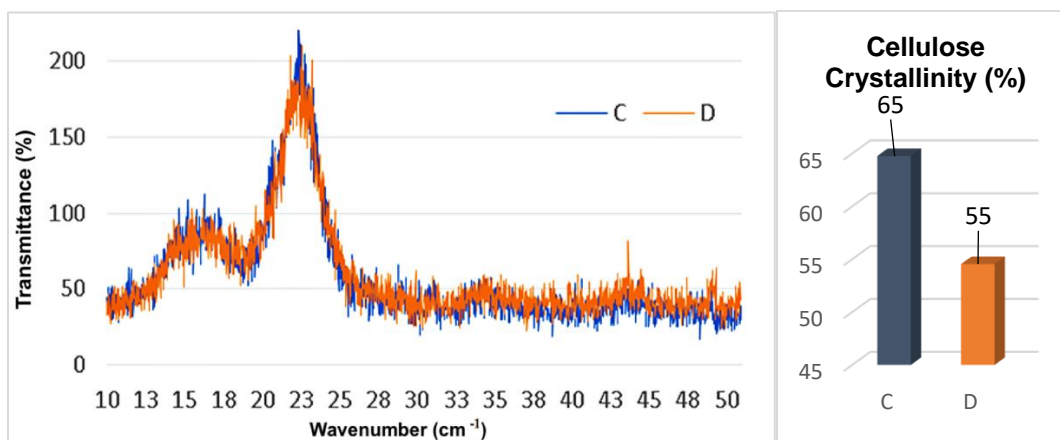
**Fig. 6.** The XRD graphs of the C and D sections of the wooden samples

When comparing the outer surface (C) and the less degraded inner surface (D) of the wooden samples, the crystallinity index of the outer surface (C) was determined to be 65%, while the crystallinity index of the inner surface was determined to be 55% (Fig. 6).

The reason for the increase in crystallinity index on the outer surface is believed to be the action of microorganisms, especially those causing degradation in wood materials. This may lead to the increase in crystallization of the wood component due to the degradations of lignin and hemicellulose, which have an amorphous structure (Howell *et al.* 2009). It is considered that substantial changes in crystallinity index and crystallite size may lead to an increase in the relative ratio of crystalline wood components after the removal of the amorphous fractions (lignin and hemicellulose). In this study, the samples

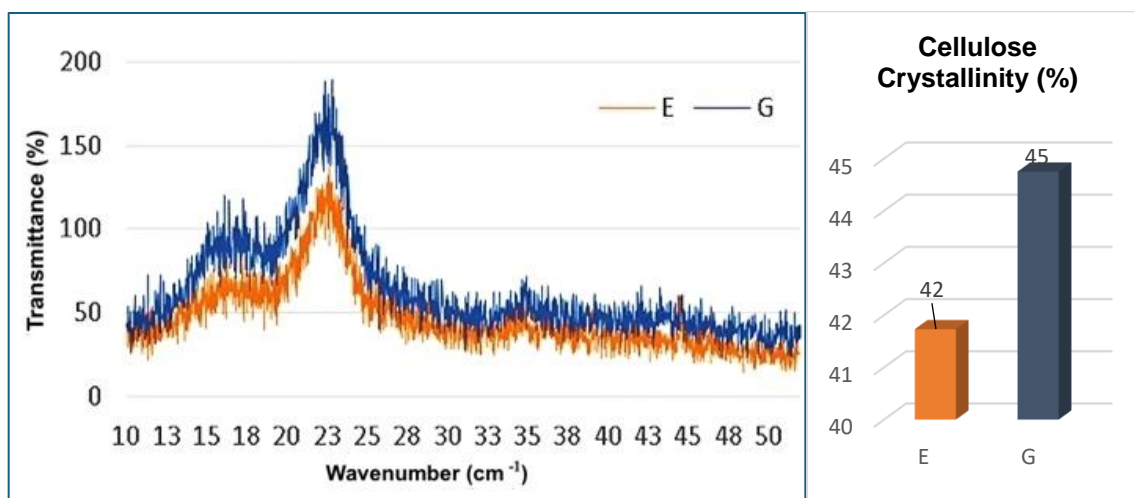
Fig. 7. The XRD graphs of the E and G sections of the wooden samples

When comparing the outer surface (E) and the less degraded inner surface (G) of the wooden samples, the crystallinity index of the outer surface (E) was determined to be 42%, while the that of the inner surface (G) was determined to be 45% (Fig. 7). It is presumed that the examined tree species is coniferous wood. In a study examining the degradation of wood under outdoor conditions, it was found that the crystallinity index of cellulose decreased due to the influence of outdoor conditions. They reported that wood cellulose was initially crystalline and that environmental degradation conditions made the wood more amorphous (Kim and Kuga 2001; Bouramdane *et al.* 2022). Additionally, they found that the loss of crystallinity was due to the opening of glycopyranose rings and the disruption of the regular structure (Kim and Kuga 2001; Li *et al.* 2011). The decrease in wood crystallinity during degradation processes under outdoor conditions indicates a reduction in hydrogen bonds in crystalline cellulose when temperature or oxidation levels increase. As a result, cellulose microfibrils become stiffer and more brittle, leading to a significant breakdown of hydrogen bonds and thus a cellulose structure that is easily degraded (Bouramdane *et al.* 2022).

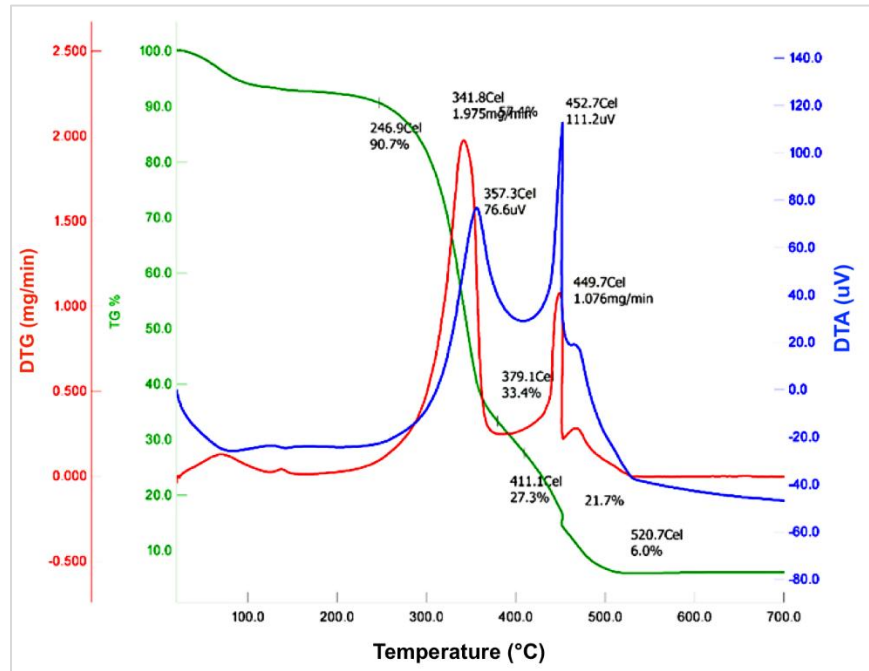
**Fig. 8.** The TGA, DTG, and DTA graphs of the C sections of the wooden samples

In the TGA, DTG, and DTA analyses of the D and C samples, the D samples (inner surface) started to degrade at 261 °C, and degradation reaction was completed at 499 °C (Figs. 8 and 9). It was determined that two exothermic reactions occurred during the degradation reaction, and at the beginning of the first degradation reaction, there was 89.6% substance, while the reaction started with 16.8% substance at the beginning of the second reaction. 72% of the substance was degraded between the two reactions. About 3.3% of the substance remained after the combustion reaction. The highest weight loss in the first reaction occurred at 352 °C with a rate of 2.151 mg/min, while in the second degradation occurred at 454 °C with a rate of 1.309 mg/min. The C sample (outer part) started to degrade at 246 °C and ended at 520.7 °C. Two exothermic reactions occurred

during the degradation process. At the beginning of the first degradation reaction, there was 90.7% substance, while the reaction started with 27.3% substance at the beginning of the second reaction. 63.4% of the substance was degraded between the two reactions. 6% of the substance remained after the reaction. It was determined that the weight loss rate of the D sample was higher than that of the C sample in both reactions.

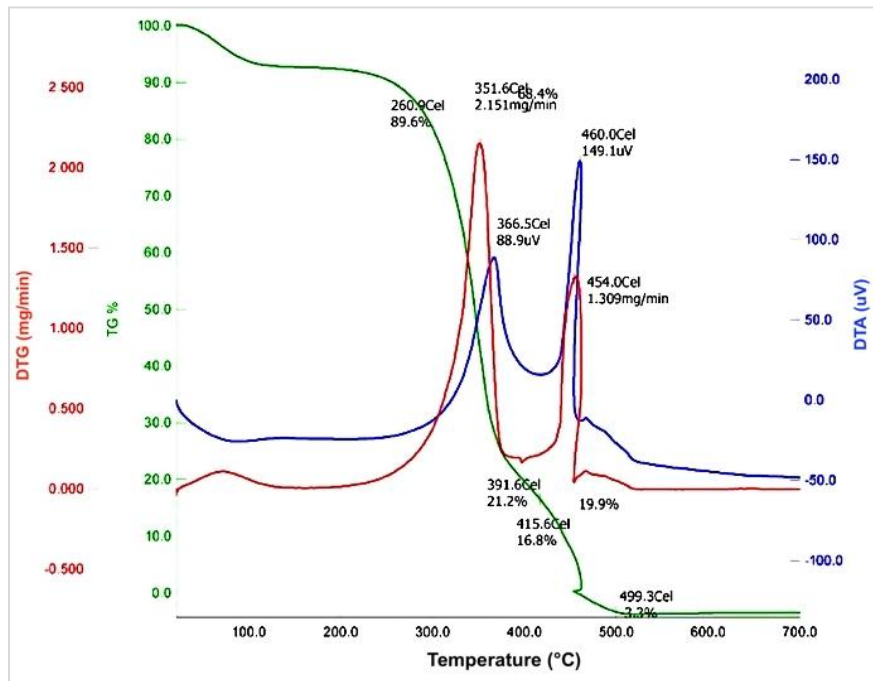
**Fig. 9.** The TGA, DTG, and DTA graphs of the D sections of the wooden samples

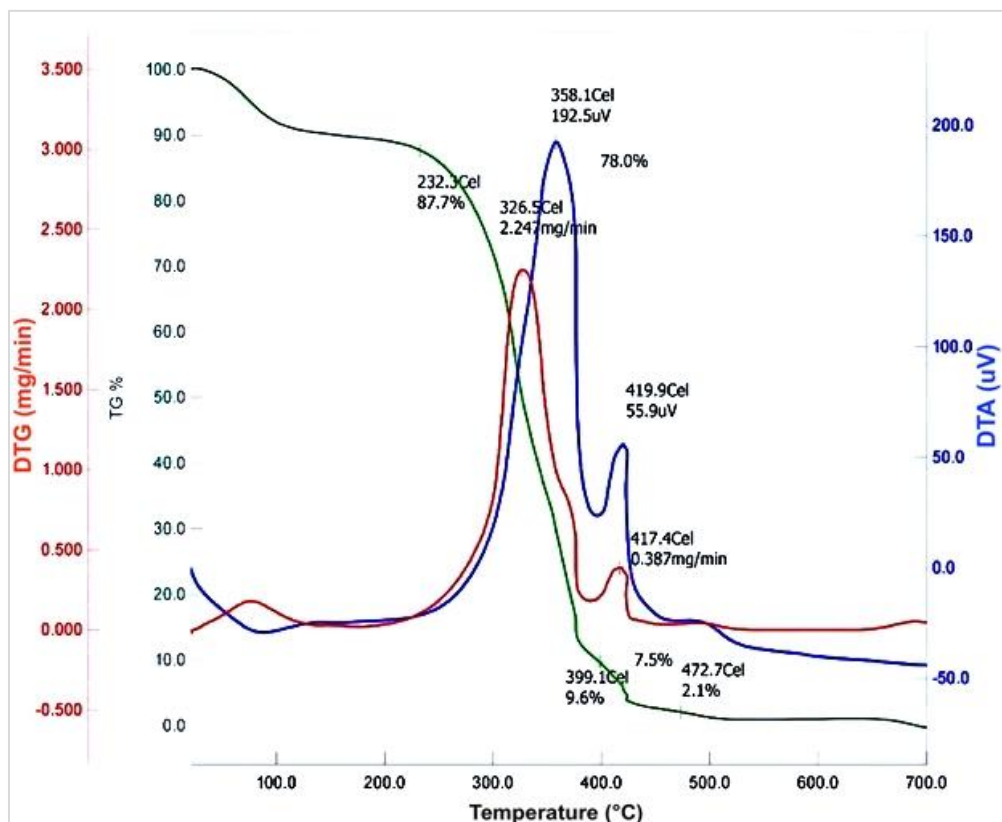
Fig. 10. The TGA, DTG, and DTA graphs of the E of the wooden samples

Upon examination of the TGA, DTG, and DTA graphs of the E and G samples (Figs. 10 and 11), it is apparent that the degradation reaction of sample G began at 239 °C and was completed at 489 °C. At the end of the degradation reaction, 0% of the substance remained. The degradation involved two exothermic reactions. The first exothermic reaction of the G sample occurred at the highest temperature of 333.7 °C, with a degradation rate of 1.995 mg/min, while the second degradation reaction occurred at the highest temperature of 429 °C, with a rate of 0.829 mg/min. At the end of the reaction, 0% of the substance remained.

According to the TGA, DTG, and DTA graphs of the E sample, the degradation reaction began at 232.3 °C and was completed at 399 °C. The reaction occurred in two stages as exothermic. At the end of the reaction, 2.1% of the substance remained. The first exothermic reaction of the E samples occurred at the highest temperature of 326.5 °C, with a degradation rate of 2.247 mg/min, while the second degradation reaction occurred at the highest temperature of 417 °C, with a rate of 0.387 mg/min. It was observed that the weight loss rate of the E samples was higher in the first exothermic reaction, while it was higher for the G samples in the second exothermic reaction.

Upon examination of the E and G samples, it was observed that the starting and completion temperatures of the degradation reaction due to thermal effects were lower for the E samples, which are more exposed to degradation under outdoor conditions, compared to the inner part (G), indicating a decrease in the thermal stability of the wooden samples.

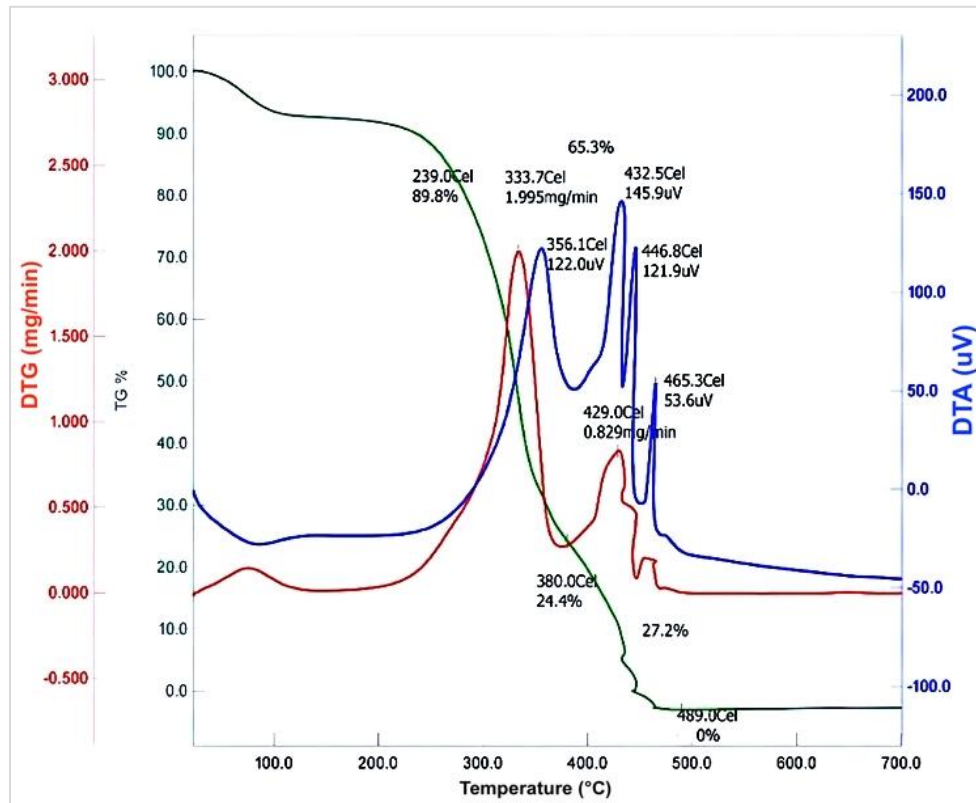
Fig. 11. The TGA, DTG, and DTA graphs of the G of the wooden samples
