Status Investigation and Damage Analysis of the Dougong under the External Eaves of the Main Hall of Chuzu Temple in the Shaolin Temple Complex

Ziyin Yao,^{a,#} Yilin Que,^{b,#} Xiaolin Yang,^{c,#} Qicheng Teng,^d Zherui Li,^a Xiaolan Zhang,^a Weizhen Cai,^a Hongyi Lv,^c Tongyu Hou,^a Yifan Liu,^a and Zeli Que^{a,*}

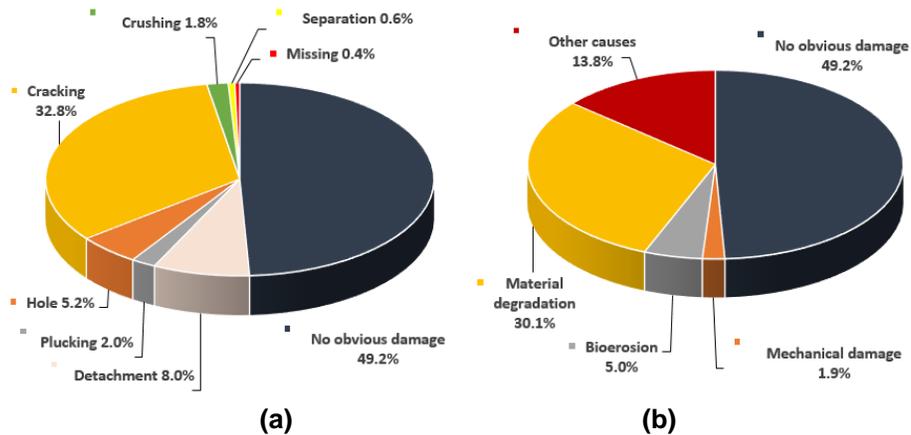
Fig. 6. Percentages of various types of damage (a) and causes (b)

The main types of damage (Fig. 5) included detachment, plucking (tenon pulled out), holes, cracking, crushing, separation, and missing parts. The summary statistics of the damage types are shown in Table 1. Percentages of the various damage types are shown in Fig. 6a.

Among all of the damaged members, the number of members with cracking damage was 241, which was the largest amount and accounted for a high proportion of the damage (32.8%). The number of cracked members of the east dougong was 56. Because the dominant wind direction in Dengfeng area is the northeasterly wind, the cracks resulting from degradation defect of wood material in the east was more significant. The Secondly, there were some members with detachment damage, which accounted for 8% of all of the damaged members. The number of members with hole defects accounted for 5.2%. The north side of the building was less exposed to sunlight and the roof is leaking, so the dark and humid environment was suitable for fungi and termites. Therefore, the hole damage in the north side was more significant than other three sides, and there were 20 members of the north dougong with holes caused by bioerosion. The plucked members accounted for 2%, and the proportion of the members with crushing damage was 1.8%. Additionally,

there were 0.6% of the members with a separated part and 0.4% of the members with a missing part.

The main causes were mechanical damage, bioerosion, and material degradation. The summary statistics of the damage causes is shown in Table 2. Mechanical damage caused cracking and crushing problems, and bioerosion caused damage such as wormholes and decay. Material degradation led to aging and cracking, which resulted in the wood cracking along the direction of the wood rays and caused large radial cracks. Some of these cracks were filled with mud which was filled in these members during restoration according to the information offered by local people. The percentages of the various causes are shown in Fig. 6b. Among the estimated members, the number affected by material degradation was 221, which was the largest proportion, accounting for 30.1%. The proportion of the members affected by bioerosion was 5%, and 1.9% of the members were

damaged by mechanical damage. The cause of 13.8% of the damaged members needs to be further studied.
