Detection and Analysis of an Eave Purlin of the Timber Building Eroded by Carpenter Bees Based on Computed Tomography

Xiaoxia Yang,^a Yisheng Gao,^{b,*} Ziyu Zhao,^a Zhedong Ge,^a Xiaoping Liu,^a and Yucheng Zhou^a

DOI: 10.15376/biores.17.2.2443-2456

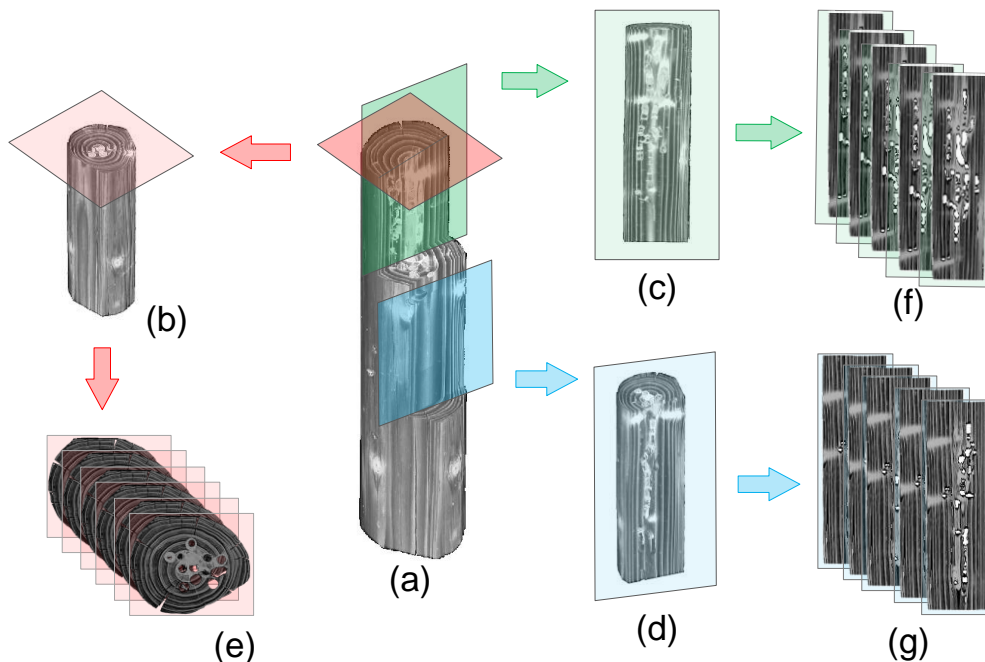
Fig. 2. 3D and 2D images of three sections of logs: (a) log specimen; (b) the transverse section in 3D; (c) the radial section in 3D; (d) the tangential section in 3D; (e) the transverse sections in 2D; (f) the radial sections in 2D; (g) the tangential sections in 2D

Based on CT technology, the transverse sections of the log referred to the section perpendicular to the growth direction of the trunk main axis, as shown in Figs. 2 (b) and (e). Tangential sections referred to the longitudinal section of the trunk that did not pass through the pith core, as shown in Figs. 2. (d) and (g). Figure 2 (a) shows the 3D structure of the log. From this picture, the transverse, radial, and tangential sections can be seen. As shown in Fig. 2., the log was cut with the red, green, and blue planes, so multiple 2D images of wood transverse, radial, and tangential sections could be obtained.

As shown in Fig. 2, wood is an anisotropic material. Through the comparative observation of transverse sections, radial sections, and tangential sections of wood, the internal structure of wood may be fully understood. In this paper, Log A, Log B, and Log C were scanned to obtain 2D transverse-sectional images. From the transverse sections, radial sections, and tangential sections of each log, 10 section images seriously eroded by carpenter bees were randomly selected. The number and diameter of holes in transverse sections, the number and depth of holes in radial sections, and tangential sections were analyzed. As shown in Table 3, the number of holes in Log B was the largest, with 105 holes.
