Assessment of Reuse Potential of Maritime Pine Utility Poles for Structural Applications after Removal from Service

Keywords: Timber utility poles; Maritime pine; Structural reuse; Mechanical properties; Bending test

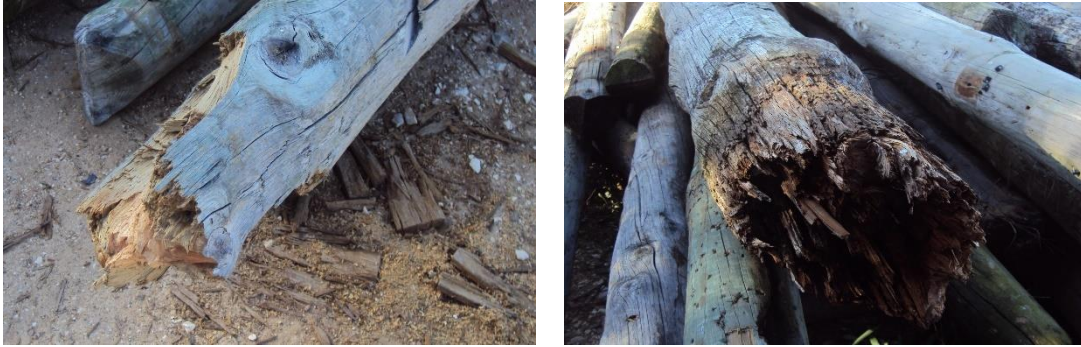
Fig. 1. Attainment of maximum bending moment near the ground-line

A total of 51 specimens were selected by simple visual inspection; utility poles with serious damage were rejected. Some selected utility poles showed signs of damage such as attainment of maximum bending moment near the ground-line (Fig. 1), rot in the previously buried length (Fig. 2), and woodpecker holes in the upper part of the utility pole (Fig. 3).

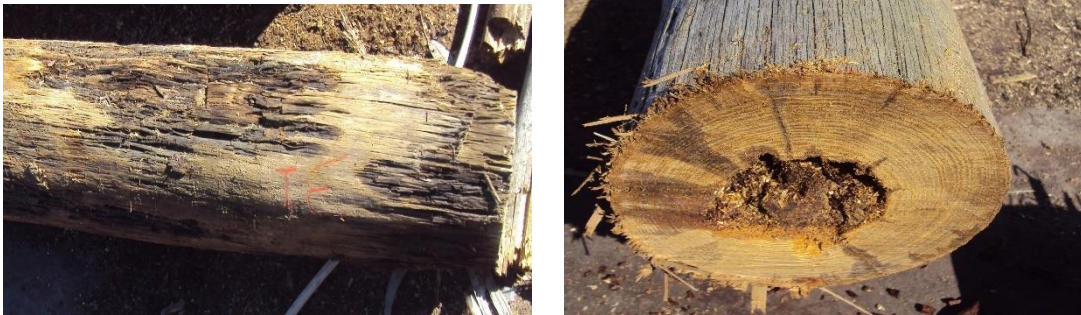
Fig. 2. Rot in the previously buried length

The lowest MOR value (11.7 MPa) was from a utility pole that presented biological degradation in the previously buried area and the damage influenced the mechanical behavior of the utility pole. Therefore, special attention needs to be paid to the level of damage of UPRFS if they are to be reused for structural applications. UPRFS could be used in other structural applications if a good selection is made, refusing severely damaged specimens. If a damage-free utility pole selection is not possible, the alternative is to process the utility poles and remove damaged areas, usually near the ground-line and/or near the top.

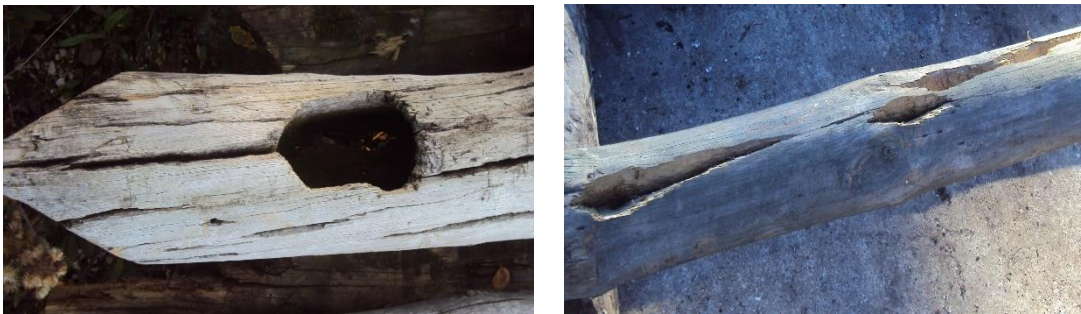
Fig. 3. Woodpecker holes

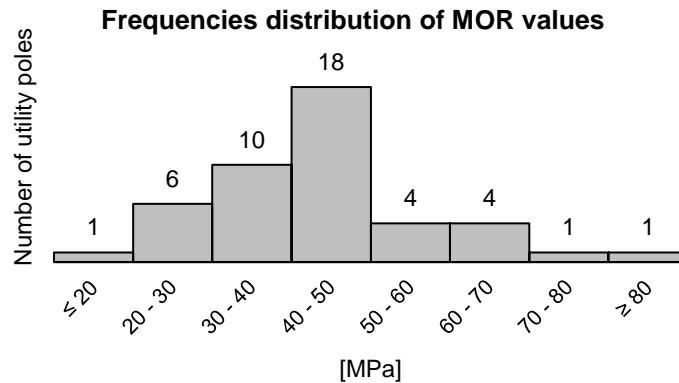
Fig. 5. Distribution of the frequencies of the MOR values obtained in destructive tests

Compared with new utility poles, with $MOR_k = 37.0$ MPa (Martins and Dias 2012), UPRFS exhibited a 49% decrease in the characteristic value of MOR. This difference is directly related with the higher standard deviation of UPRFS, which leads to a coefficient of variation of 31.3%, against the 13.1% coefficient of variation of the new utility poles. The cause for the higher standard deviation for UPRFS was the wide range of MOR values. Not only low values were obtained, due to the several damages found in UPRFS, but also high values, as it is showed in the frequencies distribution of MOR values, in Fig. 5. However, the reduction of the MOR mean value of UPRFS was only 14% when compared with the mean value of the new utility poles (50.2 MPa). Regarding MOE, the mean value of UPRFS was 6% lower than in new utility poles (10.9 GPa).
