Experimental Behavior of Laminated Veneer Lumber with Round Holes, with and without Reinforcement

Laminated veneer lumber (LVL) is an engineered wood product that is commonly used for joists in wooden buildings. Holes in joists are often necessary to allow piping systems to pass through. Introducing a hole into an LVL joist remarkably changes the distribution of stresses in the vicinity of the hole. Tensile stresses occur perpendicular to the grain, and the capacity of the joist can be decreased accordingly. This study presents the experimental results of LVL joists with holes and reinforcement methods around the holes. The results showed that cutting a large enough hole contributed substantially to the strength reduction of LVL joists. Holes with a diameter-to-joist depth ratio of 0.4, 0.5, and 0.6 reduced the load-capacity 50.1%, 59.6%, and 68.8%, respectively. Glued plywood and glued-in threaded rods were both effective methods for reinforcing LVL joists with holes having a diameter-to-joist depth ratio of less than 0.5. The reinforcement effect of nailed plywood was relatively poor, increasing the load-capacity less than 30%. The reinforcement effect of all of the methods depe

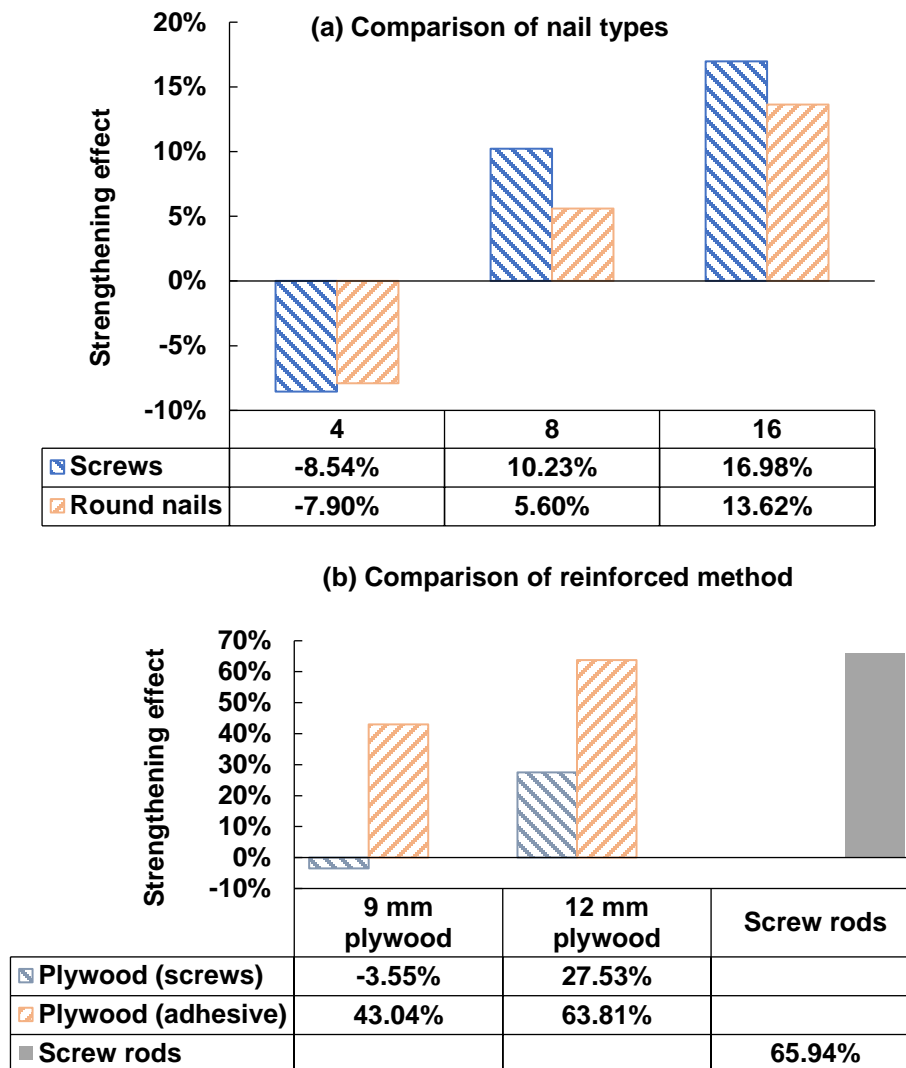
Fig. 7. Strengthening effect of various reinforcement methods for joists with 80-mm holes. Comparison of nail types (a) and reinforced method (b)

As shown in Figs. 5b and 7a, the quantity and type of nails influenced the strengthening effect of nailed plywood. The plywood with 4 screw nails or round nails did not strengthen the joists but weakened them. This result may have been because the strengthening effect of this setup was minimal. More round nails or screw nails provided a greater contribution to the bond between the plywood and the LVL so that the stress could be transferred from the LVL to the plywood through these nails. Especially in the case of using 16 screw nails, the nailed plywood slowed the development of cracks around the holes, delayed the time to breakage, and provided a maximum load of 36.58 kN, which was close to the joists without holes. During the bending tests, it was discovered that the nailed plywood rotated and broke away from the LVL under the stress around the holes (Figs. 6a, b).

The nails around the holes were distorted and sank into the joists, particularly the nails around the cracks (Fig. 6c). Thus, these nails transmitted the stress from the LVL to the plywood and bore shear stress at the same time. The bond between the LVL and the plywood was tighter, the separation of the plywood was more difficult, and the failure time of the joists was longer with an increasing number of nails, and thus, the load-bearing capacity of the joists was better. Because of the higher withdrawal capacity in comparison with the round nails, the screw nails required more stress to distort and pull out, and thus, contributed to more load-bearing during the tests (Fig. 7a). The thickness of the plywood

80-mm holes reinforced with 12-mm glued plywood, failure occurred at mid-span (Fig. 9a). The 12-mm glued plywood contributed more strength (approximately 20.81%, as shown in Fig. 7b) than the 9-mm plywood, and stopped the extension of cracks around the holes, successfully changing the failure mechanism. Therefore, the thicker plywood was able to bear more stress.

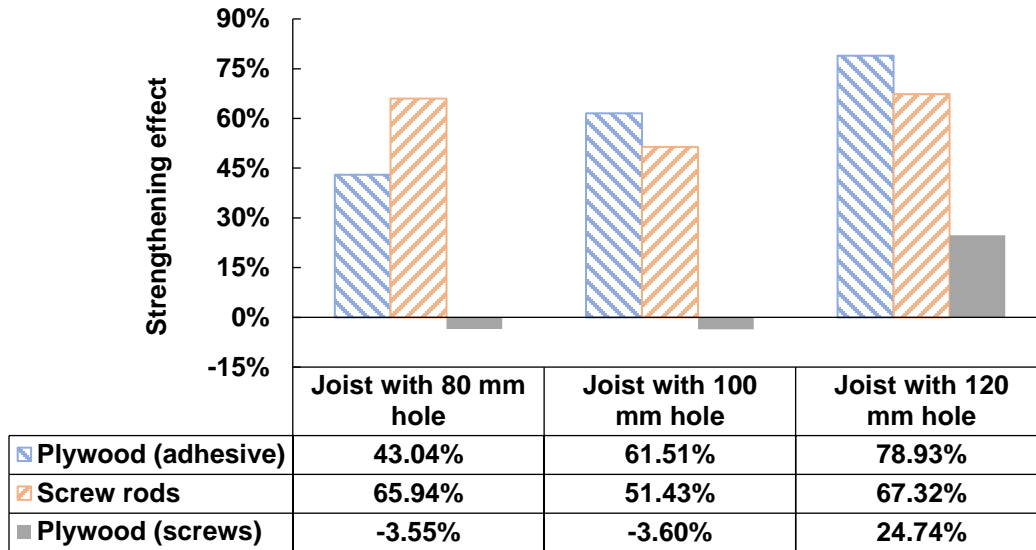
Fig. 8. Increase in failure load of joists with various reinforcement methods in comparison with joists with holes and without reinforcement

The plywood that was glued to the LVL reinforced the joists substantially. As shown in Fig. 8, for joists with 80-mm, 100-mm, and 120-mm holes, 9-mm glued plywood increased the failure load by 43.0%, 61.5%, and 78.9%, respectively, compared to the joists with holes and without reinforcement. In some cases, the maximum load of the reinforced joists exceeded that of the joist without holes. However, the 9-mm plywood did not prevent the propagation of cracks. The failure mode of the joists was shear failure around the holes, and plywood on both sides of the joists also showed shear failure (Fig. 9b). For joists with

As shown in Figs. 5d and 8, the glued-in threaded rod was an effective method for reinforcing joists with holes. Similar to adhesive plywood, the use of glued-in threaded rods for holes up to 100 mm (0.5 of the joist depth) yielded excellent results in recovering the load-carrying capacity to that of intact joists. As for larger holes, *i.e.*, 120 mm, the failure load was increased by 67.32%. It was observed that the rod over the upper crack (Fig. 10a) was undamaged, while the other rod (Fig. 10c) was bent or broken, and the interface between the rod and the timber was fractured. Limited by the threaded rod, the upper crack could not extend over the boundary, and the tension stress could not be released through the development of the crack, which led to new cracks above the hole and a bulge of the timber in that area (Fig. 11).

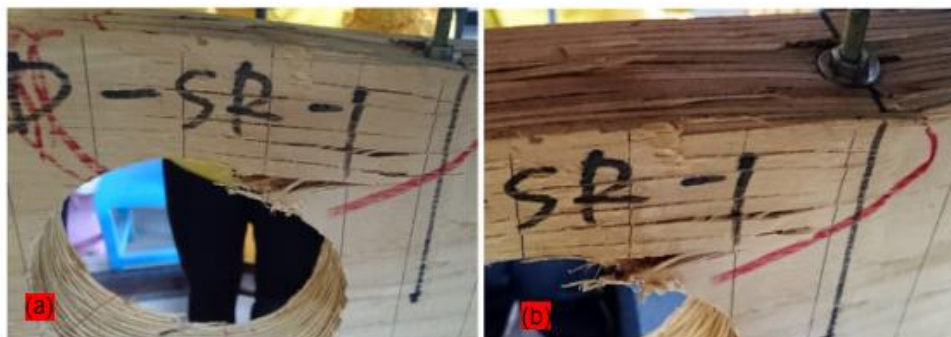
Fig. 11. Cracks above the hole were confined within the two rods (a), and the wood under the washer was compressed (b)
