Review of the Current State of Application of Wood Defect Recognition Technology

Yutang Chen, Chengshuo Sun, Zirui Ren, and Bin Na *

Keywords: Wood defects; Detection and identification; Equipment; Wood processing

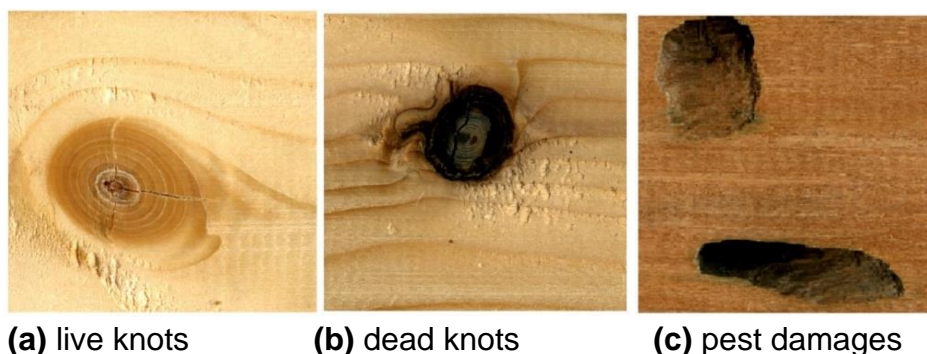
Fig. 1. Major wood defects

The main growth defects in timber are knots, cracks, slashes, burrs, resin capsules, *etc.* Most of these defects are due to the normal growth of the tree. However, from the perspective of wood panel utilisation, these are wood defects. Of these, knots are divided into live knots, as shown in Fig. 1a, and dead knots, as shown in Fig. 1b.

Defects caused by various pests are known as wood pest damage, which is mainly manifested in the form of holes and grooves in wood cuts, as shown in Fig. 1c. Pest damage that involves eaten round timber to a radial depth of less than 10 mm is known as surface holes and grooves. Holes with a minimum diameter of less than 3 mm are known as small holes, and holes with a minimum diameter of 3 mm or more are known as large holes. Surface pest holes and grooves can often be removed with the veneer and therefore have little effect on the use of the timber. Scattered small pest holes have little effect, too. However, large holes with a depth of 10 mm or more and deep, dense small holes can damage the integrity of the timber and reduce its mechanical properties. Moreover, pest holes and grooves are an important channel for sapwood discolouration and decay.

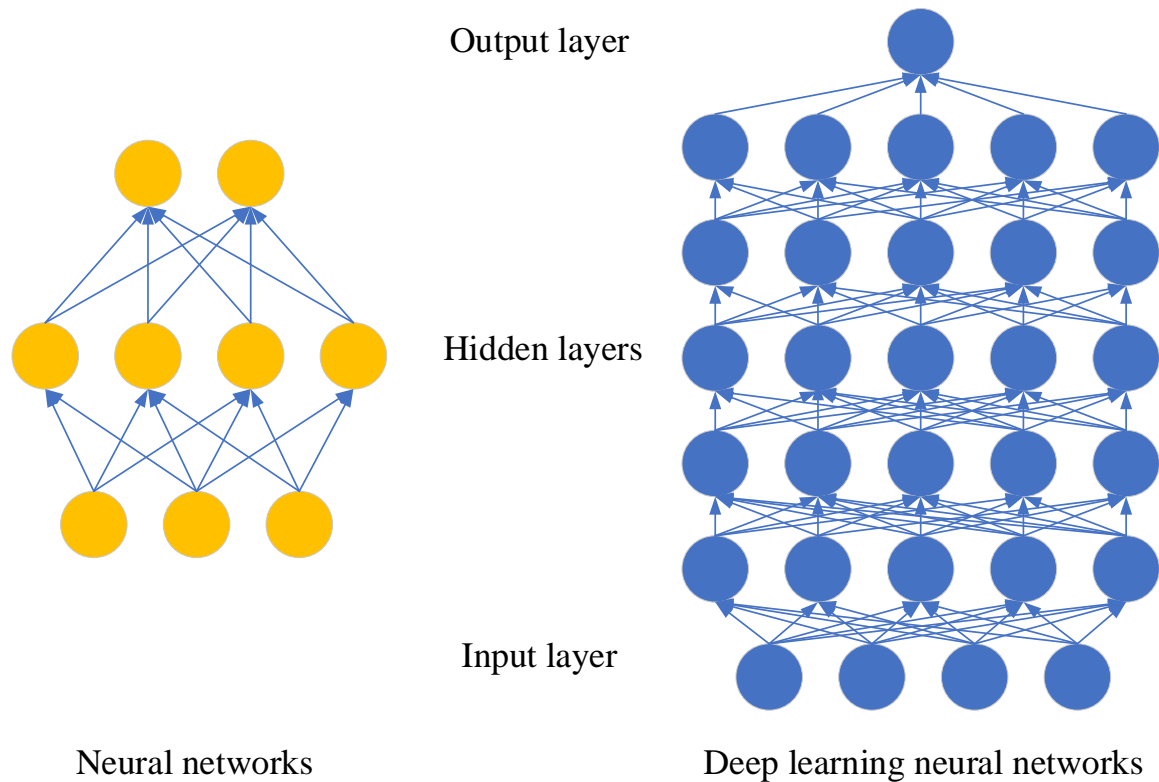
Fig. 2. Different amounts of data between deep learning and ordinary neural networks

Deep learning is a branch of neural networks, and its superiority lies in the greater amount of data learned and the times it is learned. Typically, this means that deep learning will have more hidden layers. However, it is not the case that more hidden layers mean better learning results. Designing the right number of hidden layers for a specific issue is one of the keys to a successful deep learning design. A comparison of the structure of deep learning and ordinary neural networks is shown in Fig. 2.

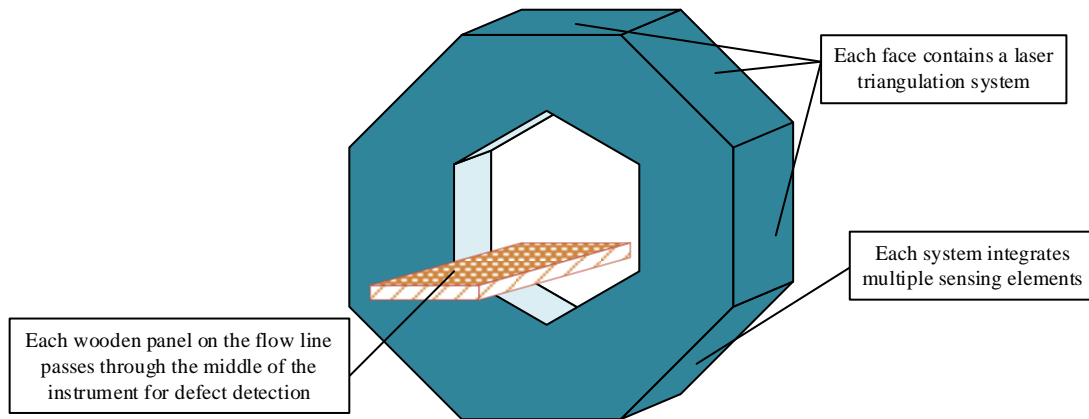
Fig. 3. Schematic diagram of multi-faceted detection architecture

uses multi-angle defect detection based on laser triangulation. The advantage of this architecture (Fig. 3) is that it enables high-speed detection of wood defects in conjunction with production lines. At the same time, these advanced wood defect recognition machines use other monitoring methods to achieve a wider range of applications and more accurate results.

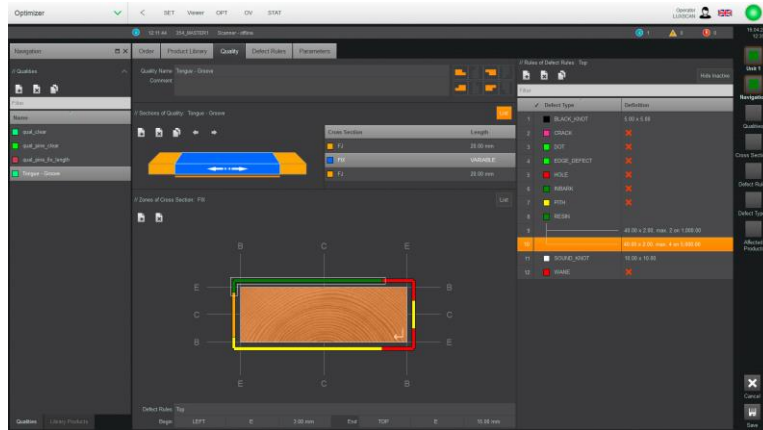
Fig. 5. The status monitoring interface

WEINIG (Germany) has also designed a wood defect recognition system using laser detection in conjunction with image detection. As the laser detection has a stronger three-dimensional feature mining capability and the image detection has a stronger two-dimensional feature mining capability, these two methods can be used together to improve the stability and accuracy of defect detection. The system is designed for the processing environment. In such systems, wood dust can be dispersed during the wood processing

process and the device is protected by separate sealed air chambers for each angle of the sensor to obtain more stable defect identification results. In addition, the system's real-time status monitoring software makes it easy for the operator to follow the real-time status of the wood defect identification and to intervene manually if necessary, with the status monitoring interface shown in Fig. 5. The small size and mass of the system compared to the previous system makes it easy to move around, allowing it to be used in a variety of factory environments, even in small workshops.
